Yale Union Window Assessment

The Condition Assessment

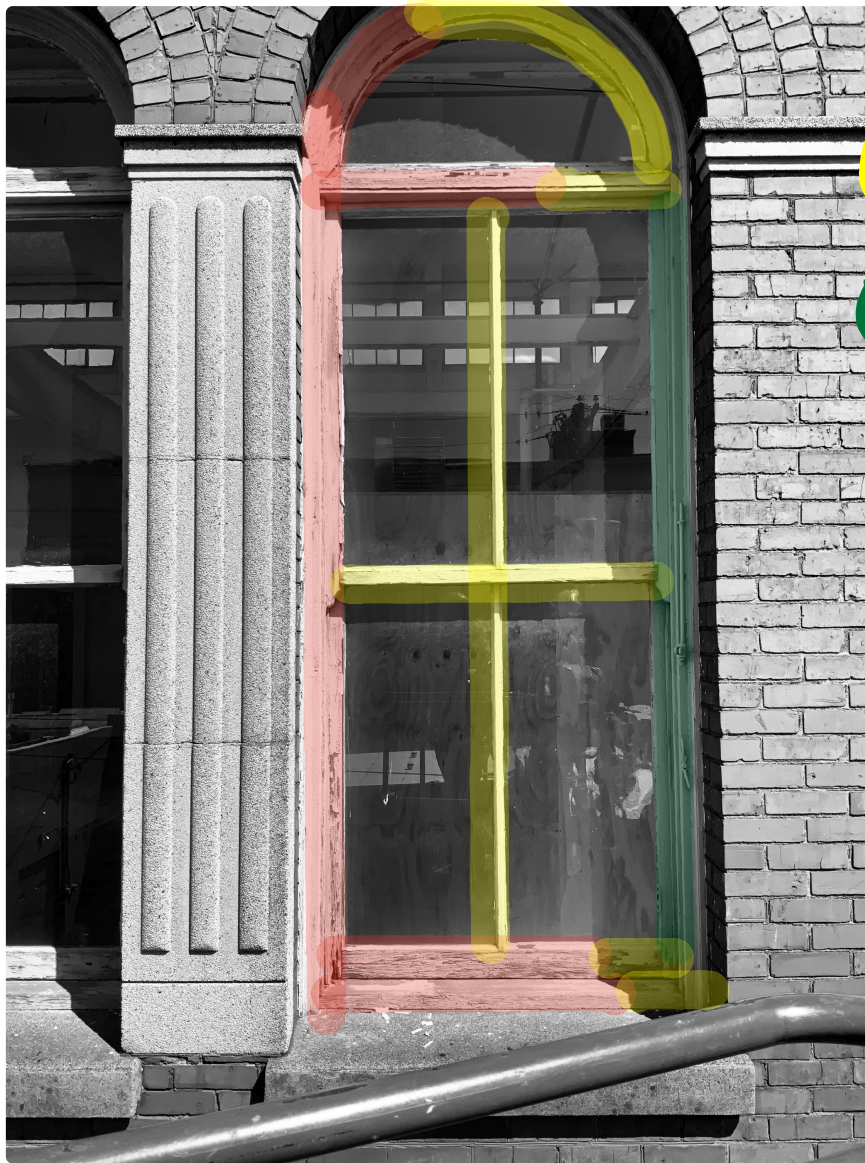
This image was converted to black and white to help indicate typical failure locations of coatings from UV damage and subsequent loss of historic substrate material where coatings are missing altogether. This is W214, and is used as an example for a baseline assessment of all of the W201-W222 windows.

Red indicates severe/high UV Damage, resulting in poor condition assessment.

Yellow indicates moderate/medium UV Damage, resulting in poor to fair condition assessment

Green indicates fair/minimal UV Damage, resulting in fair condition assessment

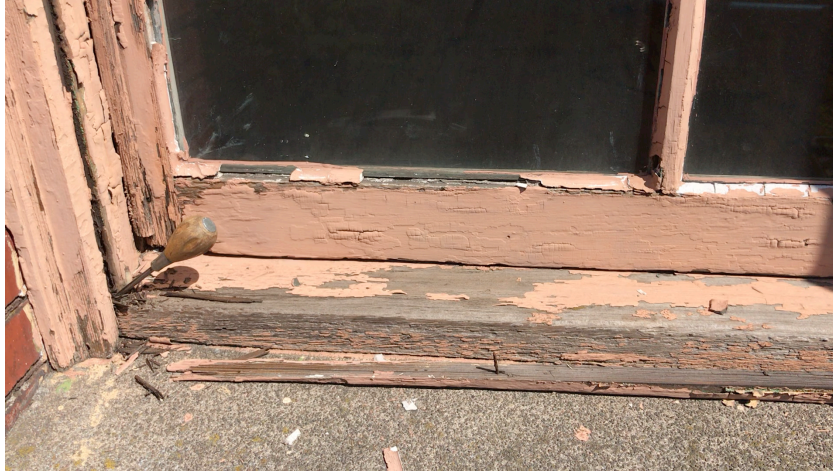
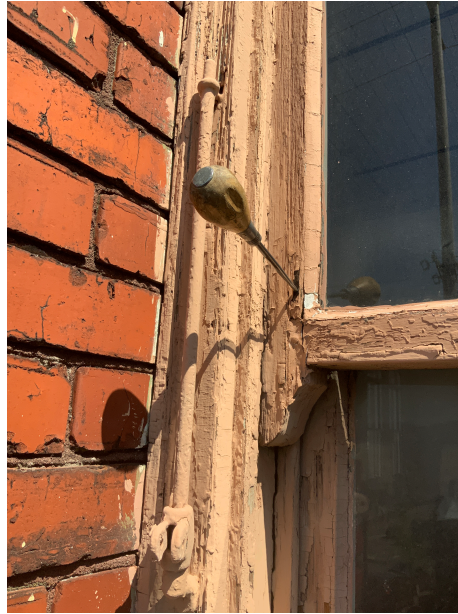
Frame/Trim: Overall the frames/trim are in Fair condition and should have all paint removed. The Frames have localized decay happening in typical locations where joints are formed and places where water can sit, and enter. Specifically the places that are the most in need of attention are the left (all from the outside) frame to sill connection, the blind-stop on the left side continuing up to the left half of the transom, the brick mold on the left side and the brick mold in the same pattern of the blind-stop. See the red areas in the photo above.

Careful epoxy work or replacement of these elements is recommended.

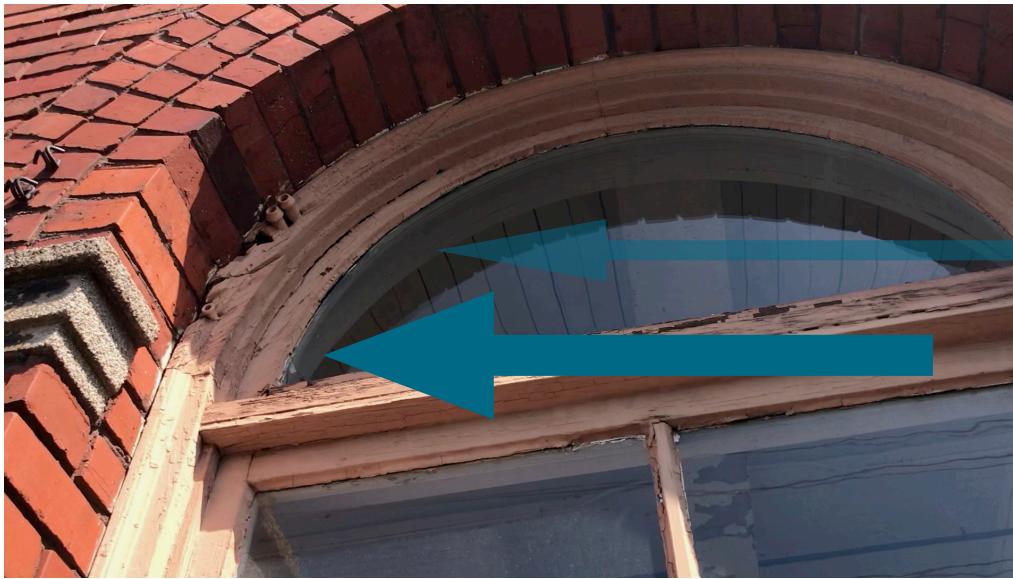
The Half-Round Transom sash here are the unfortunate bearers of bad news. The original manufacture of these sash placed a long grain joint next to a short grain joint at the worst possible location for these windows resulting in an extra high-likelihood of failure if exposed to any stressors. The common theme in these joints is indicated in the following photos.

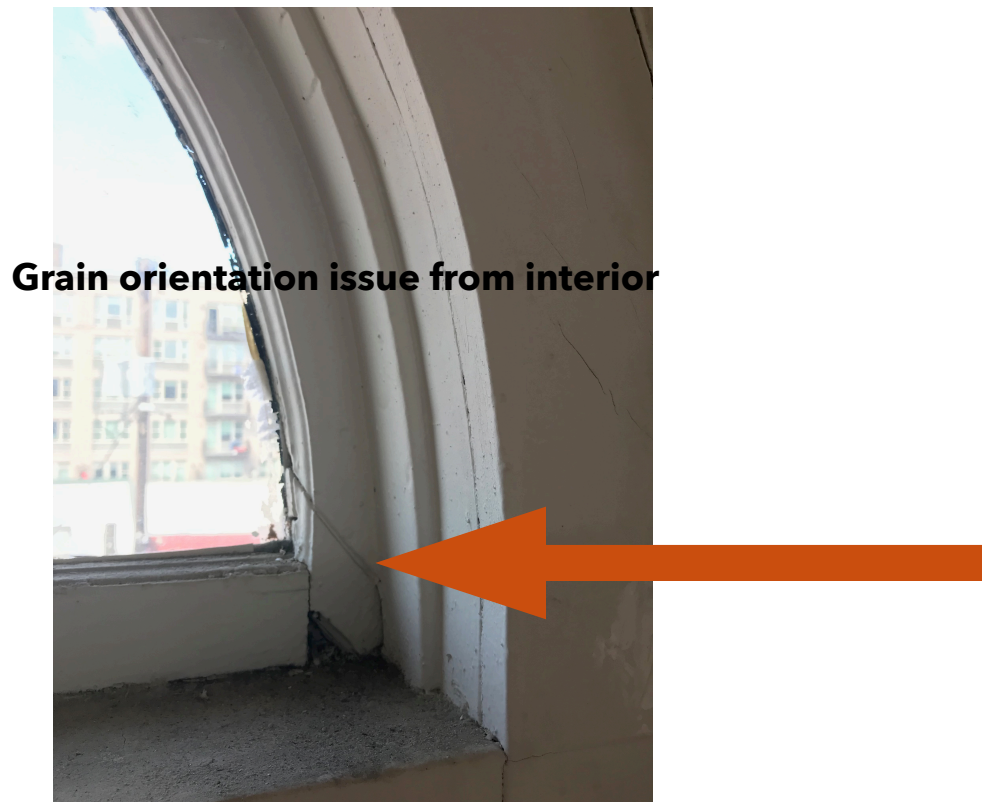
Again, left to right we have found that the grain orientation of the curved work on the transom sash and the transom brick mold to be incompatible

with the high-weather exposure location and a systematic approach to remedy this failure prone area is recommended. The replacement of the transom sash, the curved blind stop and the curved brick mold on all 22 of the West transoms is worth weighing against the repair durability and expense that will be incurred. Careful attention must be paid that the new sash and millwork are continuous and do not have splices in the material
