Yale Union Window Assessment

The Condition Assessment

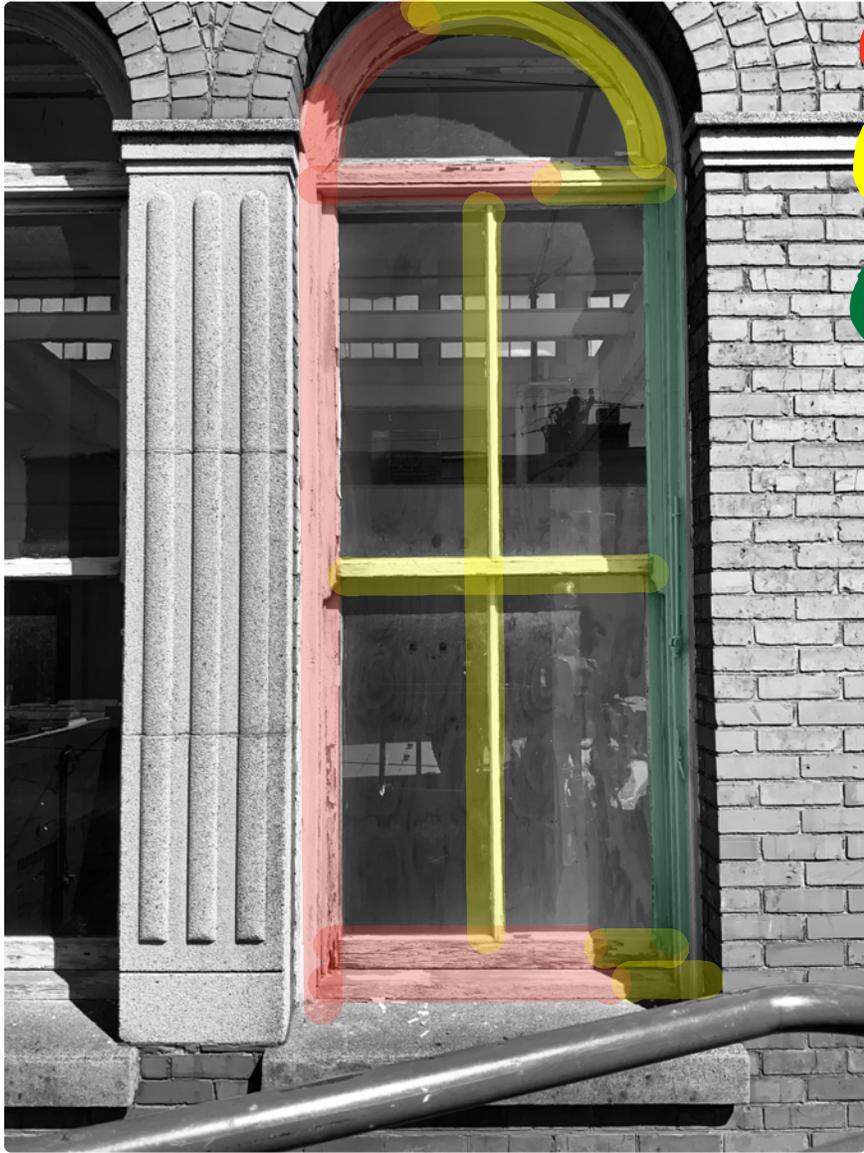
The overall condition assessment for the 22 West Facing 2 over 2 with transom is fair leaning towards poor. A few locations are critical as referenced in the survey. The windows have had extensive glass replacement over the years and have missed many maintenance periods for coatings. The result of coating failure is quite a bit of substrate material (wood) being weathered away from UV damage. Seasonal rain and sun, coupled with the fact this elevation is West facing has caused weather-checking on approximately 30% of all flat and profiled exterior surfaces. The weather patterns most evident from this survey are isolated to the left-hand side of the sash, frame, horizontal mullion and the left-hand side of the half-round transom and curved brick mold.

This image was converted to black and white to help indicate typical failure locations of coatings from UV damage and subsequent loss of historic substrate material where coatings are missing altogether. This is W214, and is used as an example for a baseline assessment of all of the W201-W222 windows.

Red indicates severe/high UV Damage, resulting in poor condition assessment.

Yellow indicates moderate/medium UV Damage, resulting in poor to fair condition assessment

Green indicates fair/minimal UV Damage, resulting in fair condition assessment

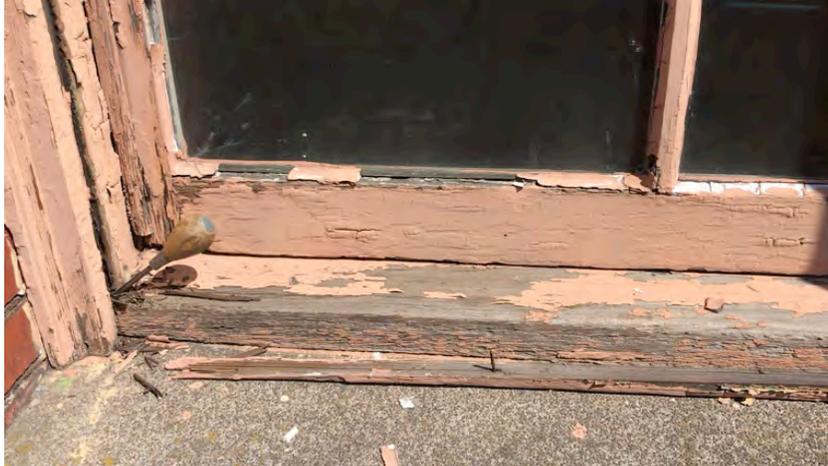
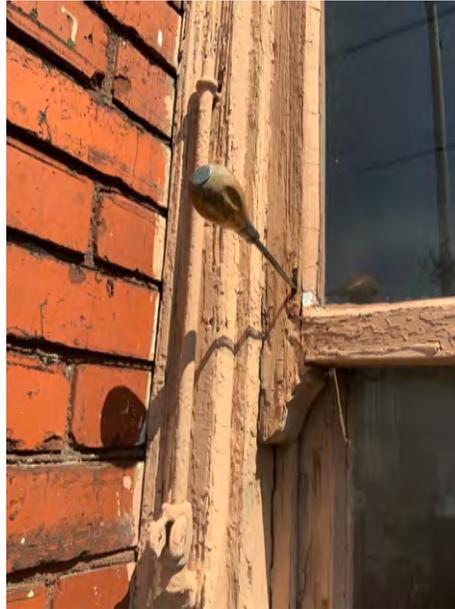
Frame/Trim: Overall the frames/trim are in Fair condition and should have all paint removed. The Frames have localized decay happening in typical locations where joints are formed and places where water can sit, and enter. Specifically the places that are the most in need of attention are the left (all from the outside) frame to sill connection, the blind-stop on the left side continuing up to the left half of the transom, the brick mold on the left side and the brick mold in the same pattern of the blind-stop. See the red areas in the photo above.

Careful epoxy work or replacement of these elements is recommended.

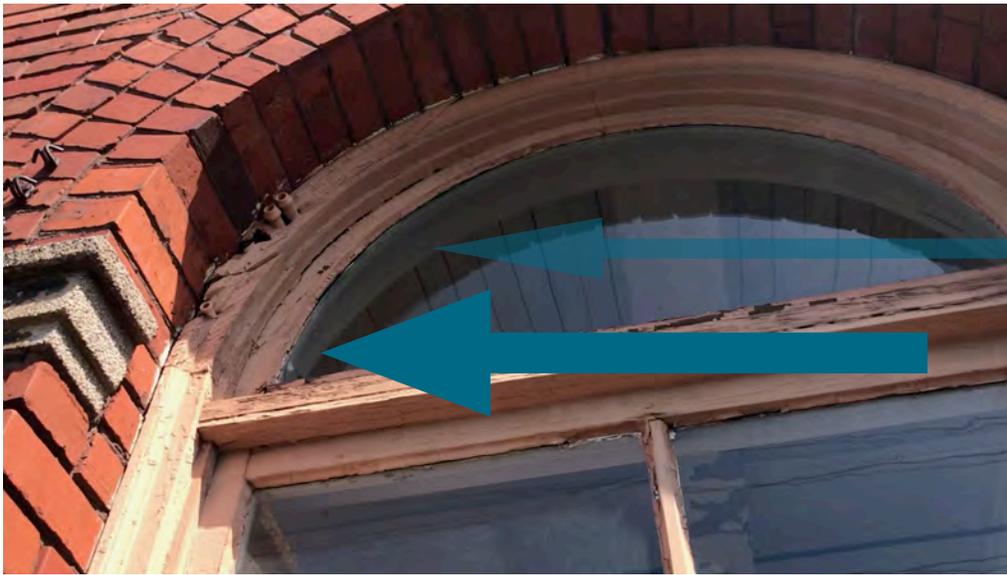
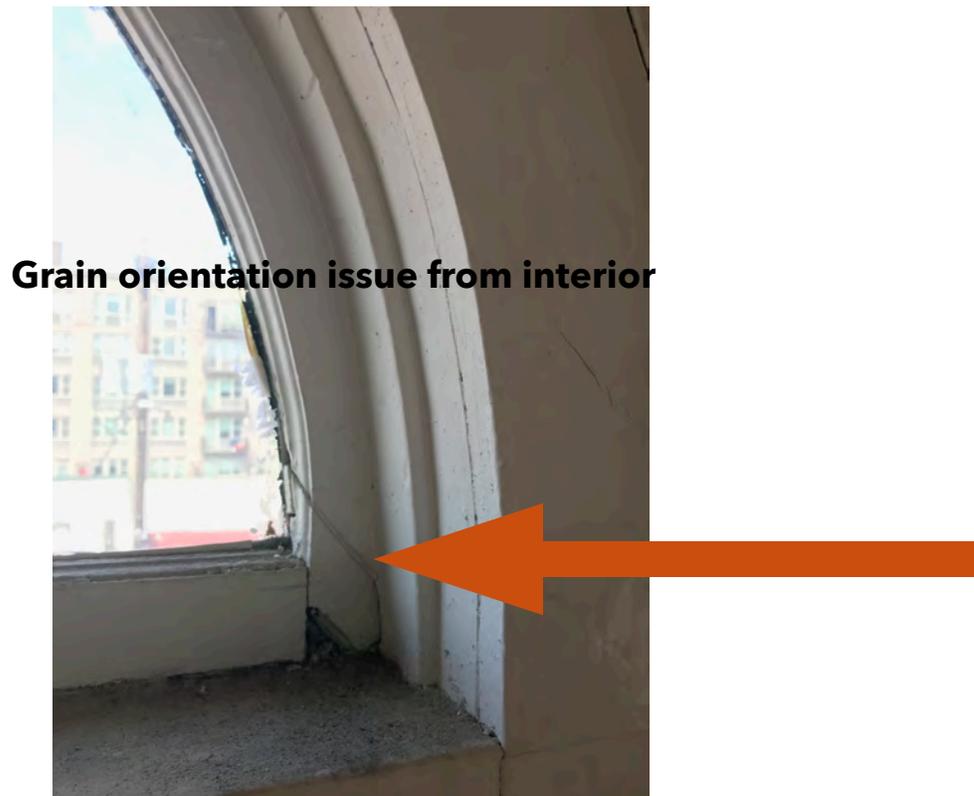
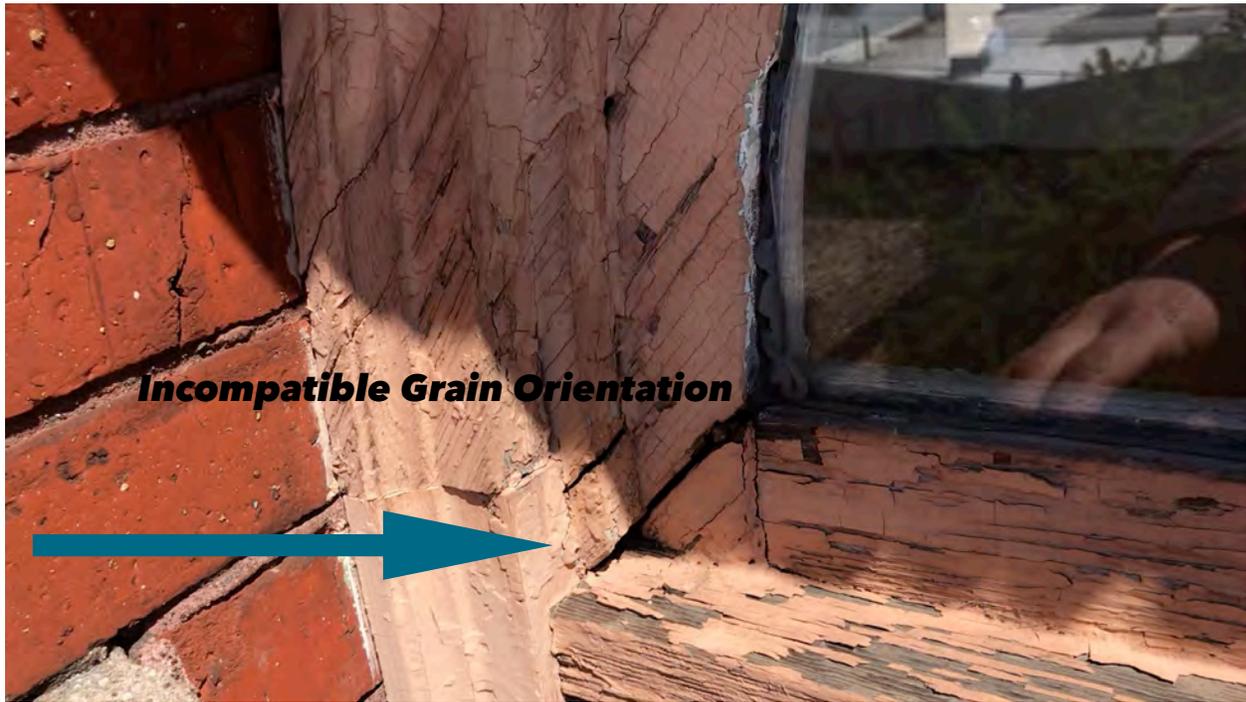
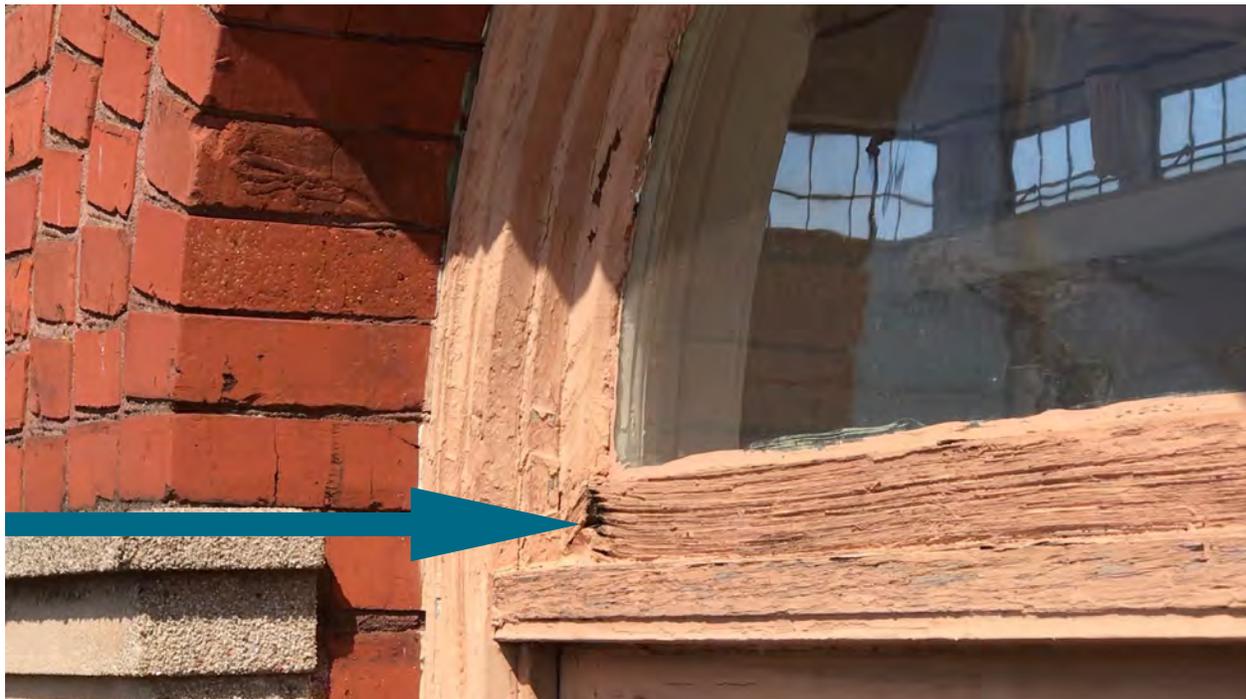
The Half-Round Transom sash here are the unfortunate bearers of bad news. The original manufacture of these sash placed a long grain joint next to a short grain joint at the worst possible location for these windows resulting in an extra high-likelihood of failure if exposed to any stressors. The common theme in these joints is indicated in the following photos.

Again, left to right we have found that the grain orientation of the curved work on the transom sash and the transom brick mold to be incompatible

with the high-weather exposure location and a systematic approach to remedy this failure prone area is recommended. The replacement of the transom sash, the curved blind stop and the curved brick mold on all 22 of the West transoms is worth weighing against the repair durability and expense that will be incurred. Careful attention must be paid that the new sash and millwork are continuous and do not have splices in the material

on the left hand side of the work. The highest grade of lumber must be select for this repair to be effective.

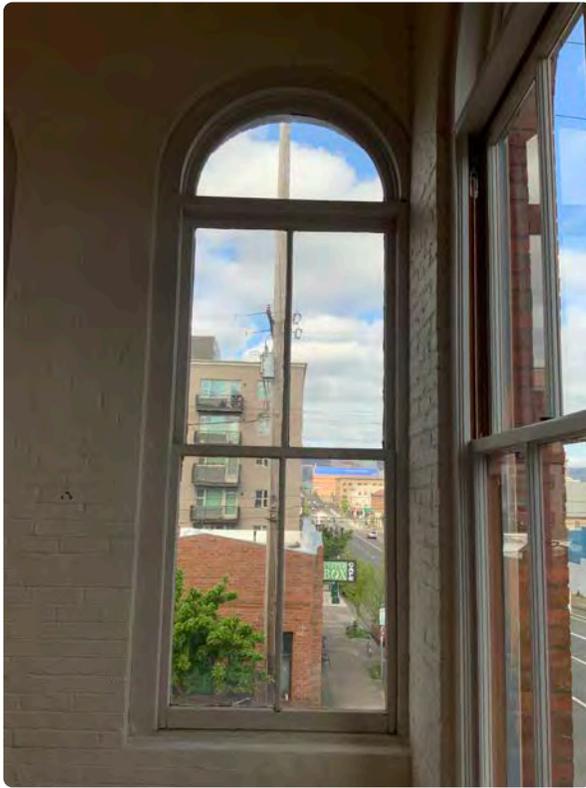
W 201

Stool: MESSML

Frame/Pulley Stiles: FAIR

Sash/Muntins/Leading: FAIR

Trim: FAIR

STEEL MOETISE PULLEY

Ropes/Chains MISSING

ails: RIGHT INT, TRIM
IS SCRIBED TO BRICK

- Strip HORIZONTAL SURFACES
- Repair
- Replace (RAILS)

- Strip
- Repair PAINT
- Replace

- Strip PULLEYS
- Missing L + L

- Replace 4 ROPES NEEDED

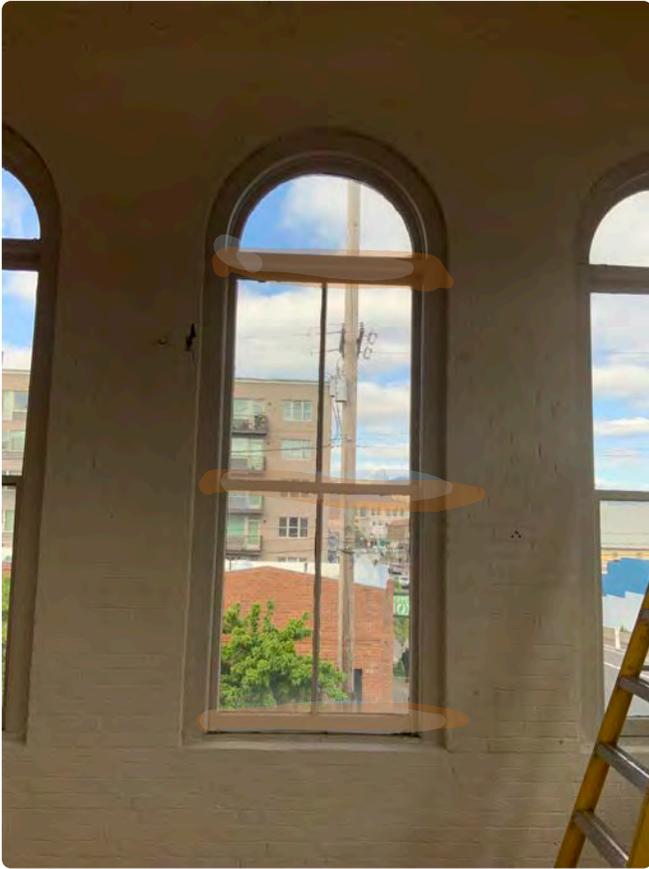
Location: <u>W202</u>
	Window Description: <u>DH w/TRANSOM</u>
	Stool: <u>MISSING</u> <input type="checkbox"/> Strip <input type="checkbox"/> Repair <input checked="" type="checkbox"/> Replace
	Frame/Pulley Stiles: <u>FAIR</u> <input checked="" type="checkbox"/> Strip <u>REFINISH</u> <input type="checkbox"/> Repair <input type="checkbox"/> Replace
	Sash/Muntins/Leading: <u>FAIR</u> <input checked="" type="checkbox"/> Strip <u>HORIZONTAL SURFACES</u> <input type="checkbox"/> Repair <input type="checkbox"/> Replace
	Trim: <u>FAIR</u> <input type="checkbox"/> Strip <input checked="" type="checkbox"/> Repair <u>+REFINISH</u> <input type="checkbox"/> Replace
	Hardware Description: <u>STEEL MORTISE PULLEY</u> <input checked="" type="checkbox"/> Strip <u>PULLEY</u> <input checked="" type="checkbox"/> Missing <u>LOCK+LIFT</u> Ropes/Chains <u>4X</u> <input checked="" type="checkbox"/> Replace
Remarks:	Weatherstripping: <u>n/a</u>

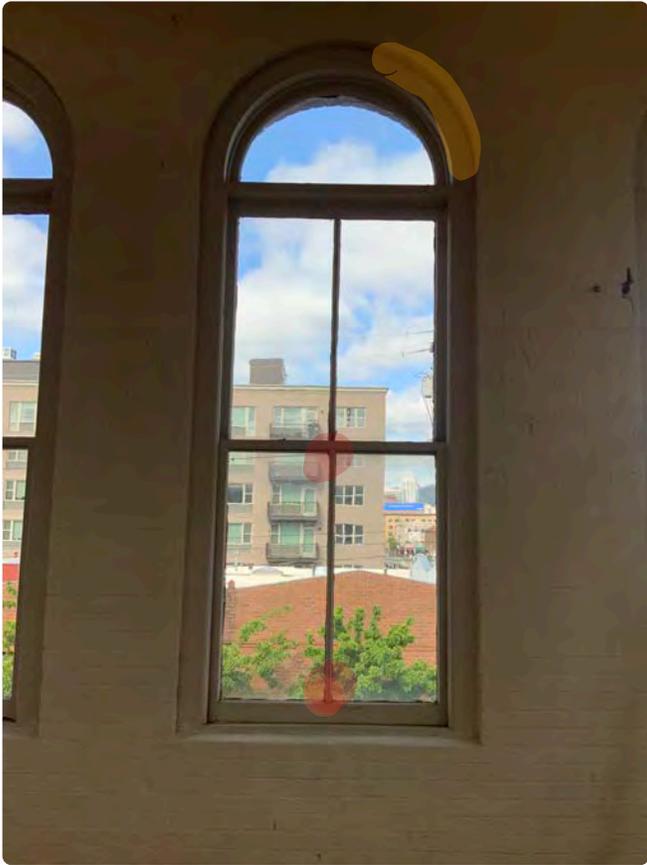
Location: W203
	Window Description: OH W/TRANSOM
	Stool: MISSING <input type="checkbox"/> Strip <input type="checkbox"/> Repair <input checked="" type="checkbox"/> Replace
	Frame/Pulley Stiles: FAIR <input checked="" type="checkbox"/> Strip + REFINISH <input type="checkbox"/> Repair <input type="checkbox"/> Replace
	Sash/Muntins/Leading: FAIR <input checked="" type="checkbox"/> Strip HORIZONTAL RAILS <input checked="" type="checkbox"/> Repair BAR JOINERY <input type="checkbox"/> Replace HAS SEPERATED
	Trim: FAIR <input type="checkbox"/> Strip APPLY <input checked="" type="checkbox"/> Repair SEALANTS <input type="checkbox"/> Replace AT MASONRY
	Hardware Description: PULLEY <input checked="" type="checkbox"/> Strip PULLEYS <input checked="" type="checkbox"/> Missing LTL
	Ropes/Chains <input checked="" type="checkbox"/> Replace 4X
Remarks:	Weatherstripping: n/a

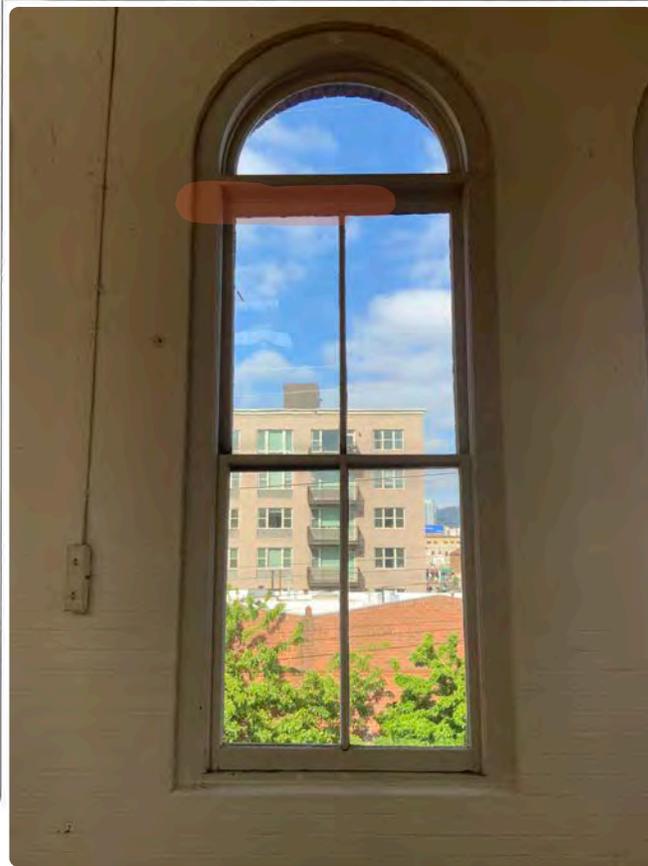
W204

ails: **UPPER SASH HAS DROPPED**
Ⓢ LEFT CORNER.

Stool: MISSING

Frame/Pulley Stiles: FAIR

Sash/Muntins/Leading: FAIR

Trim: FAIR

- Strip RAILS + BARS
- Repair
- Replace

- Strip
- Repair PAINT
- Replace

- Strip PULLEYS
- Missing LOCK + LIFT

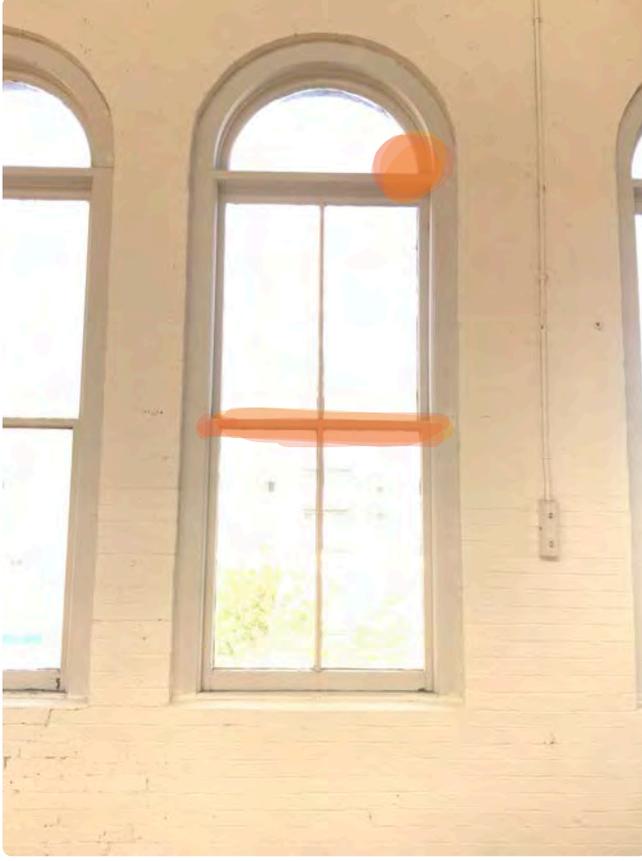
Location: W 205
	Window Description: DH w/TRANSOM
	Stool: MISSING <input type="checkbox"/> Strip <input type="checkbox"/> Repair <input checked="" type="checkbox"/> Replace
	Frame/Pulley Stiles: FAIR <input checked="" type="checkbox"/> Strip <input type="checkbox"/> Repair <input type="checkbox"/> Replace
	Sash/Muntins/Leading: FAIR <input checked="" type="checkbox"/> Strip RAILS + BARS <input checked="" type="checkbox"/> Repair TRANSOM + <input type="checkbox"/> Replace MEETING RAIL
	Trim: <input type="checkbox"/> Strip <input checked="" type="checkbox"/> Repair PAINT <input type="checkbox"/> Replace
Hardware Description: PULLEY <input checked="" type="checkbox"/> Strip PULLEY <input checked="" type="checkbox"/> Missing LOCK + LIFT	
Ropes/Chains <input checked="" type="checkbox"/> Replace 4x	
Remarks:	Weatherstripping:

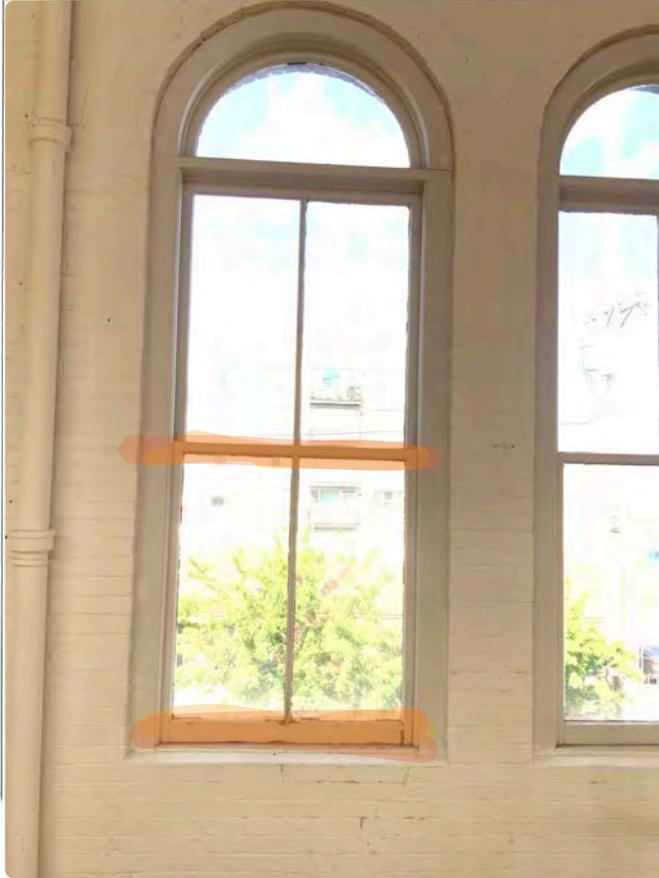
W206

→ SAME AS 205

Stool: MISSING

Frame/Pulley Stiles: FAIR

Sash/Muntins/Leading: FAIR

UV DAMAGE ON HORIZONTAL LOCATIONS

- Strip **RAILS + BARS**
- Repair **MTNG RAIL, LWR RAIL**
- Replace

- Strip
- Repair **PAINT**
- Replace

- Strip **PULLEY**
- Missing **LOCK + LIFT**

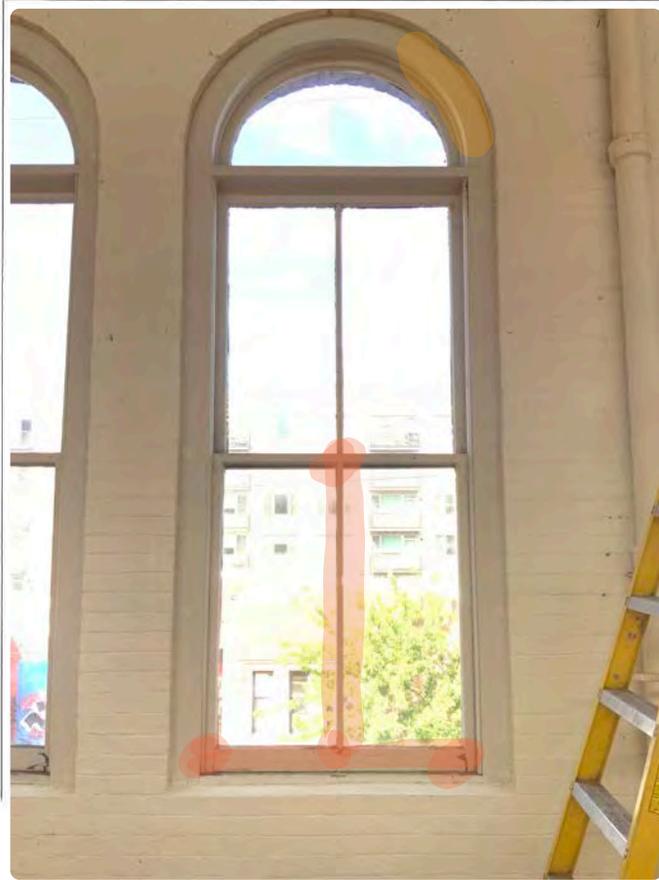
W207

Stool: MISSING

Frame/Pulley Stiles: FAIR

- Strip LOWER RAIL
- Repair BARS + LOWER RAIL
- Replace LOOSE JOINERY

- Strip
- Repair SURFACE DAMAGE IN UPPER ARCH CASING
- Replace

- PULLEY
- Strip PULLEY
- Missing LOCK UP

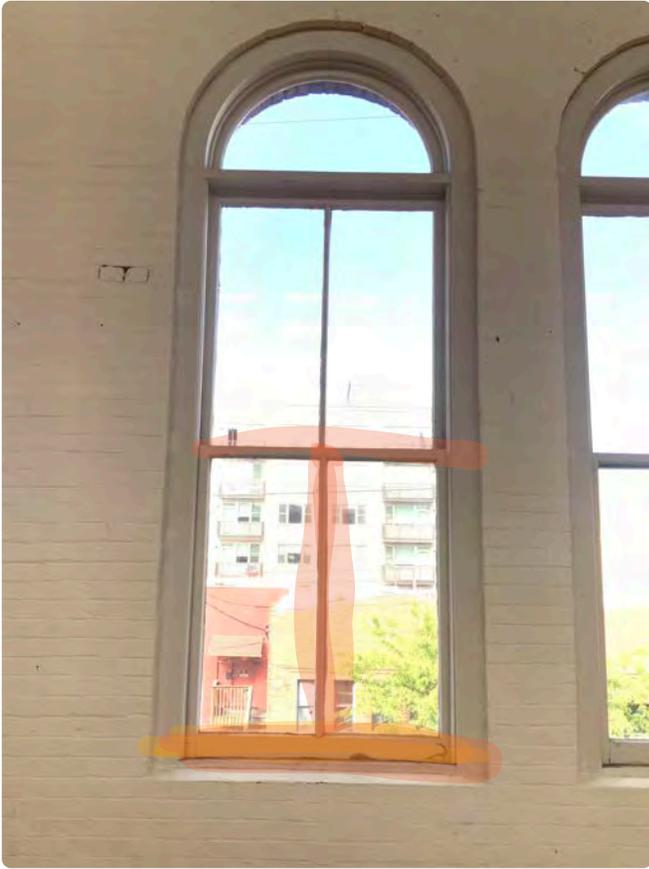
Location: W208
	Window Description: DM W/ TRANSOM
	Stool: MISSING <input type="checkbox"/> Strip <input type="checkbox"/> Repair <input checked="" type="checkbox"/> Replace
	Frame/Pulley Stiles: FAIR <input checked="" type="checkbox"/> Strip <input type="checkbox"/> Repair <input type="checkbox"/> Replace
	Sash/Muntins/Leading: FAIR <input checked="" type="checkbox"/> Strip RAILS + BARS <input checked="" type="checkbox"/> Repair LOOSE JOINERY <input type="checkbox"/> Replace
	Trim: FAIR <input type="checkbox"/> Strip <input checked="" type="checkbox"/> Repair PAINT <input type="checkbox"/> Replace
Hardware Description: PULLEY <input checked="" type="checkbox"/> Strip PULLEY <input checked="" type="checkbox"/> Missing LOCK + LIFT Ropes/Chains <input checked="" type="checkbox"/> Replace 4x	
Remarks:	Weatherstripping: N/A

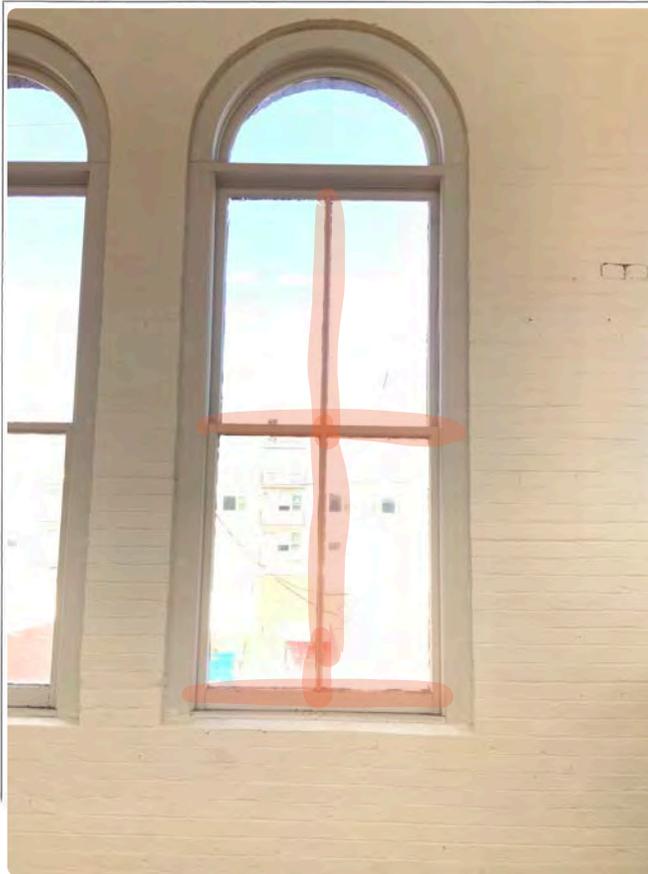
W209

Stool: MISSING

Frame/Pulley Stiles: FAIR

Sash/Muntins/Leading: FAIR

Trim: FAIR

- Strip
- Repair
- Replace PARTING BEAD

- Strip RAILS + BARS
- Repair BARS
- Replace

- Strip PULLEY
- Missing LOCK UP

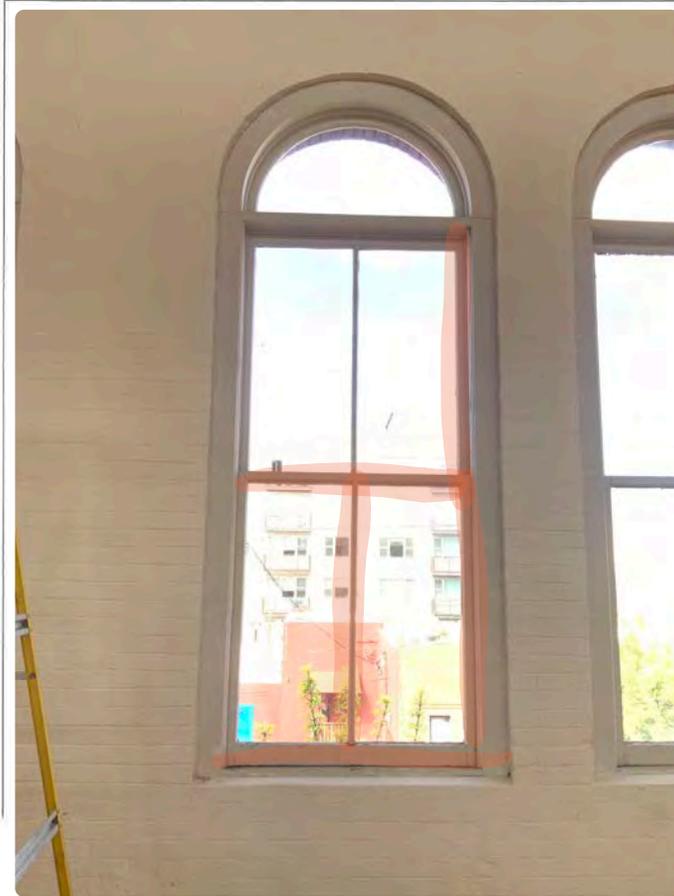
W 210

Stool: MISSING

Frame/Pulley Stiles: FAIR

Sash/Muntins/Leading: FAIR

Trim: FAIR

- Strip
- Repair
- Replace (R) POCKET DOOR

- Strip RAILS + BARS
- Repair JOINERY
- Replace

- Strip PULLEY
- Missing LOCK + LIG

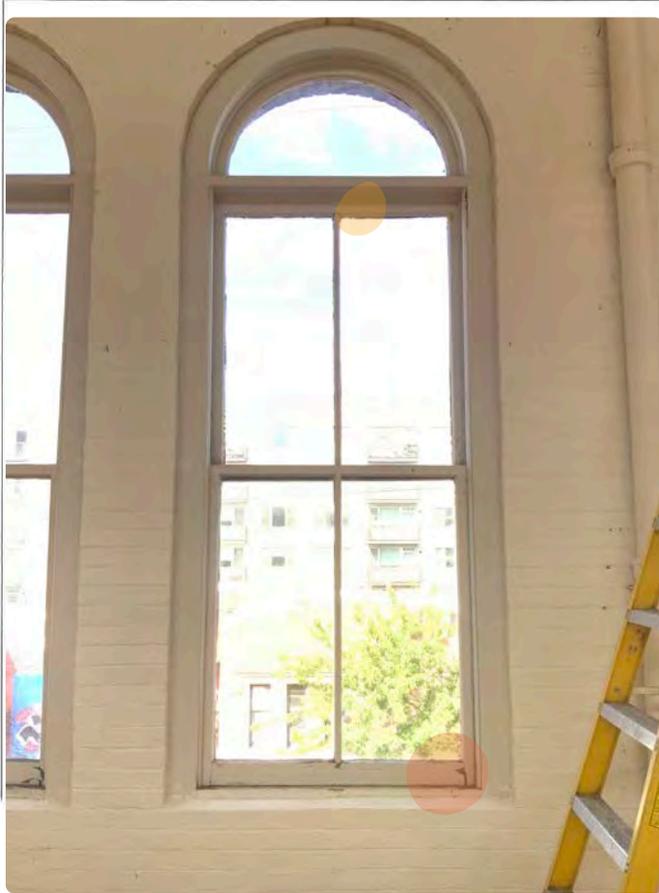
W211

Stool: MISSING

Frame/Pulley Stiles: FAIR

Sash/Muntins/Leading: FAIR

Trim: FAIR

- Strip SASH
- Repair LOWER RAIL
- Replace

- Strip PULLEY
- Missing LOCK BOLT

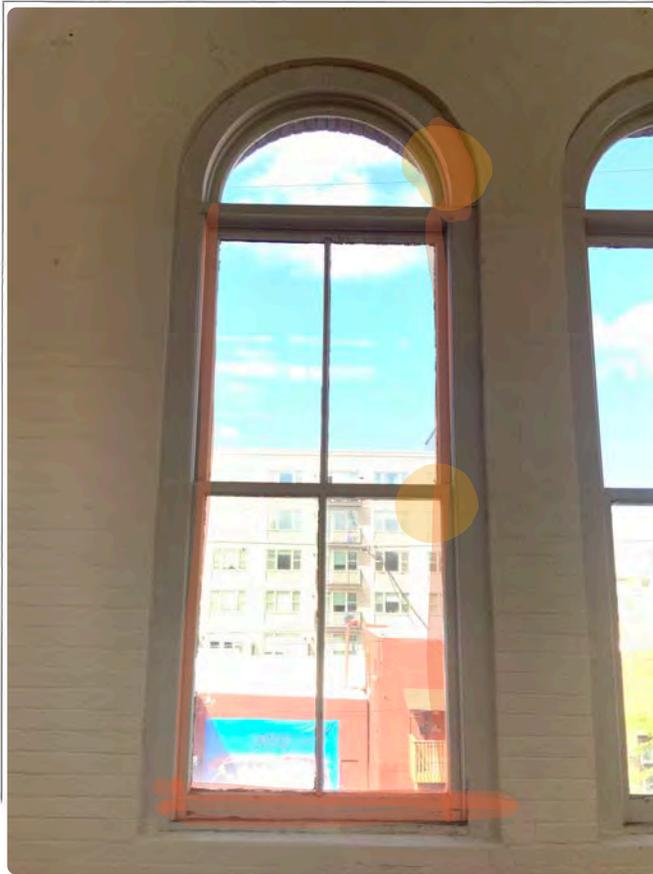
W212

Stool: MISSING

Sash/Muntin/Leading: FAIR

ails: PREVIOUS REPAIRS @
LOWER RAIL PERFORMED
POORLY

- Strip DAMAGE @ JOINT
- Repair @ JOINT
- Replace

- Strip
- Repair ARCH CASING
- Replace INT. STOP

- PULLEY
- Strip PULLEY
- Missing LOCK + LIFT

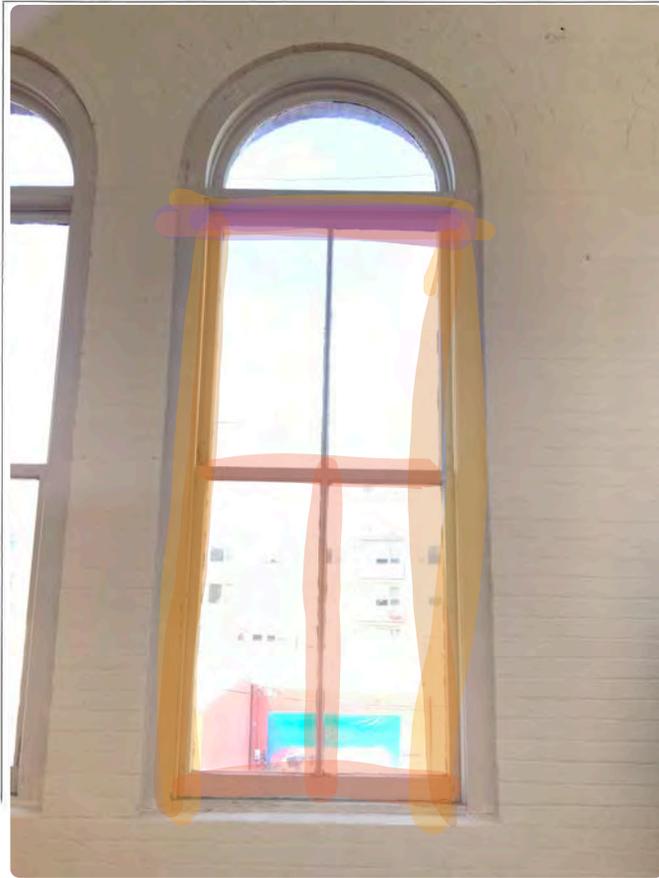
W213

Stool: MISSING

Sash/Muntins/Leading: FAIR

ails: UPPER SASH HAS
DROPPED AND VOID
HAS BEEN FILLED
WITH SEALANT

- Strip
- Repair
- Replace PARTING BEAD

- Strip RAILS + BARS
- Repair JOINERY
- Replace

- Strip
- Repair
- Replace INT. STOP

- PULLEY
- Strip PULLEY
- Missing LOCK + LIFT

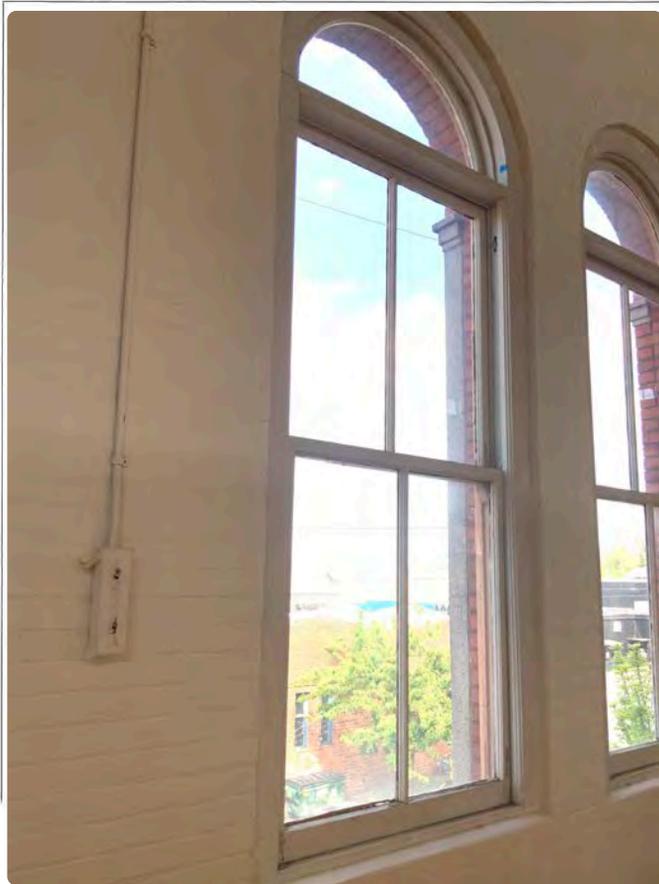
WZ14

Stool: MISSING

Sash/Muntins/Leading: FAIR

- Strip RAILS + BARS
- Repair LOOSE JOINERY
- Replace

- Strip
- Repair PAINT
- Replace PARTING BEAD

- Strip PULLEY
- Missing LOCK LIFT

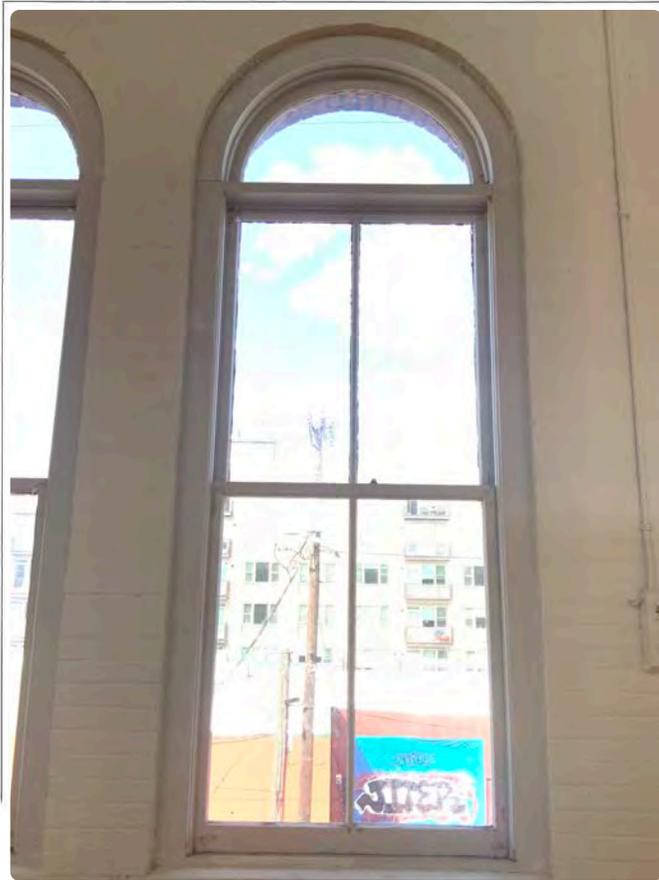
W215

Client: SAME AS 206

Stool: MISSING

Frame/Pulley Stiles: FAIR

Sash/Muntins/Leading: FAIR

- Strip BARS + TRAILS
- Repair
- Replace

- Strip
- Repair PAINT
- Replace

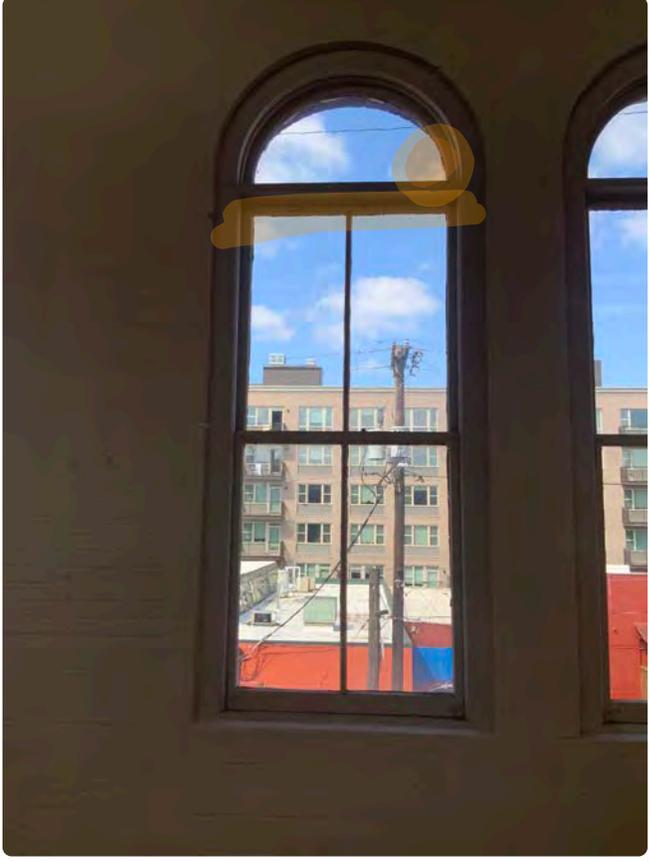
Location: <u>W216</u>
	Window Description: <u>DH w/ TRANSOM</u>
	Stool: <u>MISSING</u> <input type="checkbox"/> Strip <input type="checkbox"/> Repair <input checked="" type="checkbox"/> Replace
	Frame/Pulley Stiles: <u>FAIR</u> <input checked="" type="checkbox"/> Strip <input type="checkbox"/> Repair <input type="checkbox"/> Replace
	Sash/Muntins/Leading: <u>FAIR</u> <input checked="" type="checkbox"/> Strip <u>SASH</u> <input checked="" type="checkbox"/> Repair <u>TRANSOM TOPRAIL</u> <input type="checkbox"/> Replace
	Trim: <u>FAIR</u> <input type="checkbox"/> Strip <input checked="" type="checkbox"/> Repair <u>PAINT</u> <input type="checkbox"/> Replace
	Hardware Description: <u>PULLEY</u> <input checked="" type="checkbox"/> Strip <u>PULLEY</u> <input checked="" type="checkbox"/> Missing <u>SPRINGS IS PRESENT</u>
Remarks:	Rope/Chains: <u>4x</u> <input checked="" type="checkbox"/> Replace
Remarks:	Weatherstripping: <u>n/a</u>

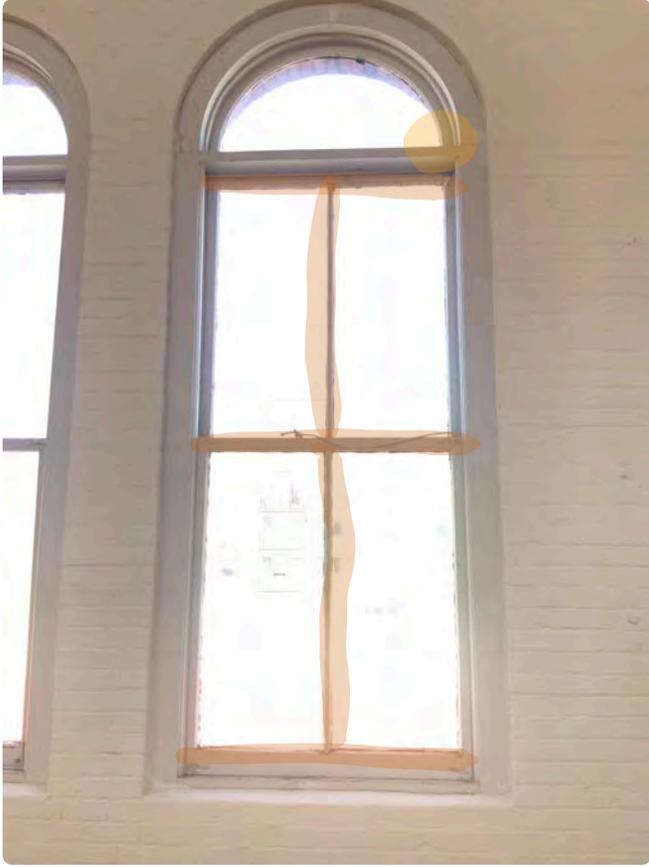
Location: W217
	Window Description: DM w/ TRANSOM
	Stool: MISSING <input type="checkbox"/> Strip <input type="checkbox"/> Repair <input checked="" type="checkbox"/> Replace
	Frame/Pulley Stiles: FAIR <input checked="" type="checkbox"/> Strip <input type="checkbox"/> Repair <input type="checkbox"/> Replace
	Sash/Muntins/Leading: <input checked="" type="checkbox"/> Strip BARSTRAILS <input checked="" type="checkbox"/> Repair TRANSOM <input type="checkbox"/> Replace
	Trim: FAIR <input type="checkbox"/> Strip <input checked="" type="checkbox"/> Repair PAINT <input type="checkbox"/> Replace
	Hardware Description: <input checked="" type="checkbox"/> Strip PULLEY <input checked="" type="checkbox"/> Missing LOCK + LIFT
Remarks:	Rope/Chains: 4x <input checked="" type="checkbox"/> Replace
Remarks:	Weatherstripping: N/A

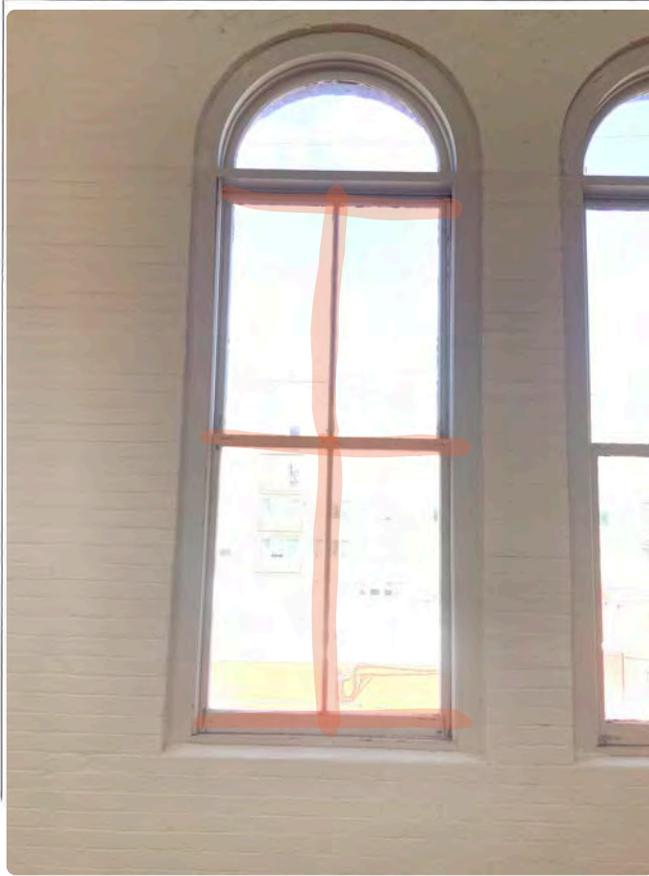
W 218

Stool: MISSING

Frame/Pulley Stiles: FAIR

Sash/Muntins/Leading: FAIR

- Strip
- Repair PAINT
- Replace PARTING BEAD

- Strip PULLEY
- Missing WORK + LIFT

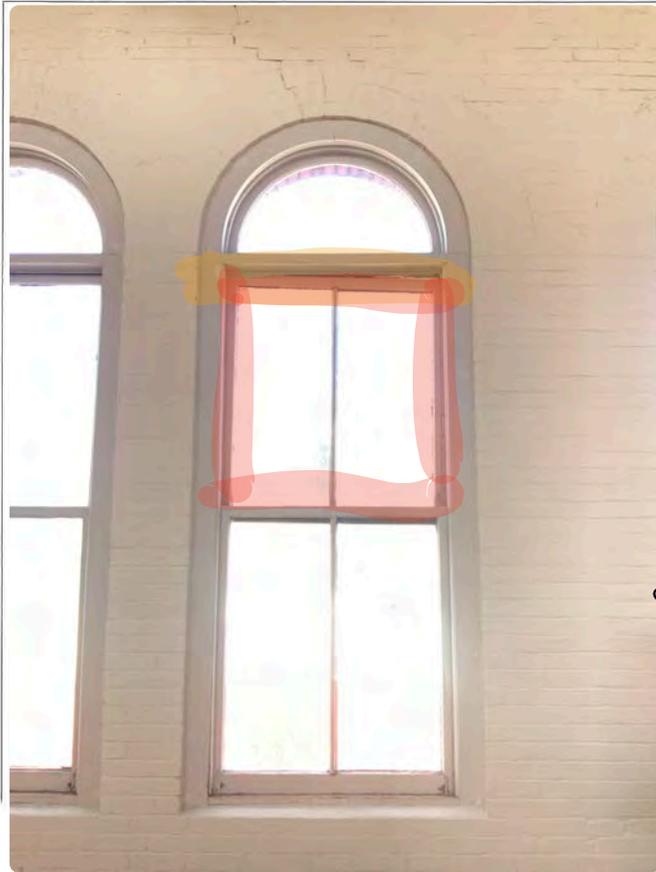
W 219

Stool: MISSING

Sash/Muntins/Leading: CRITICAL

- Strip UPPER IS CRITICAL
- Repair
- Replace

PULLEY
 Strip PULLEY
 Missing LOCK + LIFT

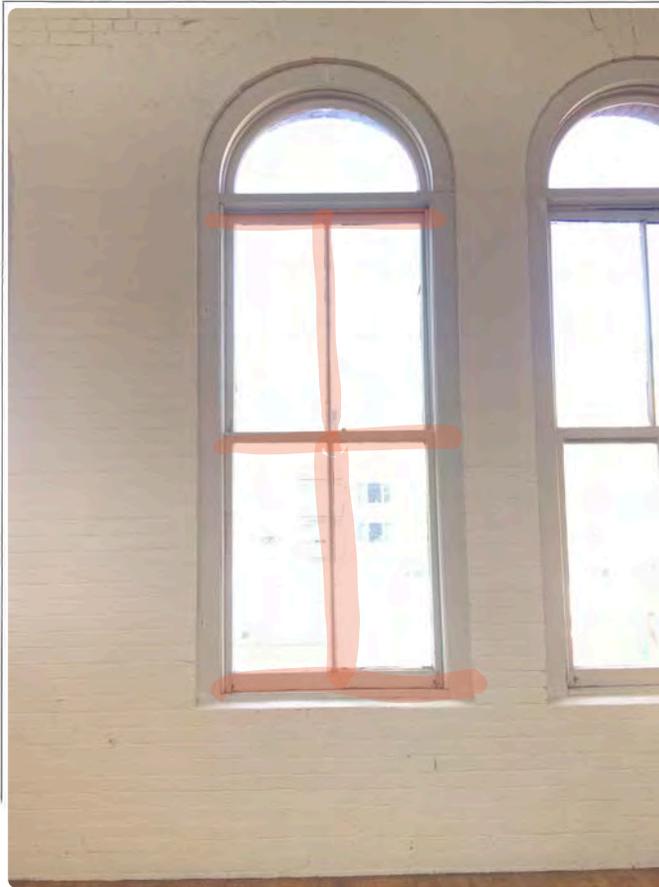
W220

Stool: MISSING

Sash/Muntins/Leading: FAIR

- Strip BARS + RAILS
- Repair UPPER SASH
- Replace

- Strip
- Repair PAINT
- Replace PARTING-BEAD + INT. SQ

- Strip PULLEY
- Missing LOCK + UFT

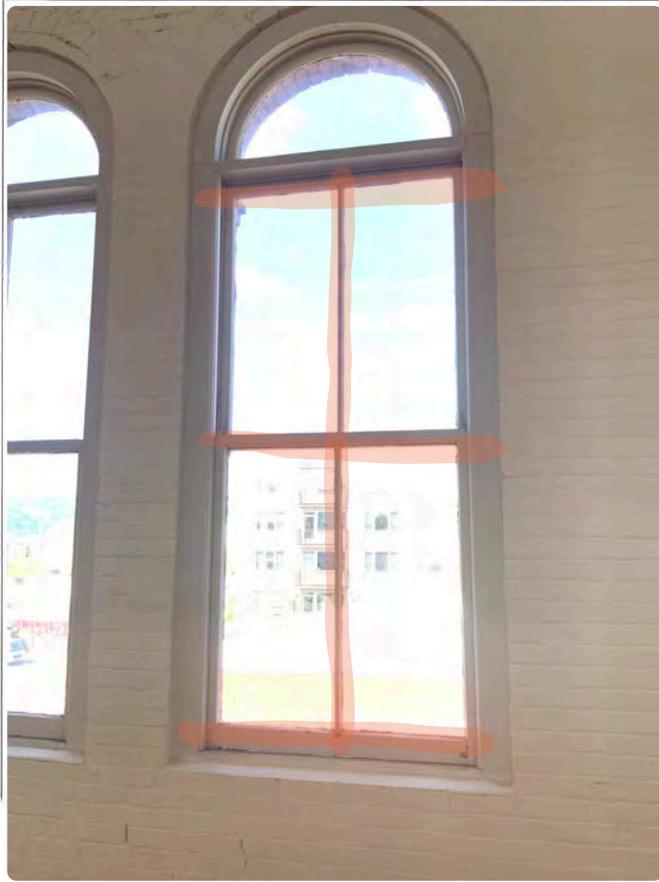
W 221

Stool: MISSING

Sash/Muntins/Leading: FAIR

- Strip
- Repair **PAINT**
- Replace **PARTING BEAD**

- Strip **PULLEY**
- Missing **LOCK+LIFT**

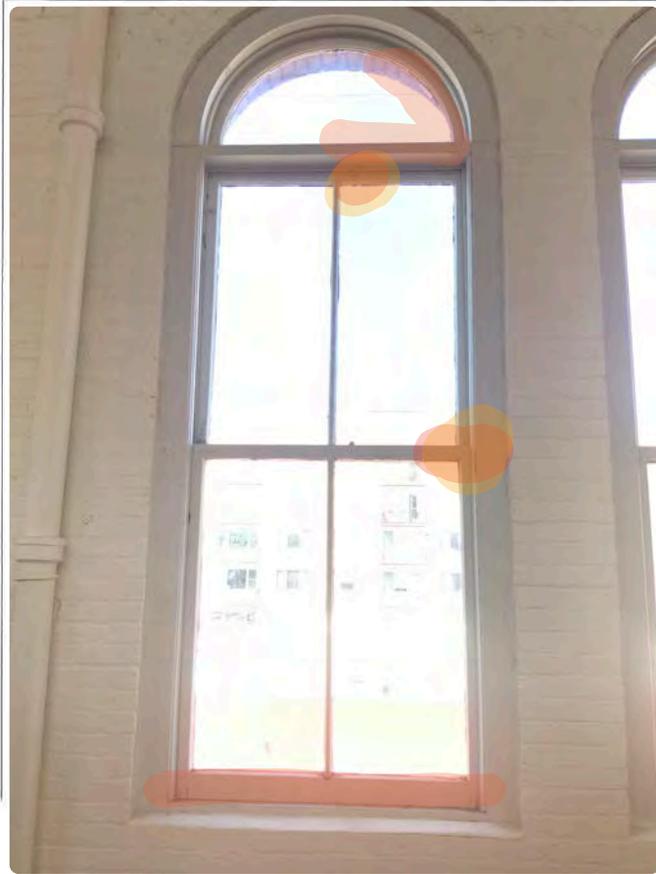
W 222

Stool: MISSING

- Strip
- Repair PROFILE JOINERY TRANSOM
- Replace

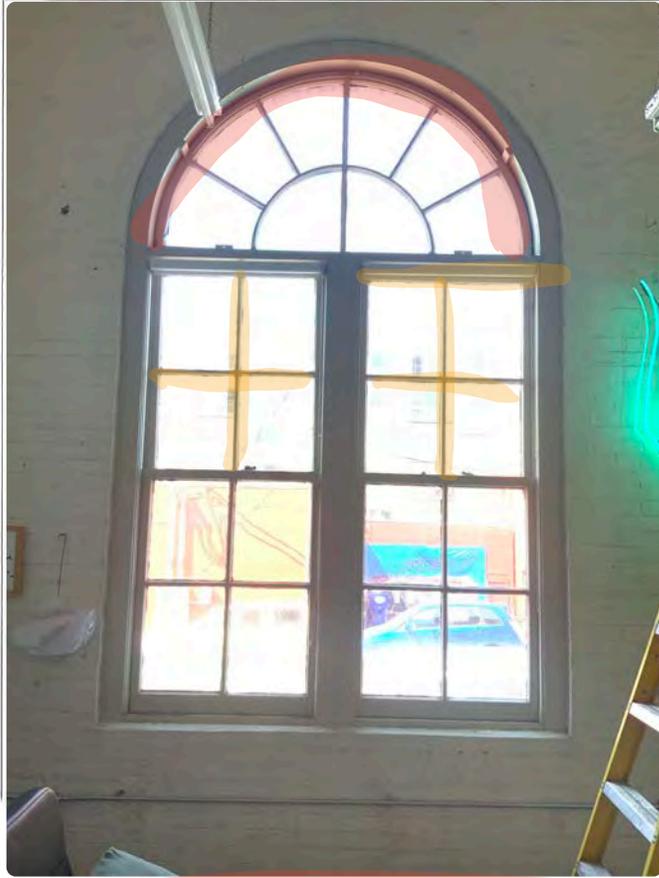
W108

- PROFILES ARE 25% DAMAGED

Stool: MISSING

Sash/Muntins/Leading: FAIR

RECOMMEND INT. STOP INSULATION

- Strip + REFINISH
- Repair TRANSOM
- Replace UPPER (R) RAIL

- Strip
- Repair SEALANTS
- Replace INT. STOP

- Strip LOCKSTAPLEYS
- Missing LIFTS

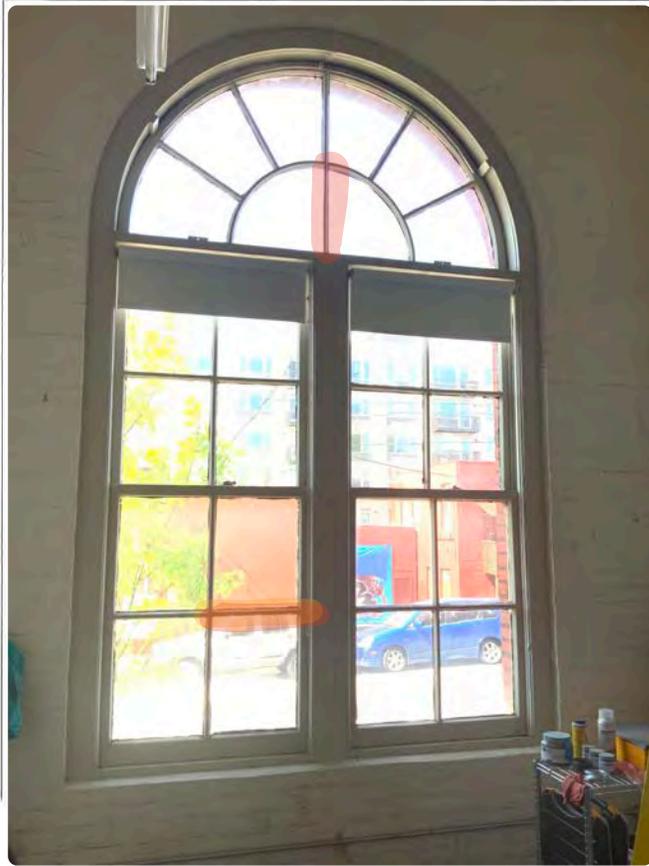
W109

MISSING SPOKE MUNTIN

Stool: MISSING

Sash/Muntins/Leading: FAIR

- Strip SASH
- Repair MUNTIN
- Replace

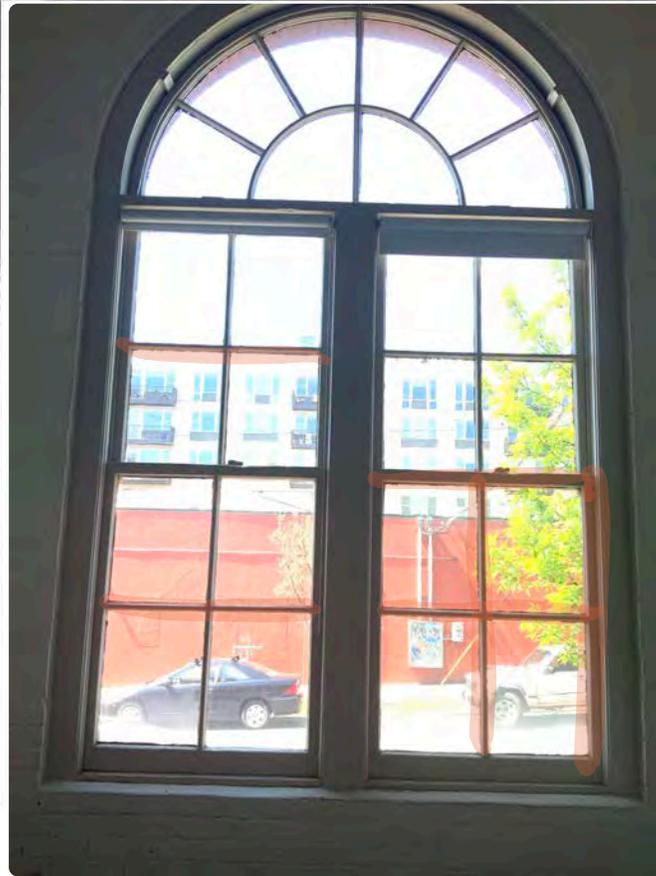
W110

108
SAME AS

Stool: MISSING

Sash/Muntins/Leading: FAIR

- Strip SASH
- Repair MUNTINS/MTNS RAIL
- Replace

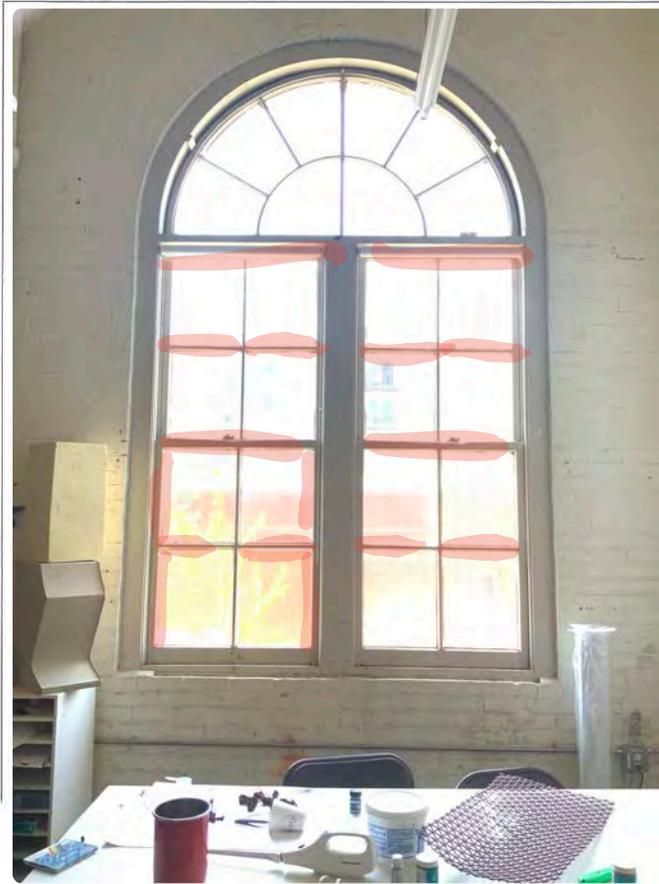
W111

Stool: MISSING

Sash/Muntins/Leading: POOR

60%

OR NEED WORK

ails: MUNTINS ARE IN POOR CONDITION.
STILES ARE IN POOR CONDITION.
BARS + LOWER RAILES ARE IN FAIR CONDITION

Remarks: REPLACEMENT PARTS
