Window Assessment--Interior

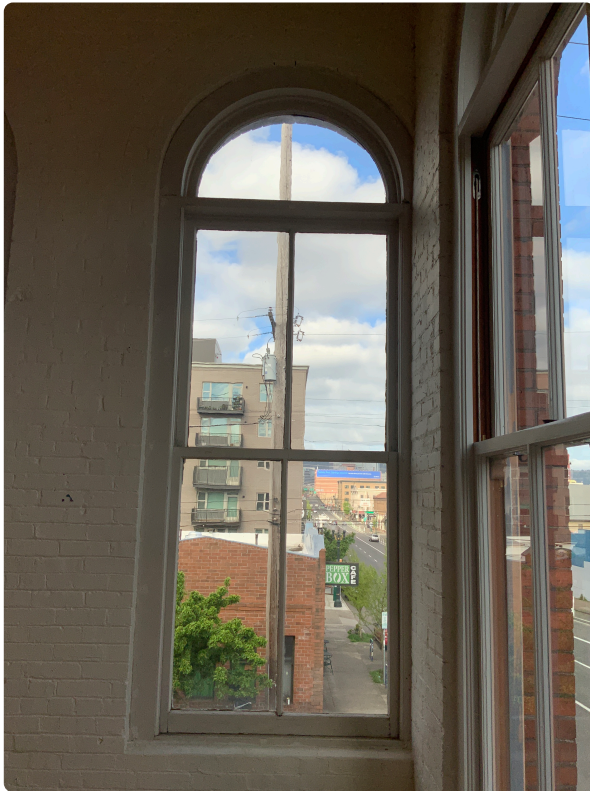
W 201

Stool: MESSML

Frame/Pulley Stiles: FAIR

Sash/Muntins/Leading: FAIR

Trim: FAIR

STEEL MOETISE PULLEY

Ropes/Chains MISSING

ails: RIGHT INT, TRIM
IS SCRIBED TO BRICK

- ☐ Strip
- ☐ Repair
- ☒ Replace

- ☒ Strip
- ☐ Repair
- ☐ Replace

- ☒ Strip HORIZONTAL SURFACES
- ☐ Repair
- ☐ Replace (RAILS)

- ☐ Strip
- ☒ Repair PAINT
- ☐ Replace

- ☒ Strip PULLEY'S
- ☒ Missing L + L

- ☒ Replace 4 ROPES NEEDED

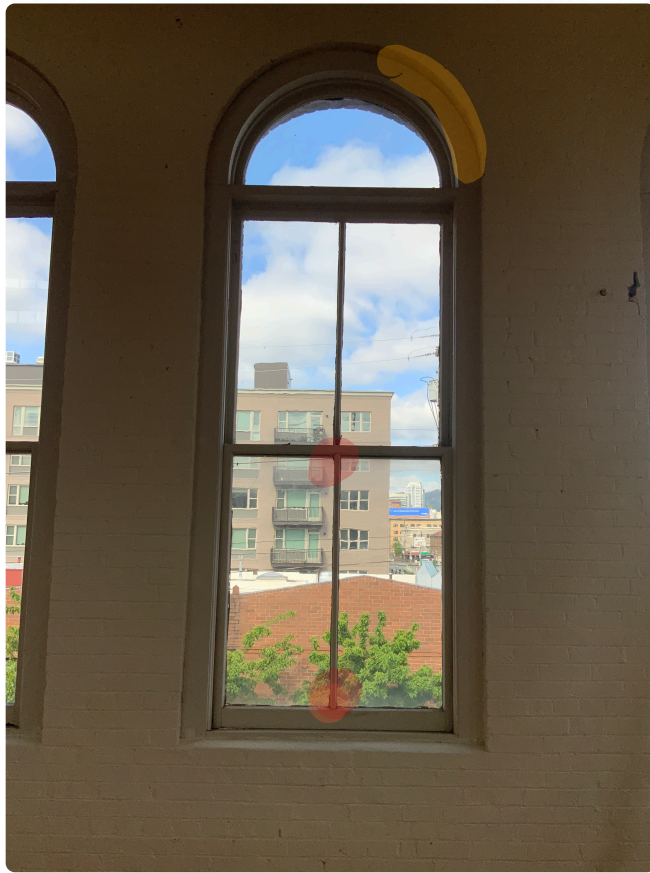
W203

Stool: MISSING

Frame/Pulley Stiles: FAIR

Sash/Muntins/Leading: FAIR

Trim: FAIR

PULLEY

Ropes/Chains

- ☐ Strip
- ☐ Repair
- ☒ Replace

- ☒ Strip + REFINISH
- ☐ Repair
- ☐ Replace

- ☒ Strip HORIZONTAL RAILS
- ☒ Repair BAR JOINERY
- ☐ Replace HAS SEPERATED

- ☐ Strip APPLY
- ☒ Repair SEALANT
- ☐ Replace AT MASONRY

- ☒ Strip PULLEYS
- ☒ Missing LTL

- ☒ Replace 4x

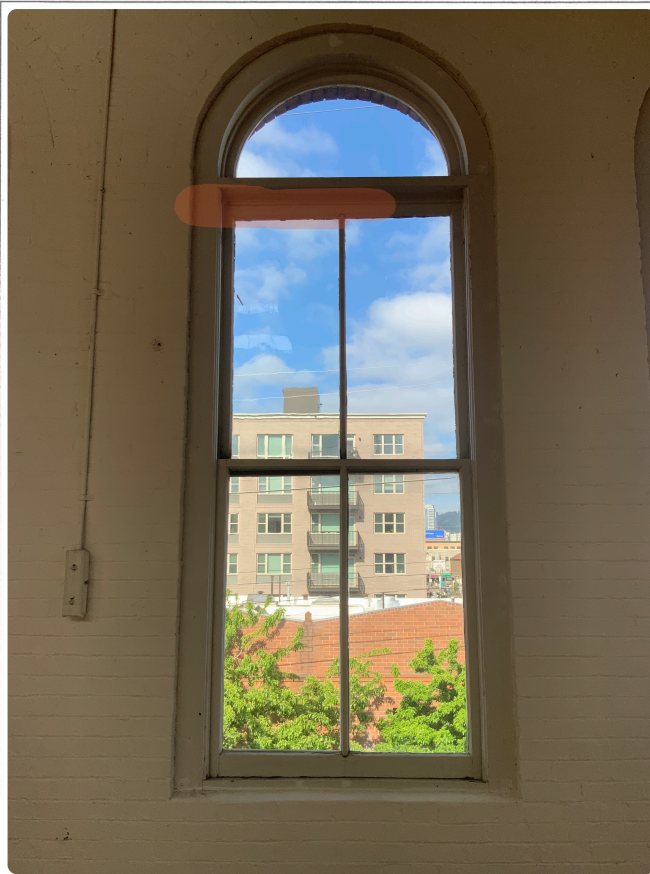
W204

Stool: MISSING

Frame/Pulley Stiles: FAIR

Sash/Muntins/Leading: FAIR

Trim: FAIR

ails: UPPER SASH HAS DROPPED
 @ LEFT CORNER.

- ☐ Strip
- ☐ Repair
- ☒ Replace

- ☒ Strip
- ☐ Repair
- ☐ Replace

- ☒ Strip RAILS + BARS
- ☒ Repair
- ☐ Replace

- ☐ Strip
- ☒ Repair PAINT
- ☐ Replace

- ☒ Strip PULLEYS
- ☒ Missing LOCK + LIFT

- ☒ Replace

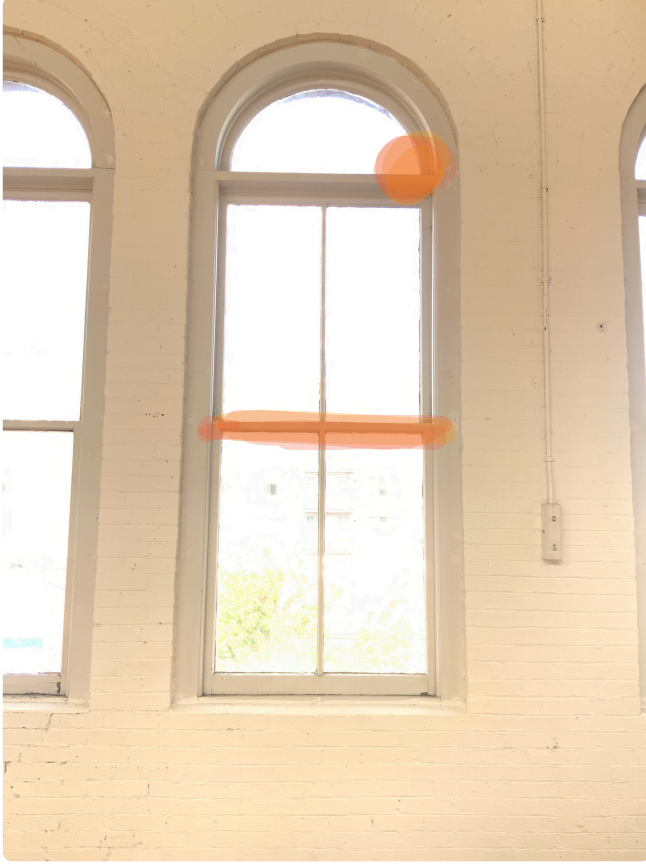
Location: <u>W 205</u>
	Window Description: <u>DH w/ TRANSOM</u>
	Stool: <u>MISSING</u> <input type="checkbox"/> Strip <input type="checkbox"/> Repair <input checked="" type="checkbox"/> Replace
	Frame/Pulley Stiles: <u>FAIR</u> <input checked="" type="checkbox"/> Strip <input type="checkbox"/> Repair <input type="checkbox"/> Replace
	Sash/Muntins/Leading: <u>FAIR</u> <input checked="" type="checkbox"/> Strip <u>RAILS + BARS</u> <input checked="" type="checkbox"/> Repair <u>TRANSOM +</u> <input type="checkbox"/> Replace <u>MEETING RAIL</u>
	Trim: <input type="checkbox"/> Strip <input checked="" type="checkbox"/> Repair <u>PAINT</u> <input type="checkbox"/> Replace
	Hardware Description: <u>PULLEY</u> <input checked="" type="checkbox"/> Strip <u>PULLEY</u> <input checked="" type="checkbox"/> Missing <u>LOCK + LIFT</u>
Remarks:	Ropes/Chains: <u>4x</u> <input checked="" type="checkbox"/> Replace

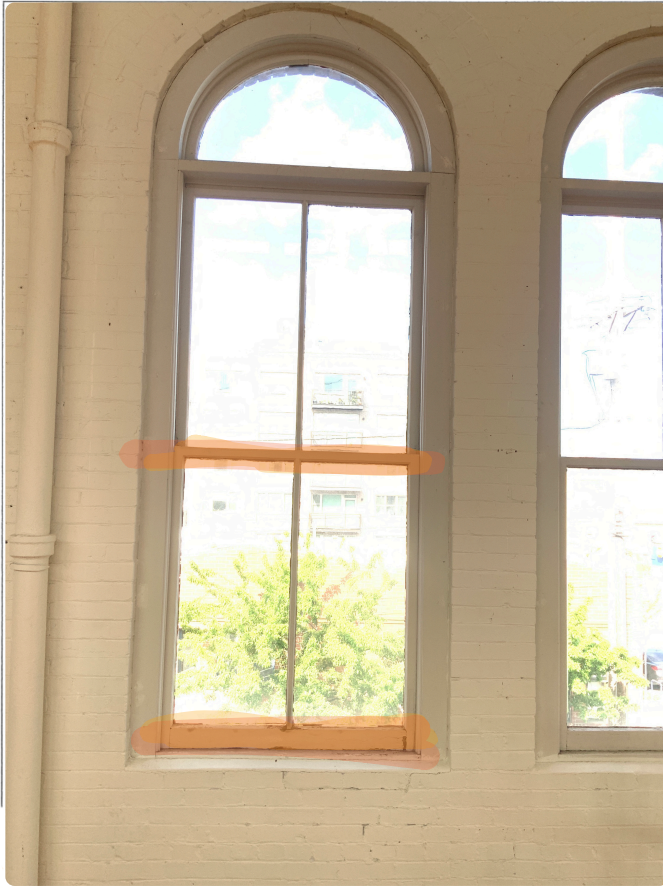
W206

Stool: MISSING

Frame/Pulley Stiles: FAIR

Sash/Muntins/Leading: FAIR

UV DAMAGE ON
HORIZONTAL LOCATIONS

☒ Replace

☒ Strip

☒ Strip RAILS + BARS

☒ Repair MTNG RAIL, LWR RAIL

☒ Repair PAINT

☒ Missing LOCK + LIFT

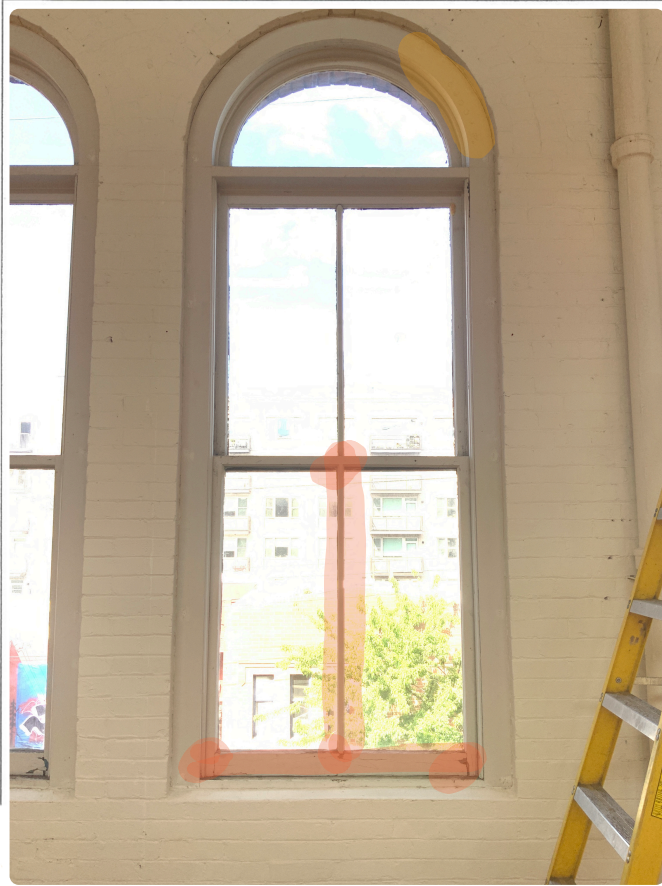
W207

Stool: MISSING

Frame/Pulley Stiles: FAIR

- ☒ Strip LOWER RAIL
- ☒ Repair BARST LOWER RAIL
- ☐ Replace LOOSE JOINERY

- ☐ Strip
- ☒ Repair SURFACE DAMAGE IN UPPER ARCH CASING
- ☐ Replace

- ☐ Strip
- ☐ Repair
- ☒ Replace

- ☒ Strip
- ☐ Repair
- ☐ Replace

- ☒ Strip PULLEY
- ☒ Missing LOCK+LIFT

- ☒ Replace 4X

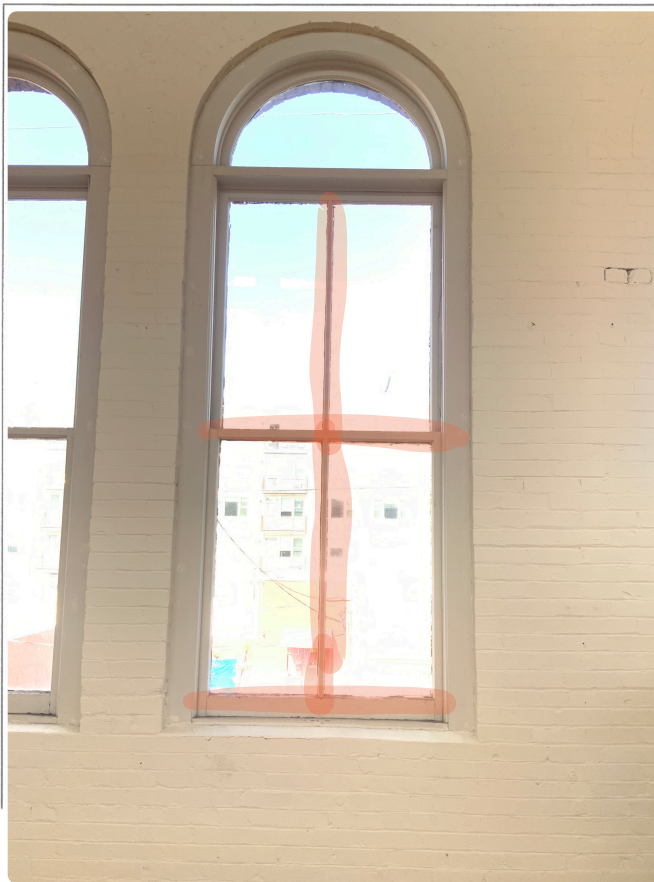
W209

Stool: MISSING

Frame/Pulley Stiles: FAIR

Sash/Muntins/Leading: FAIR

Trim: FAIR

☒ Replace

☒ Replace PARTING BEAD

☒ Strip RAILS + BARS

☒ Repair BARS

☒ Repair PAINT

☒ Missing LOCK + LIFT

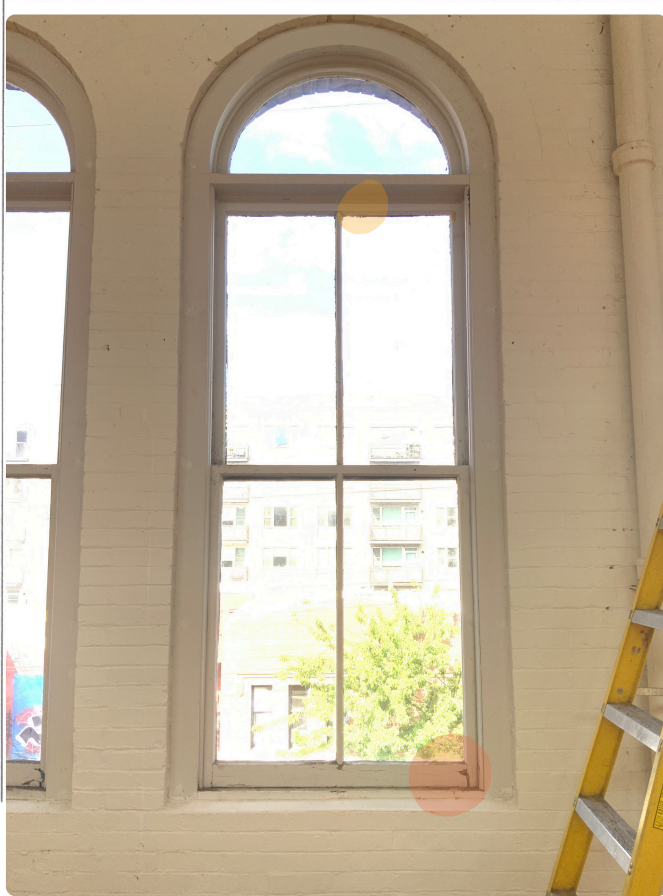
W211

Stool: MISSING

Frame/Pulley Stiles: FAIR

Sash/Muntins/Leading: FAIR

Trim: FAIR

- ☐ Strip
- ☐ Repair
- ☒ Replace

- ☒ Strip SASH
- ☒ Repair LOWER RAIL
- ☐ Replace

- ☐ Strip
- ☒ Repair PAINT
- ☐ Replace

- ☒ Strip PULLEY
- ☒ Missing LOCK TIGHT

- ☒ Replace 4X

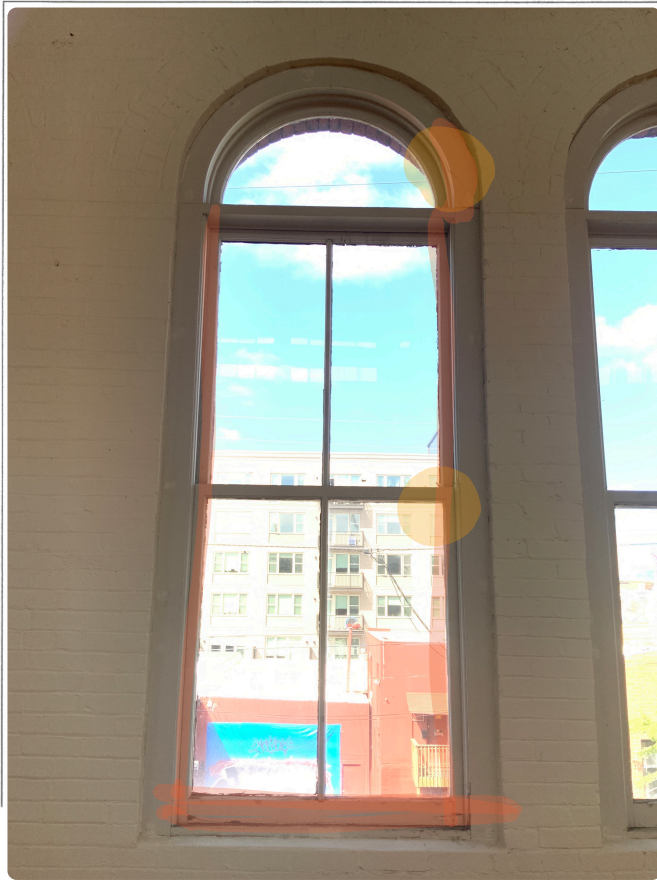
W212

Stool: MISSING

Frame/Pulley Stiles: FAIR

Sash/Muntins/Leading: FAIR

Trim: FAIR

ails: PREVIOUS REPAIRS @
LOWER RAIL PERFORMED
POORLY

☒ Replace

☒ Repair ARCH CASING

☒ Replace INT. STOP

☒ Missing LOCK + LIFT

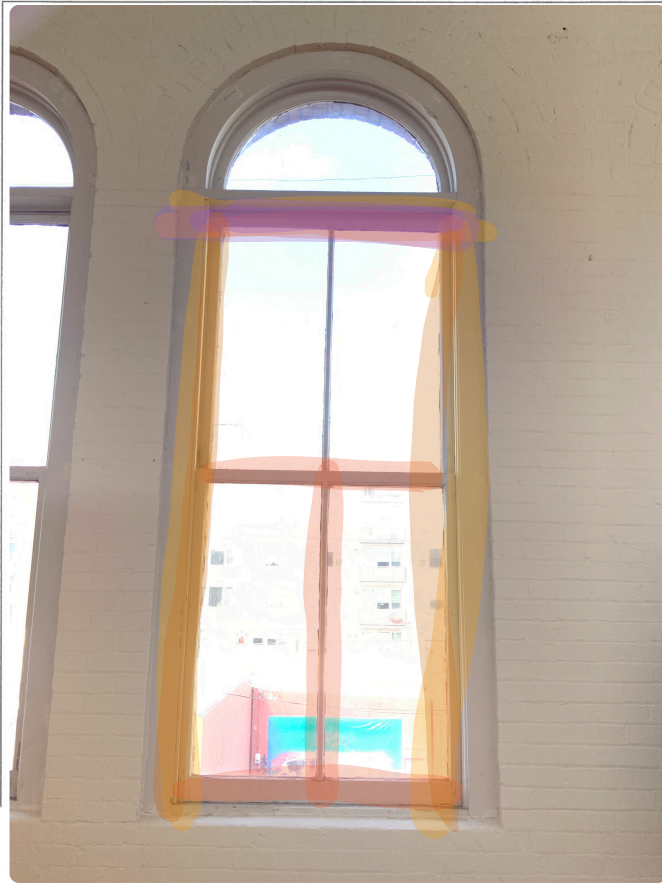
W213

Stool: MISSING

Frame/Pulley Stiles: FAIR

Sash/Muntins/Leading: FAIR

Trim: FAIR

ails: UPPER SASH HAS
DROPPED AND VOID
HAS BEEN FILLED
WITH SEALANT

☒ Replace

☒ Replace PARTING BEAD

☒ Strip RAILS + BARS

☒ Repair JOINERY

☒ Replace INT. STOP

☒ Missing LOCK + LIFT

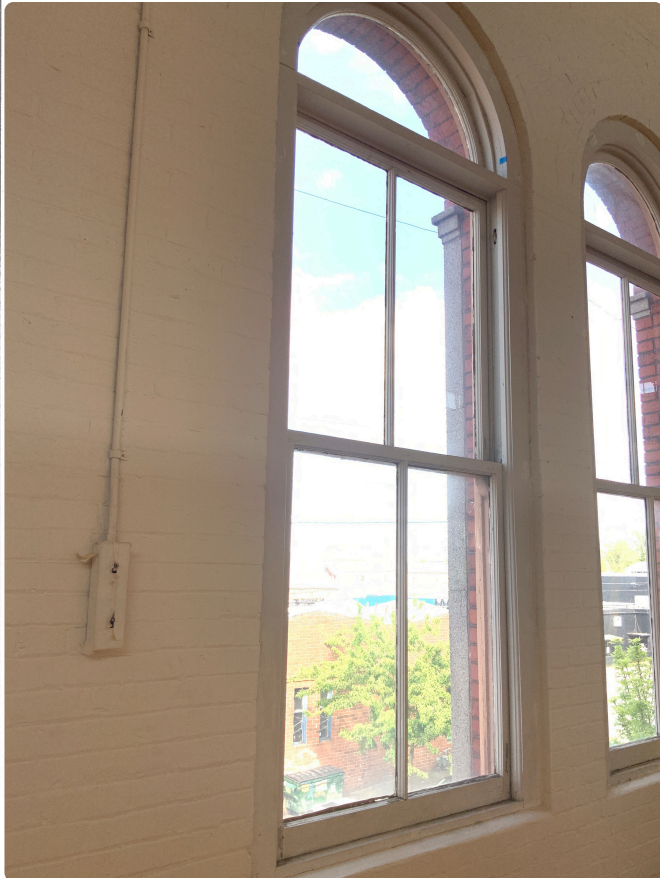
Location: <u>WZ14</u>
	Window Description: <u>DH w/TRANSOM</u>
	Stool: <u>MISSING</u> <input type="checkbox"/> Strip <input type="checkbox"/> Repair <input checked="" type="checkbox"/> Replace
	Frame/Pulley Stiles: <u>FAIR</u> <input checked="" type="checkbox"/> Strip <input type="checkbox"/> Repair <input type="checkbox"/> Replace
	Sash/Muntins/Leading: <u>FAIR</u> <input checked="" type="checkbox"/> Strip <u>RAILS + BARS</u> <input checked="" type="checkbox"/> Repair <u>LOOSE JOINERY</u> <input type="checkbox"/> Replace
	Trim: <u>FAIR</u> <input type="checkbox"/> Strip <input checked="" type="checkbox"/> Repair <u>PAINT</u> <input checked="" type="checkbox"/> Replace <u>PARTING BEAD</u>
	Hardware Description: <u>PULLEY</u> <input checked="" type="checkbox"/> Strip <u>PULLEY</u> <input checked="" type="checkbox"/> Missing <u>LOCK LIFT</u>
<u>ails:</u>	<u>Ropes/Chains</u> <u>4x</u> <input checked="" type="checkbox"/> Replace

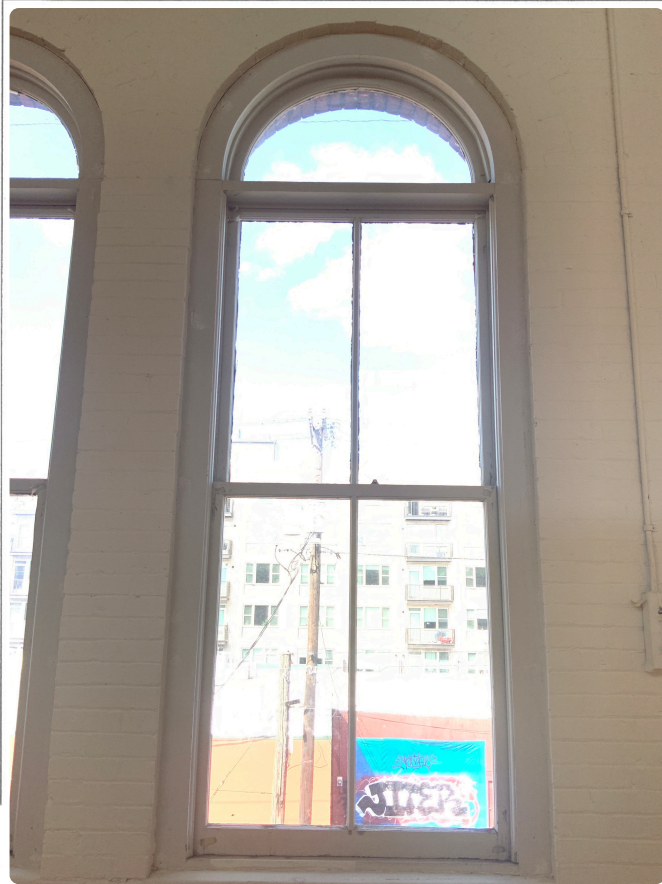
WZ15

Stool: MISSING

Frame/Pulley Stiles: FAIR

Sash/Muntins/Leading: FAIR

Trim: FAIR

☒ Missing STRIKE IS PRESENT

☒ Replace

☒ Strip BARS + TRAILS

☒ Repair PAINT

☒ Replace 4X

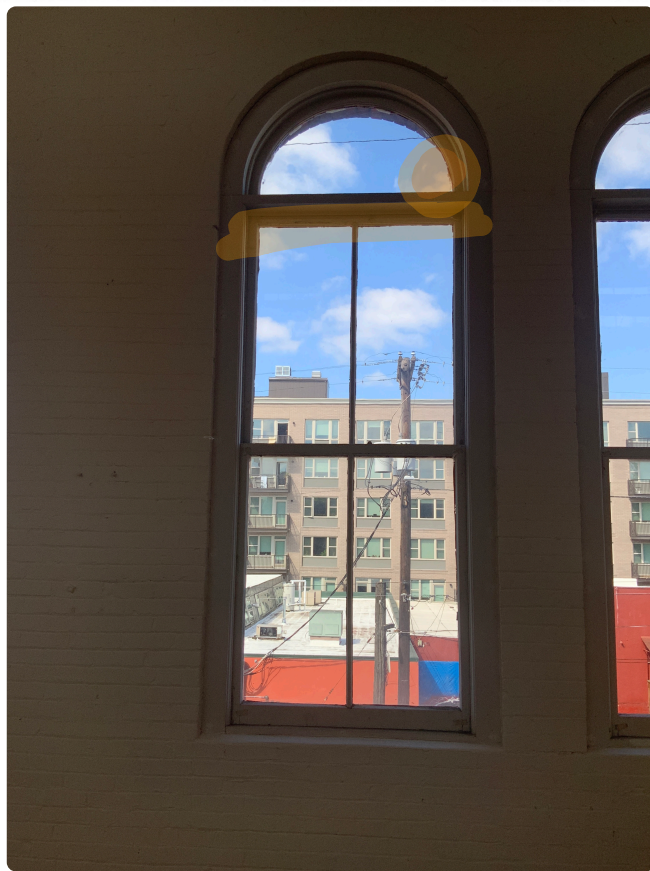
W216

Stool: MISSING

Frame/Pulley Stiles: FAIR

Sash/Muntins/Leading: FAIR

Trim: FAIR

☒ Replace

☒ Strip SASH

☒ Repair TRANSOM TOP RAIL

☒ Repair PAINT

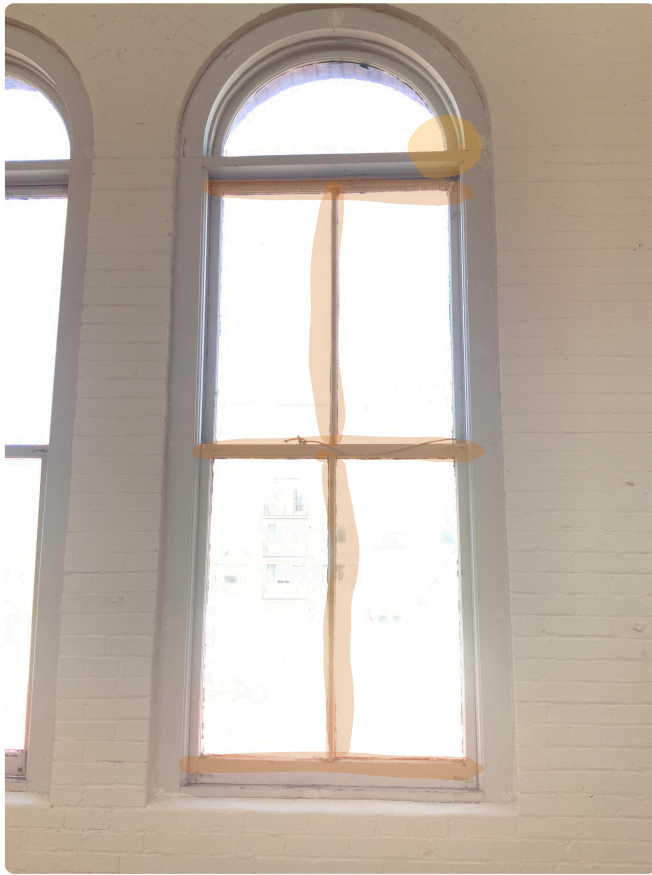
W217

Stool: MISSING

Frame/Pulley Stiles: FAIR

Trim: FAIR

- ☐ Strip
- ☐ Repair
- ☒ Replace

- ☒ Strip BARS + RAILS
- ☒ Repair TRANSOM
- ☐ Replace

- ☐ Strip
- ☒ Repair PAINT
- ☐ Replace

- ☒ Strip PULLEY
- ☒ Missing LOCK + LIFT

- ☒ Replace 4x

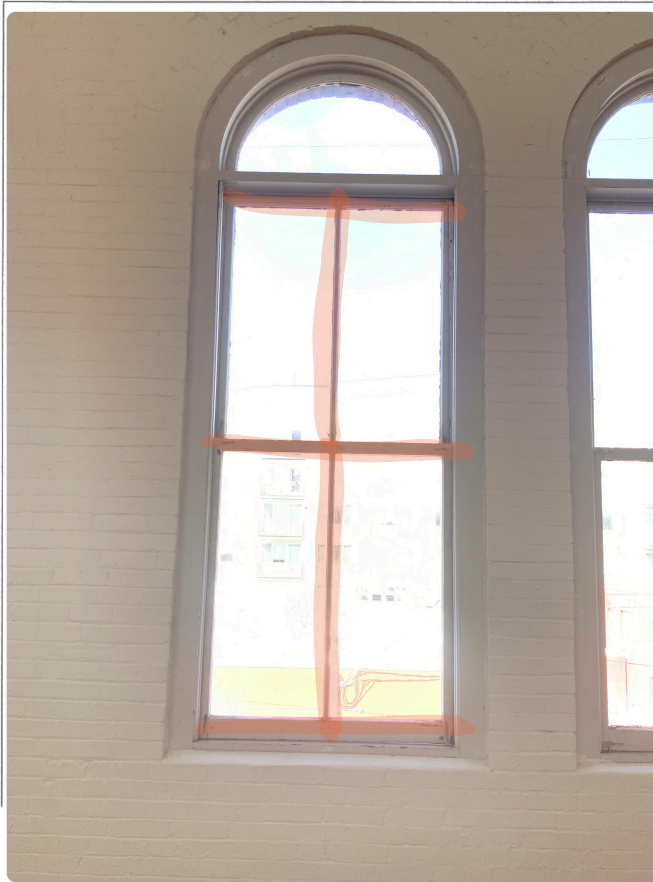
W 218

Stool: MISSING

Frame/Pulley Stiles: FAIR

Sash/Muntins/Leading: FAIR

Trim: FAIR

- ☐ Strip
- ☐ Repair
- ☒ Replace

☒ Strip BARSTRAILS

- ☐ Strip
- ☒ Repair PAINT
- ☒ Replace PARTING BEAD

- ☒ Strip PULLEY
- ☒ Missing WORK + LIFT

- ☒ Replace 4X

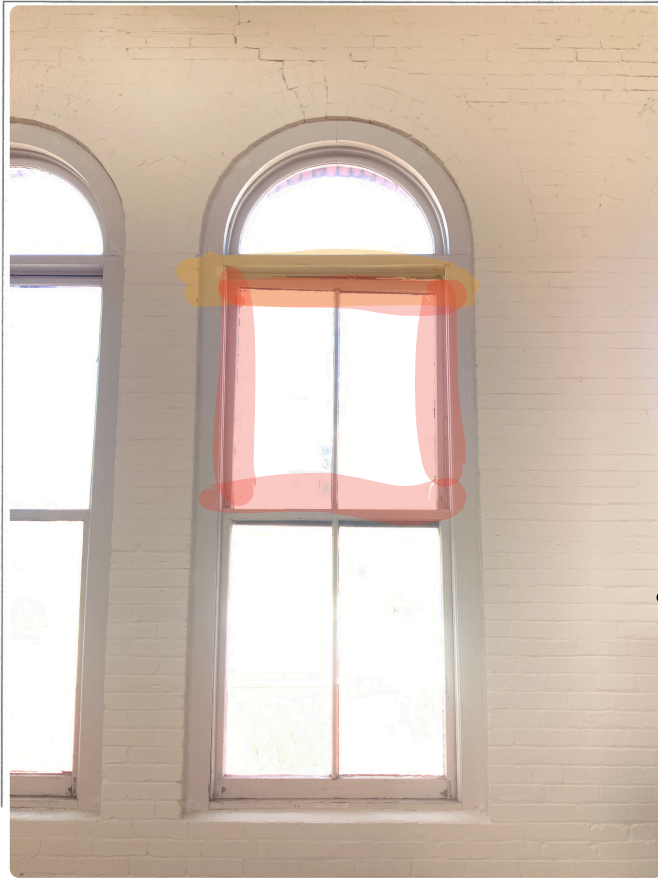
W 219

Stool: MISSING

Frame/Pulley Stiles: FAIR

Sash/Muntins/Leading: CRITICAL

- ☒ Strip UPPER IS CRITICAL
- ☒ Repair
- ☒ Replace

Trim: FAIR

- ☐ Strip
- ☐ Repair
- ☒ Replace

- ☐ Strip
- ☒ Repair PAINT
- ☐ Replace

- ☒ Strip PULLEY
- ☒ Missing LOCK + LIFT

- ☒ Replace 4x

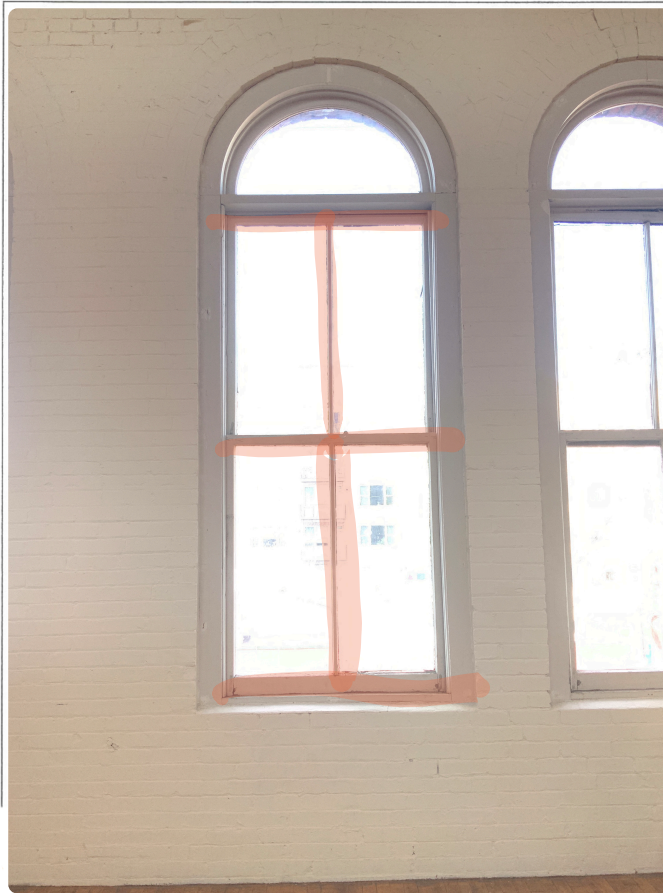
W220

Stool: MISSING

Frame/Pulley Stiles: FAIR

Sash/Muntins/Leading: FAIR

Trim: FAIR

- ☐ Strip
- ☐ Repair
- ☒ Replace

- ☒ Strip BARS + RAILS
- ☒ Repair UPPER SASH
- ☐ Replace

- ☐ Strip
- ☒ Repair PAINT
- ☒ Replace PARTING-BEAD + INT. SGP

- ☒ Strip PULLEY
- ☒ Missing LOCK + LIFT

- ☒ Replace 4X

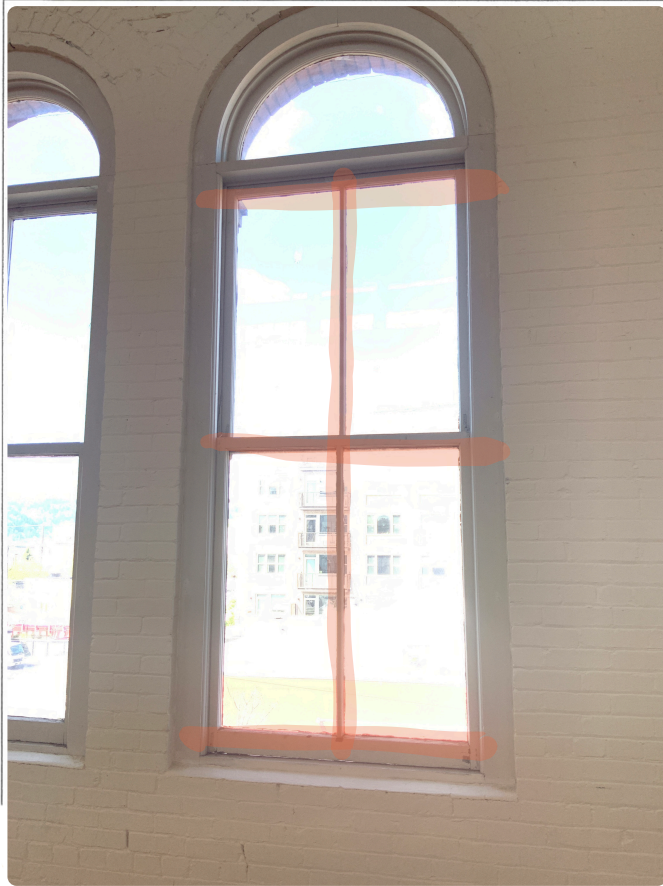
W 221

Stool: MISSING

Frame/Pulley Stiles: FAIR

Sash/Muntins/Leading: FAIR

Trim: FAIR

☒ Replace

☒ Strip BARS + RAILS

☒ Repair PAINT

☒ Replace PARTING BEAD

☒ Missing LOCK + LIFT

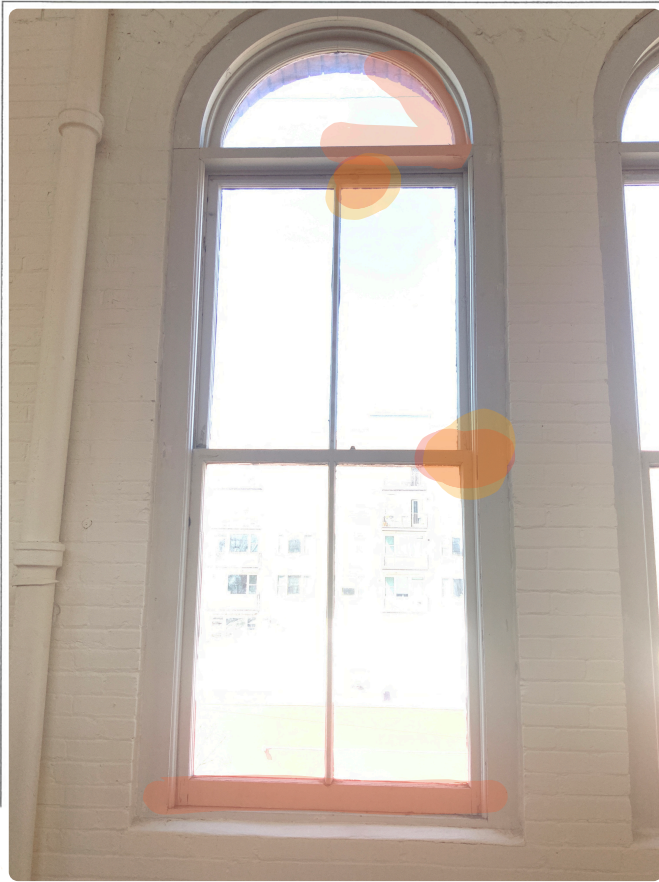
W 222

Stool: MISSING

Frame/Pulley Stiles: FAIR

Trim: FAIR

- ☒ PULLEY
- ☒ PULLEY
- ☒ Missing LATCH IS PRESENT

- ☐ Strip
- ☐ Repair
- ☒ Replace

- ☒ Strip
- ☒ Repair PROFILE JOINERY TRANSOM
- ☐ Replace

- ☐ Strip
- ☒ Repair PAINT
- ☐ Replace

- ☒ Replace 4X

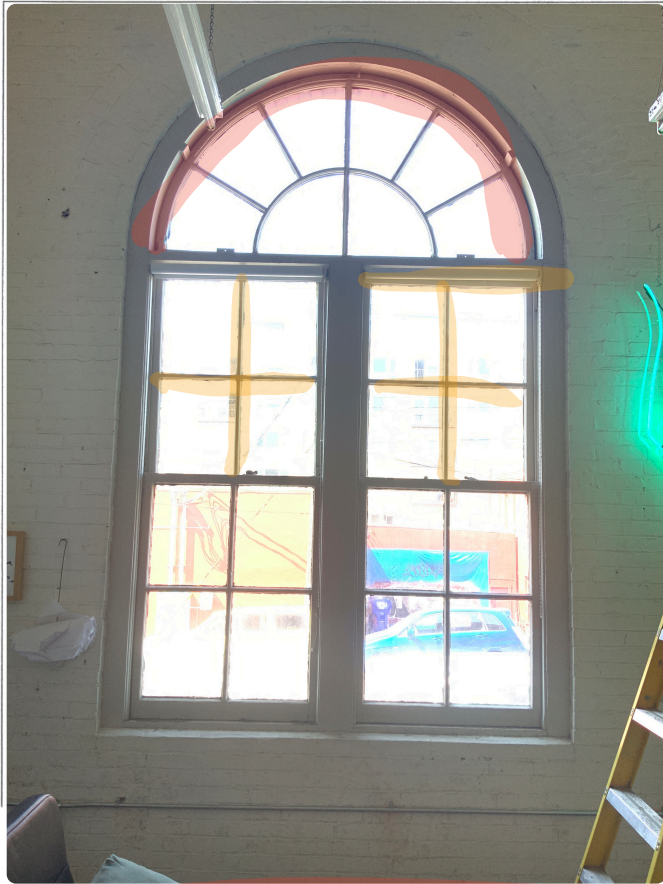
W108

**- PROFILES ARE 25%
DAMAGED**

Stool: **MISSING**

Frame/Pulley Stiles: **FAIR**

Sash/Muntins/Leading: **FAIR**

Trim: **FAIR**

RECOMMEND INT. STOP INSULATION

- ☐ Strip
- ☐ Repair
- ☒ Replace

- ☒ Strip + REFINISH
- ☒ Repair TRANSOM
- ☒ Replace UPPER RAIL

- ☐ Strip
- ☒ Repair SEALANTS
- ☐ Replace PNT. STOP

- ☒ Strip LOCKS/PULLEY
- ☒ Missing LIFTS

- ☒ Replace

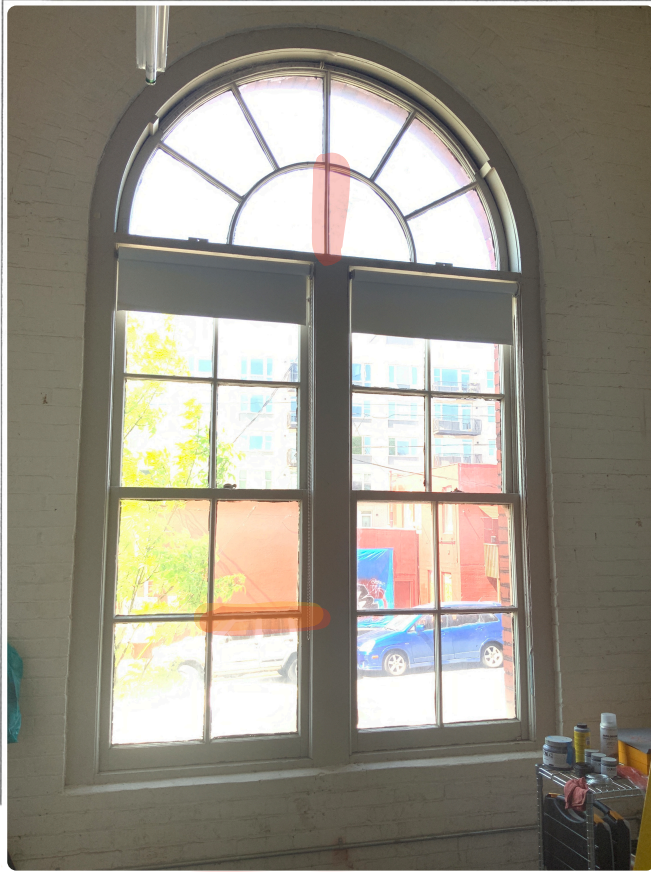
W109

MISSING SPOKE MUNTIN

Stool: MISSING

Frame/Pulley Stiles: FAIR

Sash/Muntins/Leading: FAIR

Trim: FAIR

- ☐ Strip
- ☐ Repair
- ☒ Replace

- ☒ Strip SASH
- ☒ Repair MUNTIN
- ☐ Replace

- ☐ Strip
- ☒ Repair PAINT
- ☐ Replace

- ☒ Replace 8X

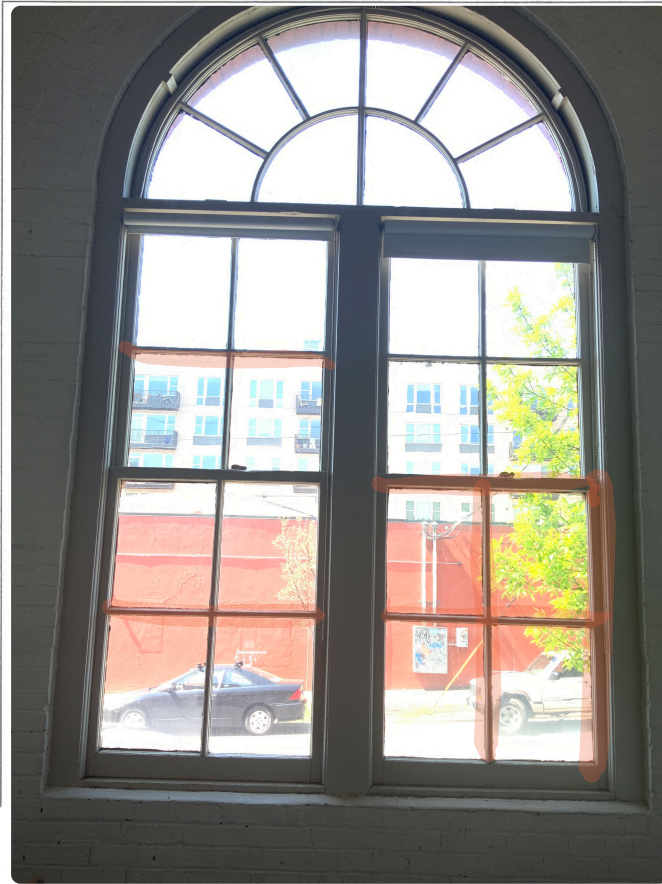
W110

Stool: MISSING

Frame/Pulley Styles: FAIR

Sash/Muntins/Leading: FAIR

Trim: FAIR

- ☐ Strip
- ☐ Repair
- ☒ Replace

- ☒ Strip SASH
- ☒ Repair MUNTINS/MTING RAIL
- ☐ Replace

- ☐ Strip
- ☒ Repair PAINT
- ☐ Replace

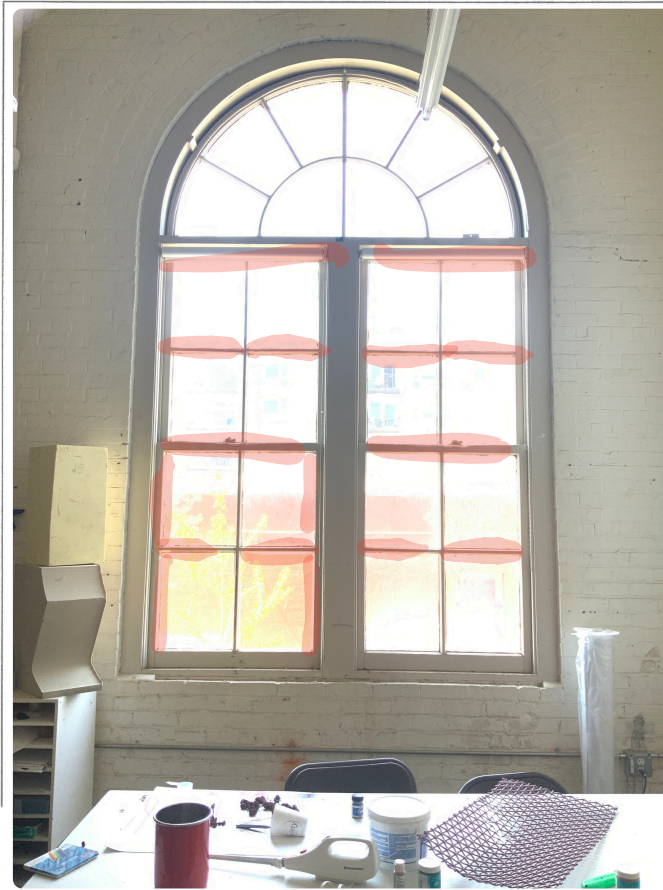
W111

Stool: MISSING

Sash/Muntins/Leading: POOR

60%

OR NEED WORK

ails: MUNTINS ARE IN
POOR CONDITION.
STILES ARE IN POOR
CONDITION.
BARS + LOWERRAILS
ARE IN FAIR CONDITION

☒ Replace

☒ Repair

☒ Repair PAINT

Remarks: REPLACEMENT PARTS
