National Register of Historic Places Registration Form

historic name Yale Union Laundry Building

street & number 800 SE 10th Avenue not for publication

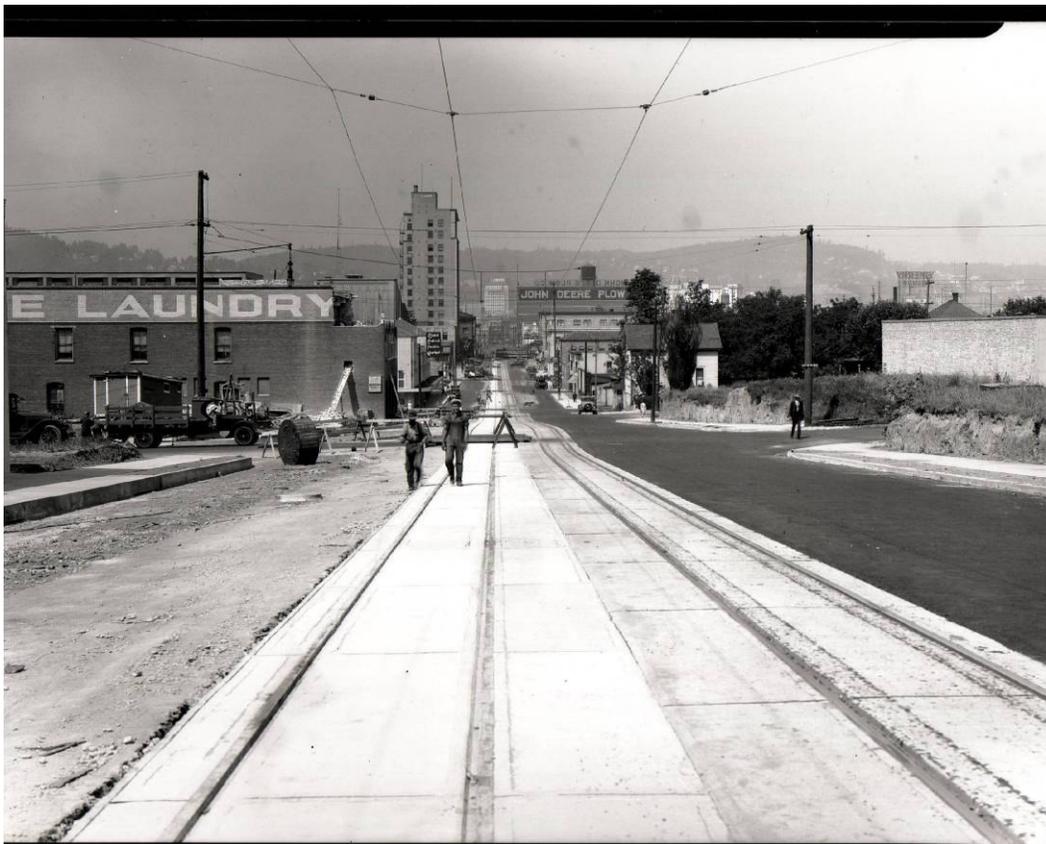
SE Morrison circa 1929
OHS Negative # COP 00739
Photograph to be used for reference use only

² See OHS photo negative # COP00739. 2001-09 Street Widening 1933. 12/4 0509-16/2 at Portland City Archives .The Yale Laundry Building is located at the corner of Morrison and E 10th Streets. Morrison Street was widened in 1929. This street was originally 60' wide. It was estimated that approximately 80-85% of the City's population was living on the east side, and yet needed to cross the river to get to the main business district. The street widening project included many streets throughout the City and spanned from 1917 through 1933. Most streets were planned to be expanded to 80', this included 56' for streets and 12' for sidewalks and curbs. Most streets were expanded from 60' to 80'. Over 2500 parcels of property were acquired from private owners. 328 people appealed to Circuit Court because they were dissatisfied with awarded damages or benefits made by the City Engineer and City Council.²This work caused a significant amount of alteration to buildings that were originally constructed right up to the property line which abutted the original right of way. In some cases the fronts of buildings were cut off and the front rebuilt. In other cases the 20' would be removed from the center of a building and then the original front moved back and joined with the rear portion. "In some instances buildings as high as five stories were moved several blocks and utilized in their new location without injury."²East Morrison was widened from 60'-84' in 1929 from Grand Avenue up to East 12th Avenue. 28 parcels were affected and there were five appeals. The total cost of the project was \$324,646.20. Ordinance 5362 granted the Home Service Company the ability to arcade the building on East Morrison between 10th and 11th Streets. The arcade was to be 10' high above the sidewalk and the distance from the outer piers of the building to the inner arcaded wall was to be 12'. The Ordinance was passed by Portland City Council on December 7, 1927 and was granted under the condition that the City of Portland could require that the arcading be removed.

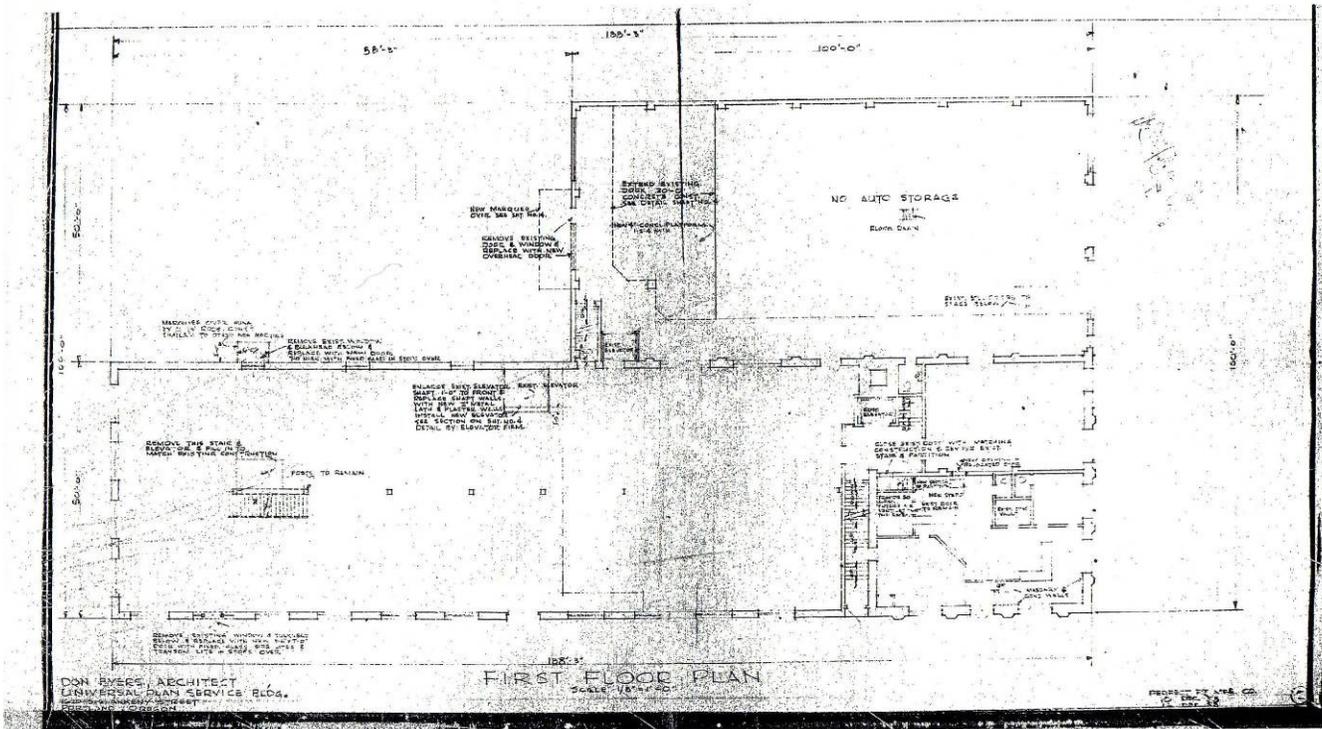
Yale Union Laundry Building, First Floor plan

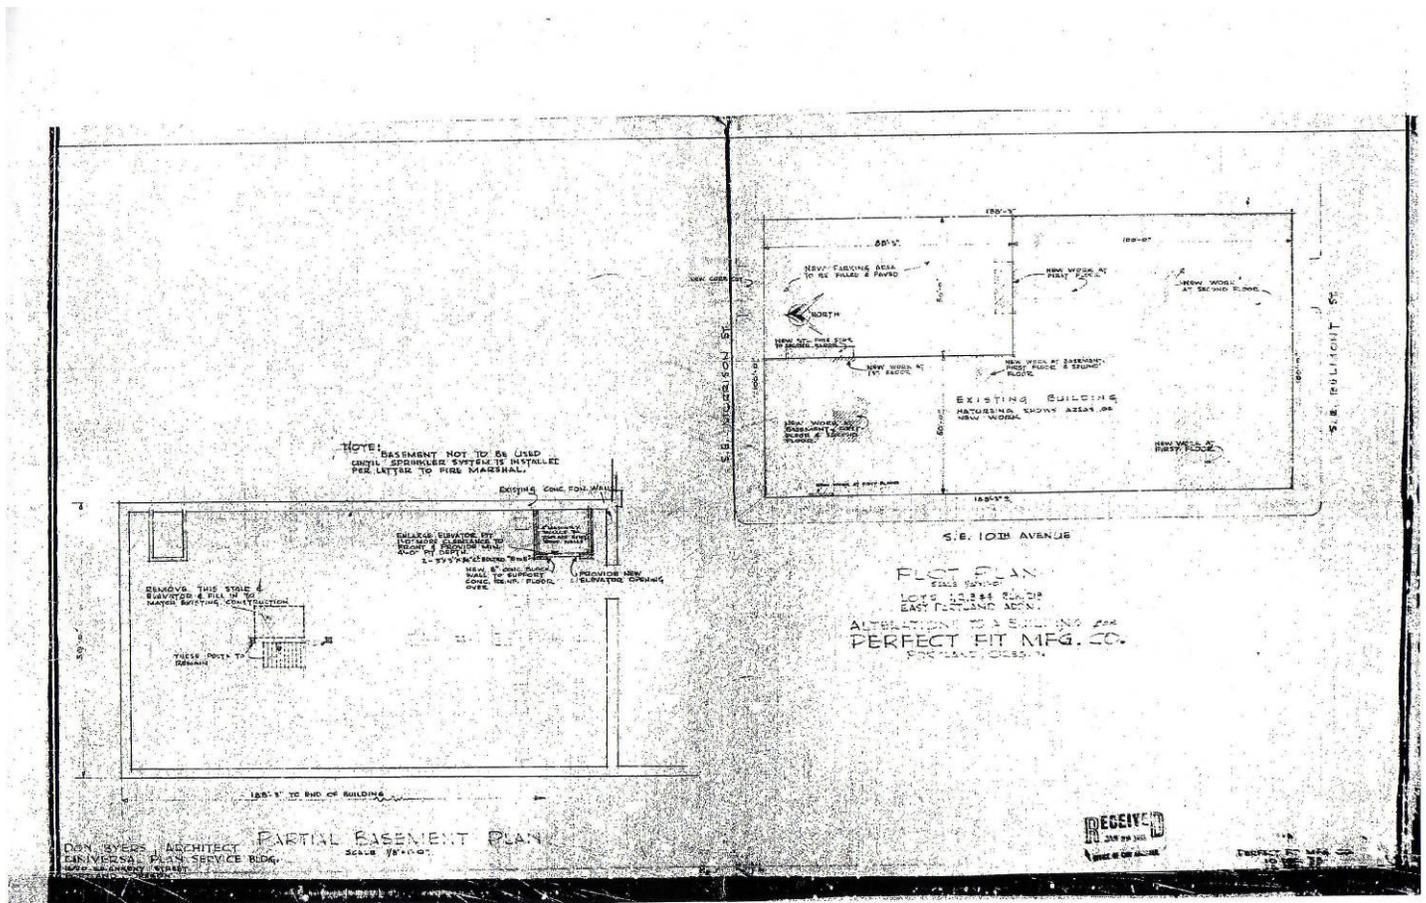
Yale Union Laundry Building, Partial Basement Plan and Plot Plan

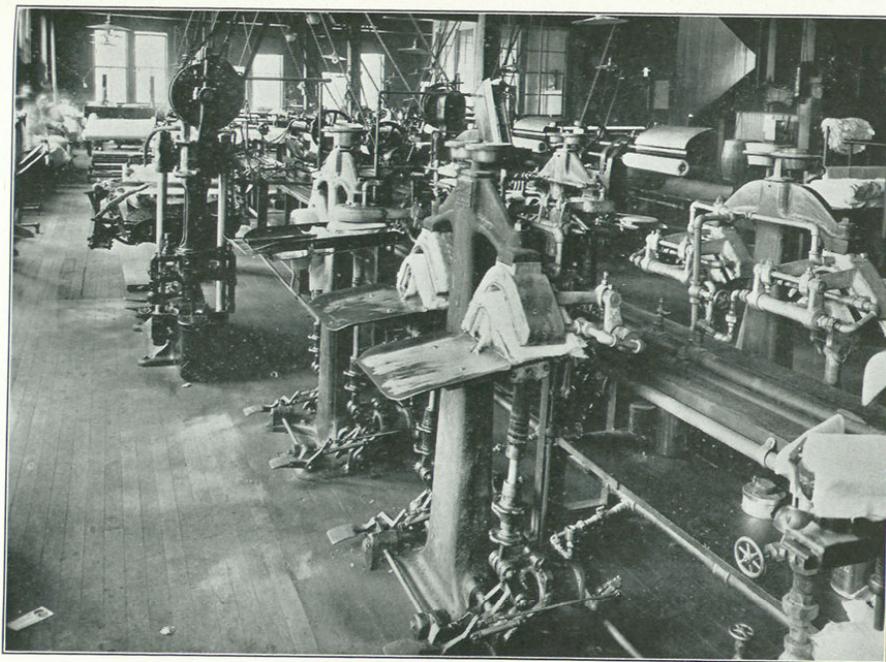
FRONTISPIECE
Body Linen Ironing Room. Showing 14 Press Machines and Body Ironers Equipped with Pneumatic Treadles,
Union Laundry, Portland.

Press Machines and Body Ironers Union Laundry, Portland, circa 1913

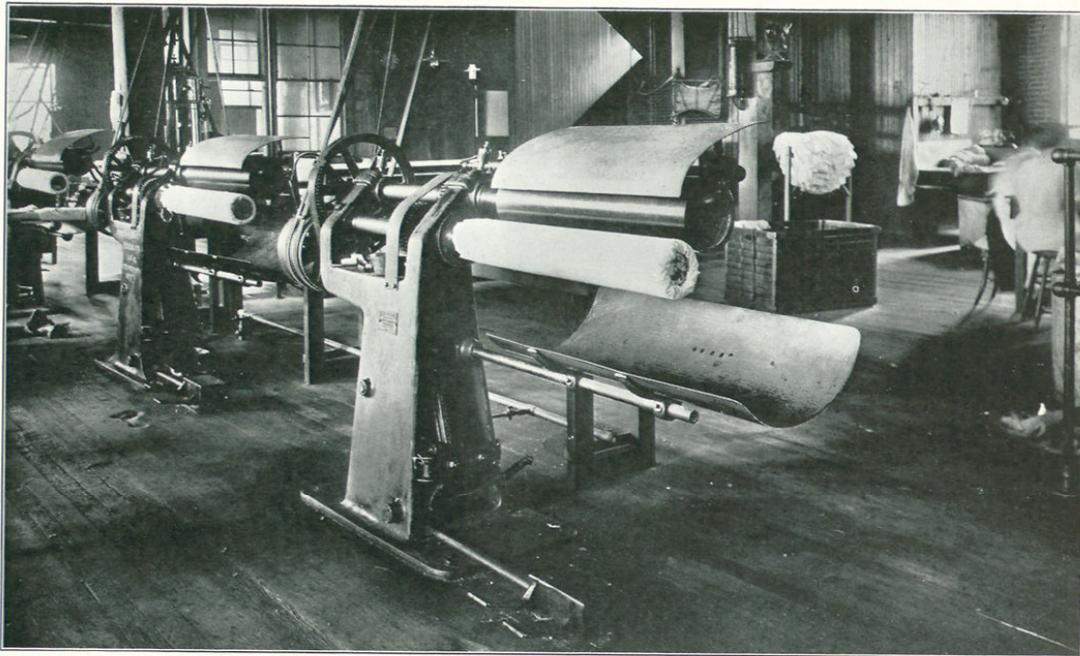
PLATE VIII. Body Ironers in Portland equipped with Pneumatic Treadles.

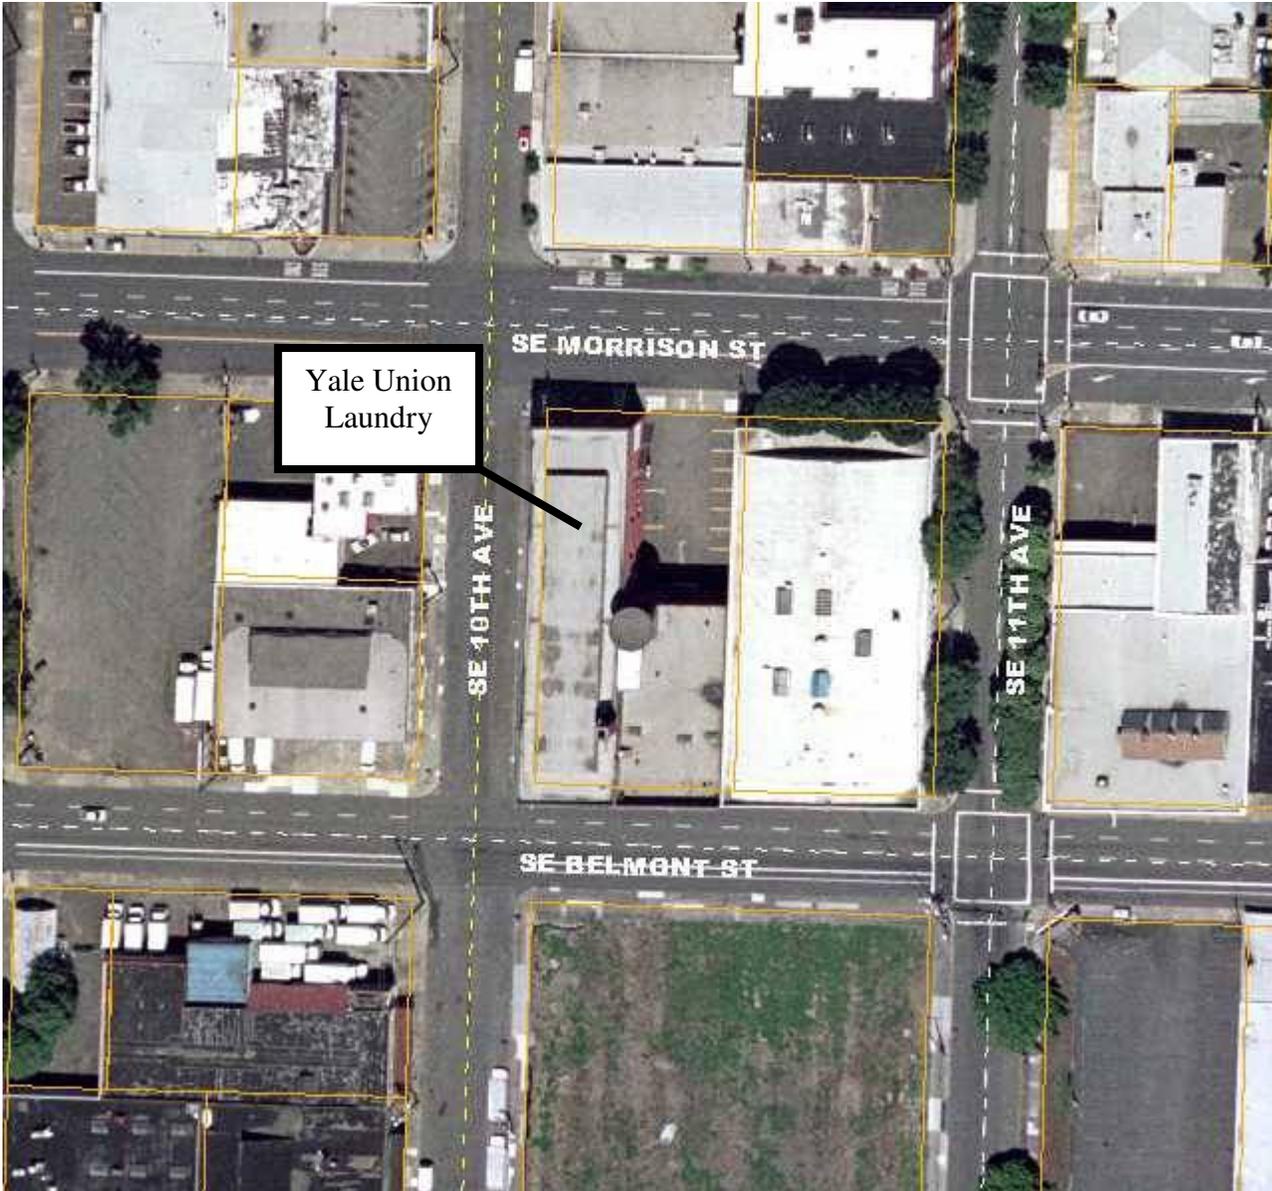
Aerial Photograph of the Yale Union Laundry
Portland Map Collection
Yale Union Laundry

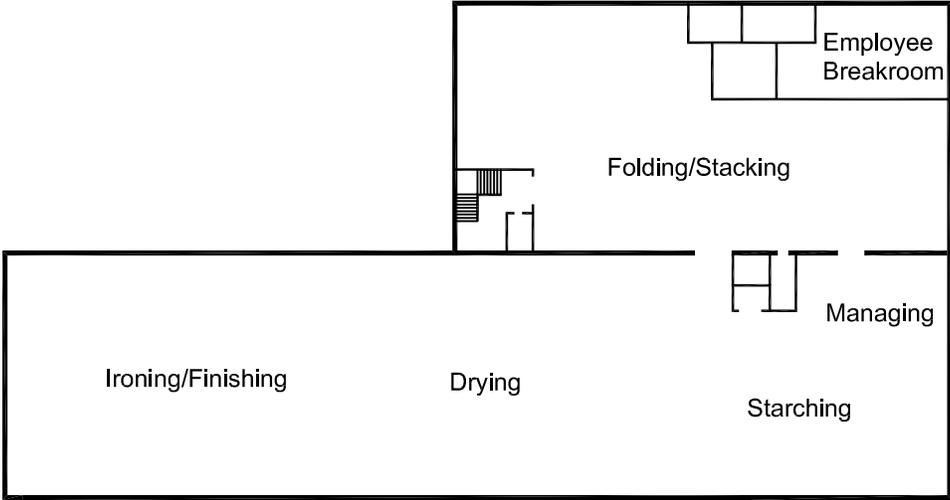
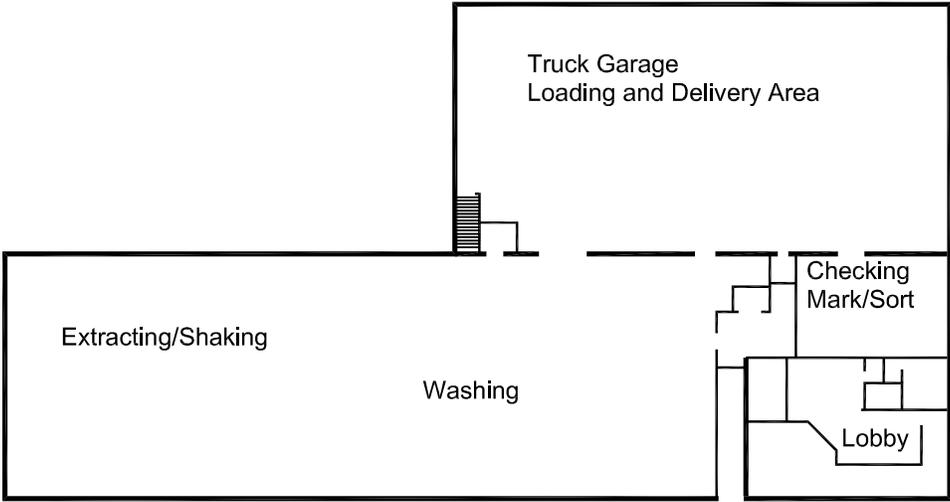
Work Process

Second Floor

First Floor

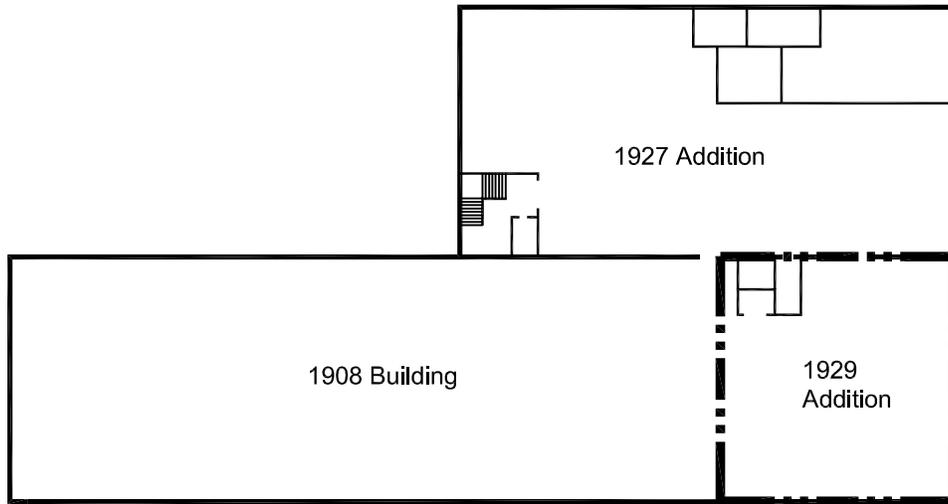
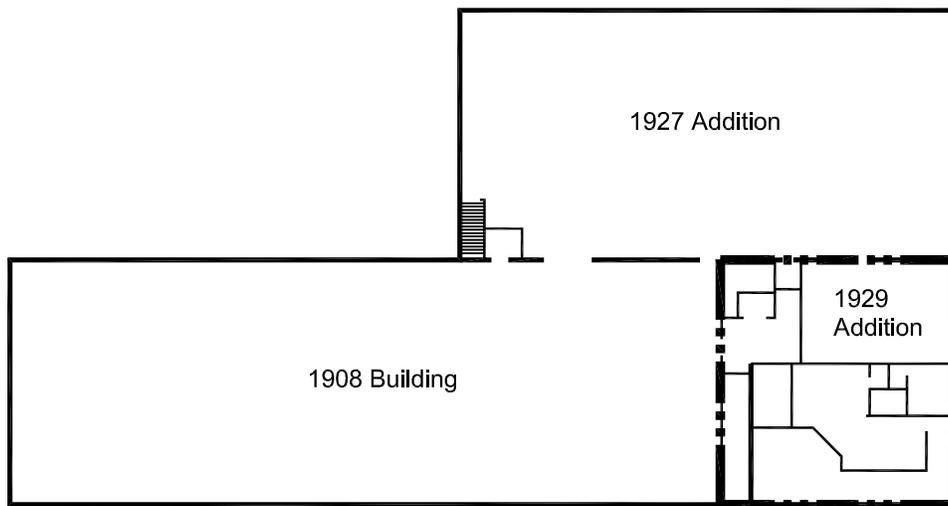
Building Evolution

Second Floor

First Floor

In 1927 an addition was made to the structure on the southeast side, replacing a smaller one story paint shop and garage. At this time several openings were added on the southern portion of the existing 1908 structure in order to provide easy access between the buildings. In 1929, both the north and south portions of the Yale Laundry Building were modified when SE Morrison Street was widened to accommodate a new street car line. Given the opportunity to either create a sidewalk arcade abutting the street or removing the rear portion of the building, the Owners elected to remove approximately 12 feet and set the north façade back adjacent to the sidewalk.² Based on the consistency in window design and masonry materials and setting techniques, it appears that new rear elevation was created from salvaged building material and replicated the original north facade. The portion of the building facing Morrison was cut off, and the front façade moved back twenty feet. It is likely that the original brick was salvaged and reused. The north façade on this portion of the building was reconstructed and many of the decorative features restored.

Also at this time, in 1929, a second two story addition was added to the south of the original 1908 building and to the west of the 1927 addition. This addition replaced an existing one story machine shop, prior to that time there was a horse barn located on this portion of the lot. The front entrance was moved from the corner of SE 10th and Morrison to this new addition at the south end of the building at the corner of SE 10th and Belmont, it was at this time that the significant cast stone decoration was added.³
