Window Assessment--Interior

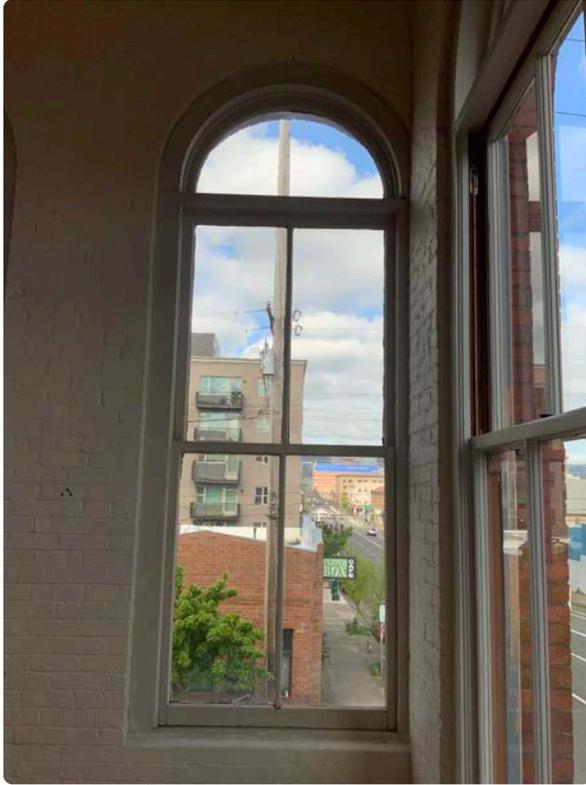
W 201

Stool: MESSML

Frame/Pulley Stiles: FAIR

Sash/Muntins/Leading: FAIR

Trim: FAIR

ails: RIGHT INT, TRIM
IS SCRIBED TO BRICK

STEEL MOETISE PULLEY

Ropes/Chains MISSING

- Strip
- Repair
- Replace

- Strip HORIZONTAL SURFACES
- Repair
- Replace (RAILS)

- Strip
- Repair PAINT
- Replace

- Strip PULLEYS
- Missing L + L

- Replace 4 ROPES NEEDED

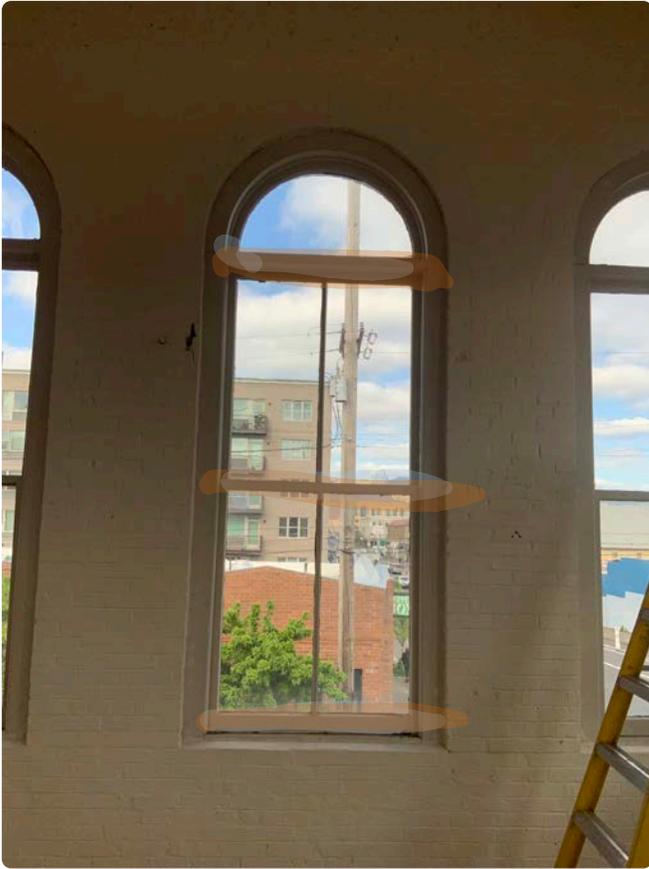
Location: <u>W202</u>
	Window Description: <u>DH w/ TRANSOM</u>
	Stool: <u>MISSING</u> <input type="checkbox"/> Strip <input type="checkbox"/> Repair <input checked="" type="checkbox"/> Replace
	Frame/Pulley Stiles: <u>FAIR</u> <input checked="" type="checkbox"/> Strip <u>REFINISH</u> <input type="checkbox"/> Repair <input type="checkbox"/> Replace
	Sash/Muntins/Leading: <u>FAIR</u> <input checked="" type="checkbox"/> Strip <u>HORIZONTAL SURFACES</u> <input type="checkbox"/> Repair <input type="checkbox"/> Replace
	Trim: <u>FAIR</u> <input type="checkbox"/> Strip <input checked="" type="checkbox"/> Repair <u>REFINISH</u> <input type="checkbox"/> Replace
ails:	Hardware Description: <u>STEEL MORTISE PULLEY</u> <input checked="" type="checkbox"/> Strip <u>PULLEY</u> <input checked="" type="checkbox"/> Missing <u>LOCK+LIFT</u>
Remarks:	Ropes/Chains: <u>4X</u> <input checked="" type="checkbox"/> Replace

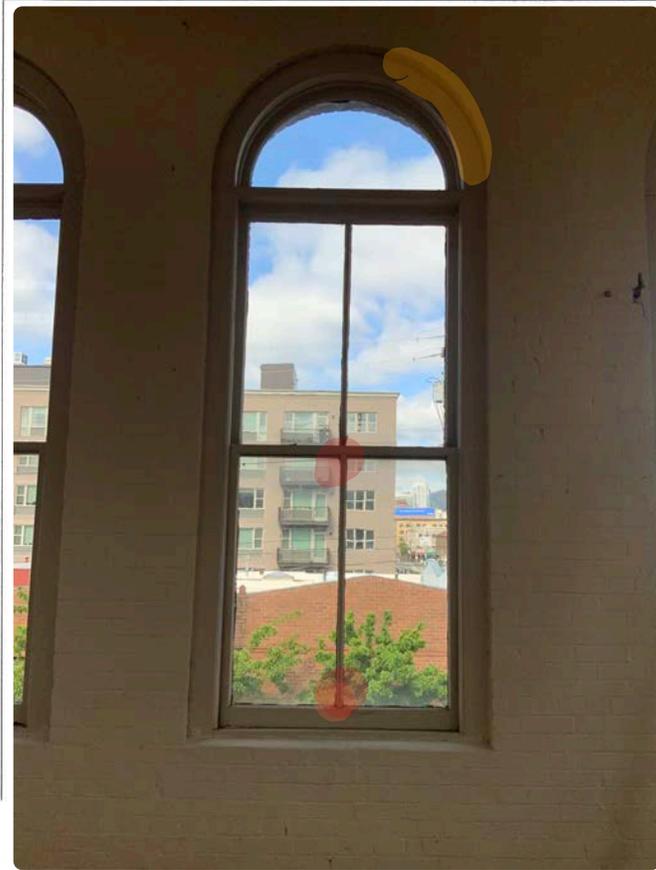
W203

Stool: MISSING

Frame/Pulley Stiles: FAIR

Sash/Muntins/Leading: FAIR

- Strip HORIZONTAL RAILS
- Repair BAR JOINERY
- Replace HAS SEPERATED

Trim: FAIR

- Strip PULLEYS
- Missing LTL

- Strip + REFINISH
- Repair
- Replace

- Strip APPLY
- Repair SEALANTS
- Replace AT MASONRY

- Replace 4X

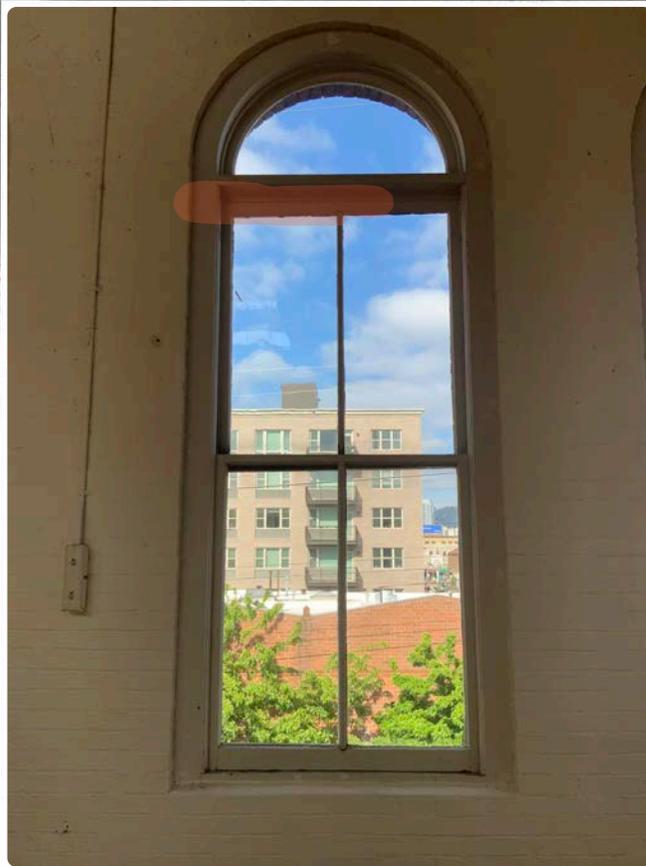
W204

Stool: MISSING

Frame/Pulley Stiles: FAIR

Sash/Muntins/Leading: FAIR

Trim: FAIR

- Strip PULLEYS
- Missing LOCK + LIFT

ails: UPPER SASH HAS DROPPED
 @ LEFT CORNER.

- Strip RAILS + BARS
- Repair
- Replace

- Strip
- Repair PAINT
- Replace

- Replace

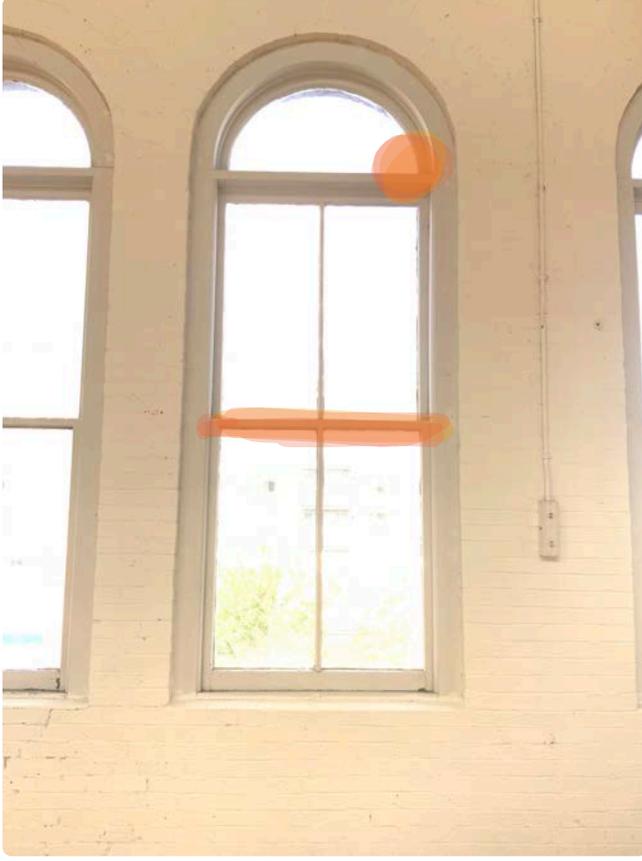
Location: W 205
	Window Description: DH w/TRANSOM
	Stool: MISSING <input type="checkbox"/> Strip <input type="checkbox"/> Repair <input checked="" type="checkbox"/> Replace
	Frame/Pulley Stiles: FAIR <input checked="" type="checkbox"/> Strip <input type="checkbox"/> Repair <input type="checkbox"/> Replace
	Sash/Muntins/Leading: FAIR <input checked="" type="checkbox"/> Strip RAILS + BARS <input checked="" type="checkbox"/> Repair TRANSOM + <input type="checkbox"/> Replace MEETING RAIL
	Trim: <input type="checkbox"/> Strip <input checked="" type="checkbox"/> Repair PAINT <input type="checkbox"/> Replace
	Hardware Description: PULLEY <input checked="" type="checkbox"/> Strip PULLEY <input checked="" type="checkbox"/> Missing LOCK + LIFT
Remarks:	Ropes/Chains <input checked="" type="checkbox"/> Replace 4x
Remarks:	Weatherstripping:

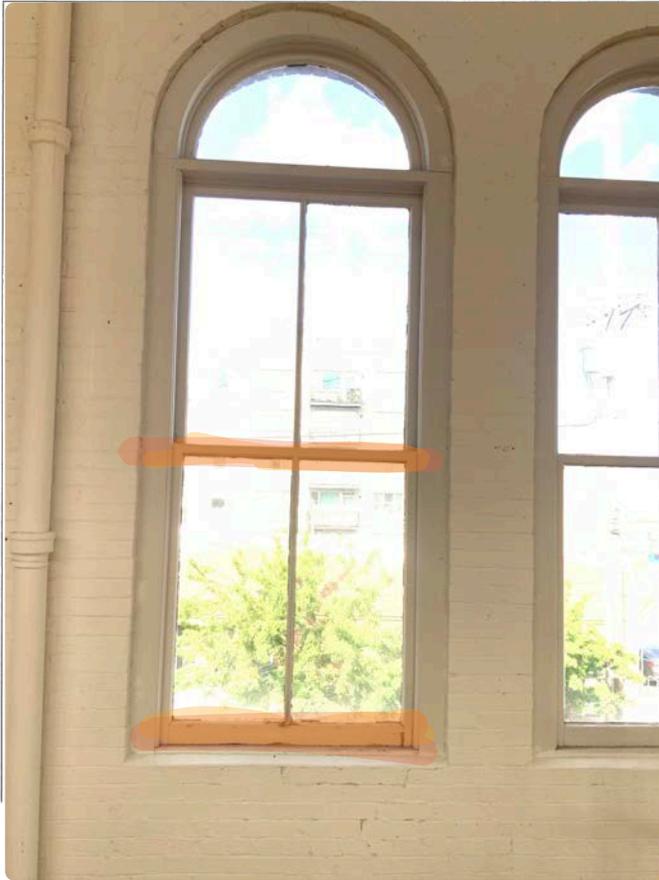
W206

Stool: MISSING

Frame/Pulley Stiles: FAIR

Sash/Muntins/Leading: FAIR

UV DAMAGE ON HORIZONTAL LOCATIONS

- Strip **PULLEY**
- Missing **LOCK + LIFT**

- Strip **RAILS + BARS**
- Repair **MTNG RAIL, LWR RAIL**
- Replace

- Strip
- Repair **PAINT**
- Replace

4X

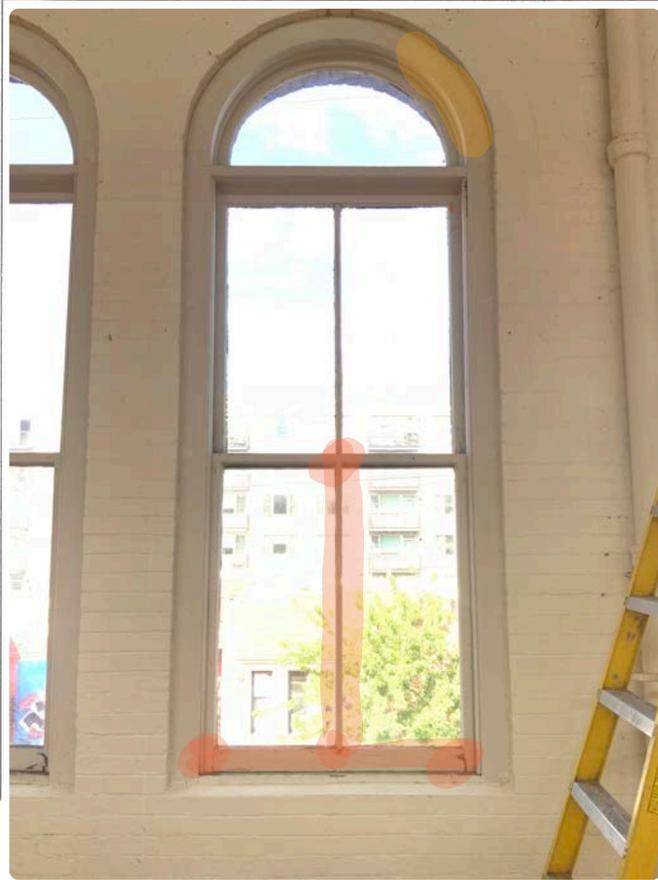
W207

Stool: MISSING

Frame/Pulley Stiles: FAIR

- Strip LOWER RAIL
- Repair BARS + LOWER RAIL
- Replace LOOSE JOINERY

- Strip
- Repair SURFACE DAMAGE IN UPPER ARCH CASING
- Replace

- PULLEY
- Strip PULLEY
- Missing LOCK UP

- Replace 4 X

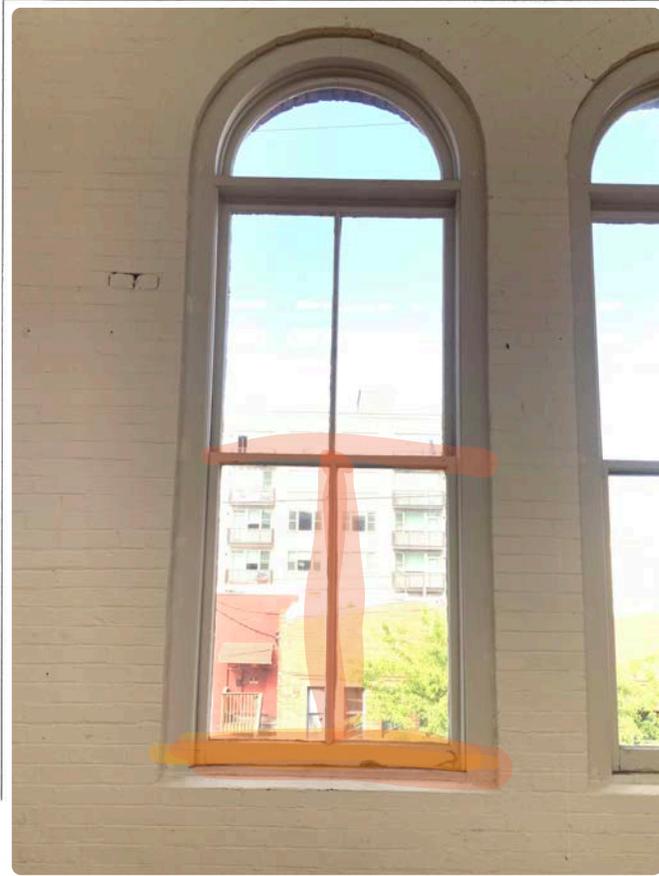
W208

Stool: MISSING

Frame/Pulley Stiles: FAIR

Sash/Muntins/Leading: FAIR

- Strip RAILS + BARS
- Repair LOOSE JOINERY
- Replace

Trim: FAIR

- Strip PULLEY
- Missing LOCK + LIFT

- Strip
- Repair PAINT
- Replace

- Replace 4x

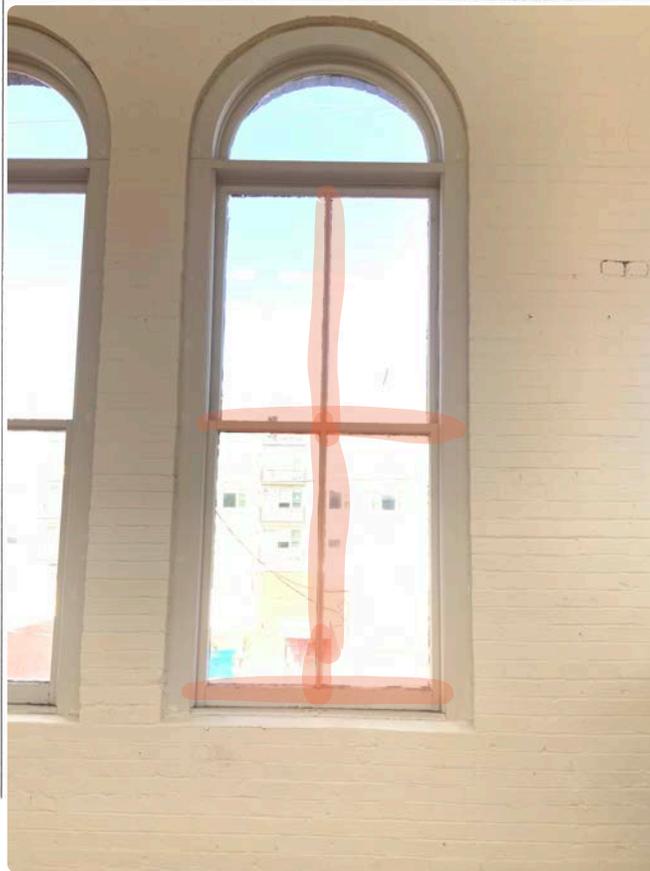
W209

Stool: MISSING

Frame/Pulley Stiles: FAIR

Sash/Muntins/Leading: FAIR

- Strip PULLEY
- Missing LOCK LIFT

- Strip
- Repair
- Replace PARTING BEAD

- Strip RAILS + BARS
- Repair BARS
- Replace

- Strip
- Repair PAINT
- Replace

- Replace 4x

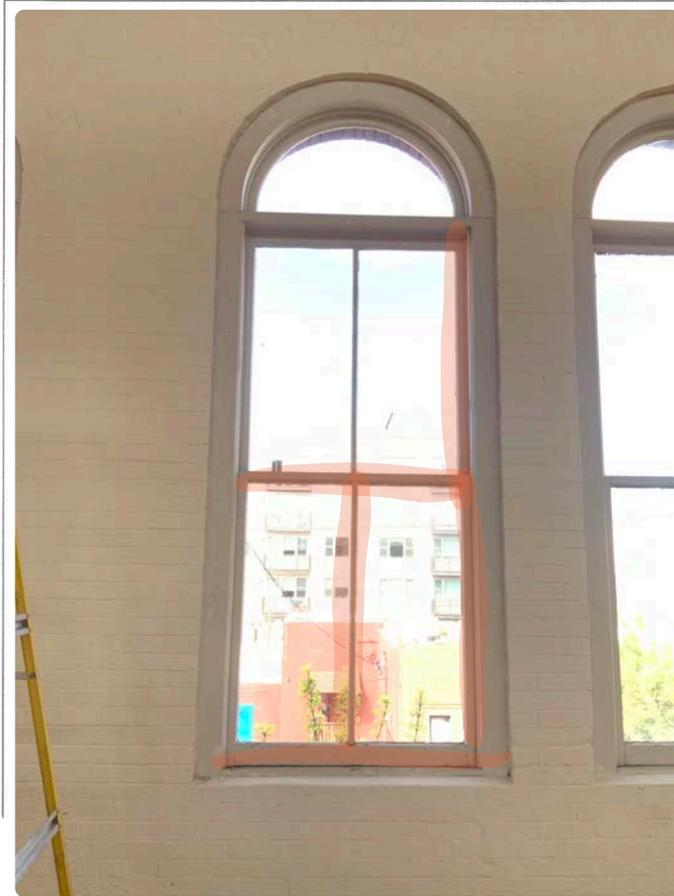
W 210

Stool: MISSING

Frame/Pulley Stiles: FAIR

Sash/Muntins/Leading: FAIR

- Strip PULLEY
- Missing LOCK + LIG

- Strip
- Repair
- Replace (R) POCKET DOOR

- Strip RAILS + BARS
- Repair JOINERY
- Replace

- Strip
- Repair PAINT
- Replace

- Replace 4X

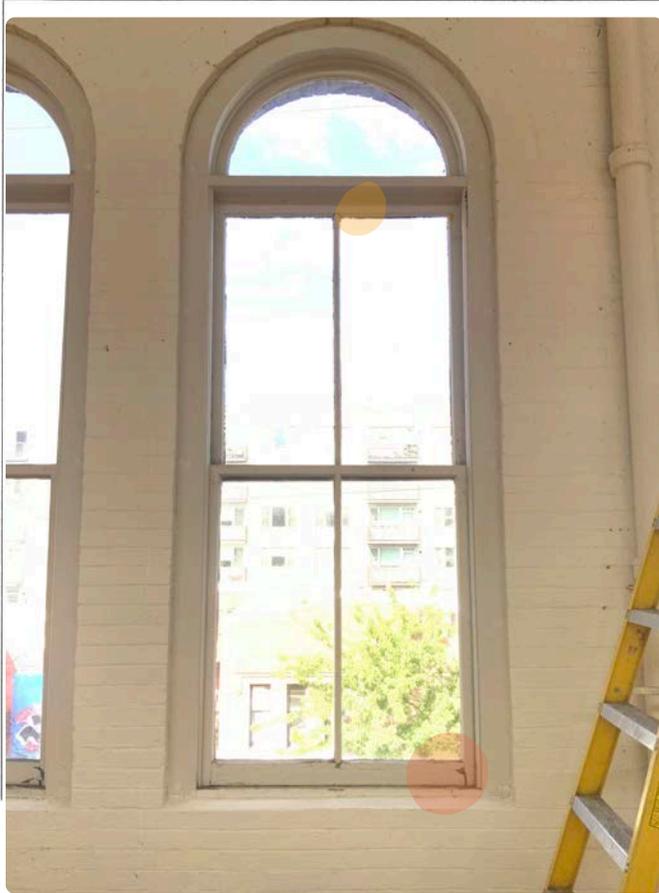
W211

Stool: MISSING

Frame/Pulley Stiles: FAIR

Sash/Muntins/Leading: FAIR

- Strip PULLEY
- Missing LOCK BOLT

- Strip SASH
- Repair LOWER RAIL
- Replace

- Strip
- Repair PAINT
- Replace

- Replace 4X

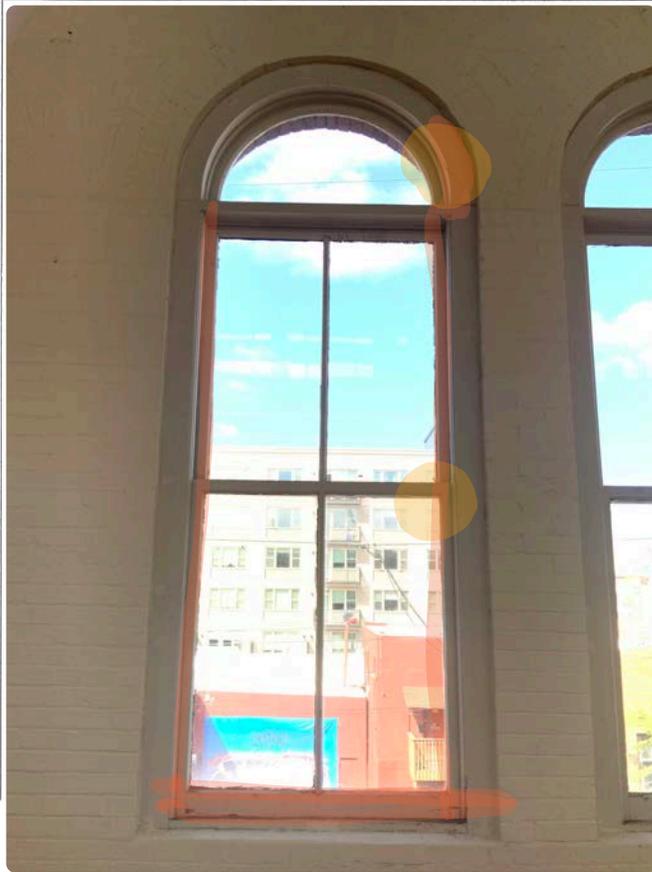
W212

Stool: MISSING

Frame/Pulley Stiles: FAIR

Sash/Muntin/Leading: FAIR

- Strip DAMAGE @ JOINT
- Repair @ JOINT
- Replace

- Strip PULLEY
- Missing LOCK + LIFT

ails: PREVIOUS REPAIRS @
LOWER RAIL PERFORMED
POORLY

- Strip
- Repair ARCH CASING
- Replace INT. STOP

- Replace 4X

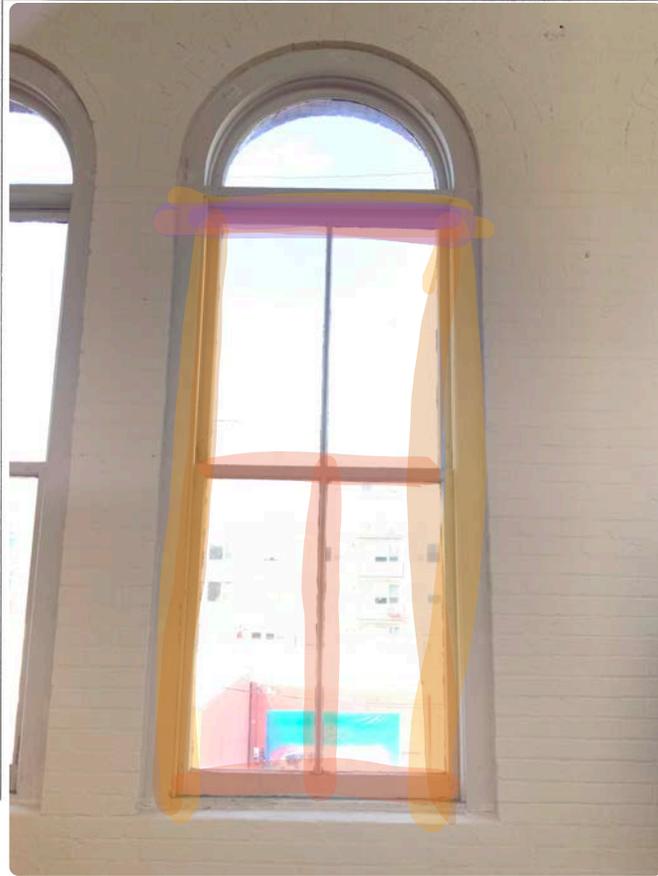
W213

Stool: MISSING

Frame/Pulley Stiles: FAIR

Sash/Muntins/Leading: FAIR

- PULLEY
- Strip PULLEY
- Missing LOCK + LIFT

ails: UPPER SASH HAS DROPPED AND VOID HAS BEEN FILLED WITH SEALANT

- Strip
- Repair
- Replace PARTING BEAD

- Strip RAILS + BARS
- Repair JOINERY
- Replace

- Strip
- Repair
- Replace INT. STOP

- Replace 4X

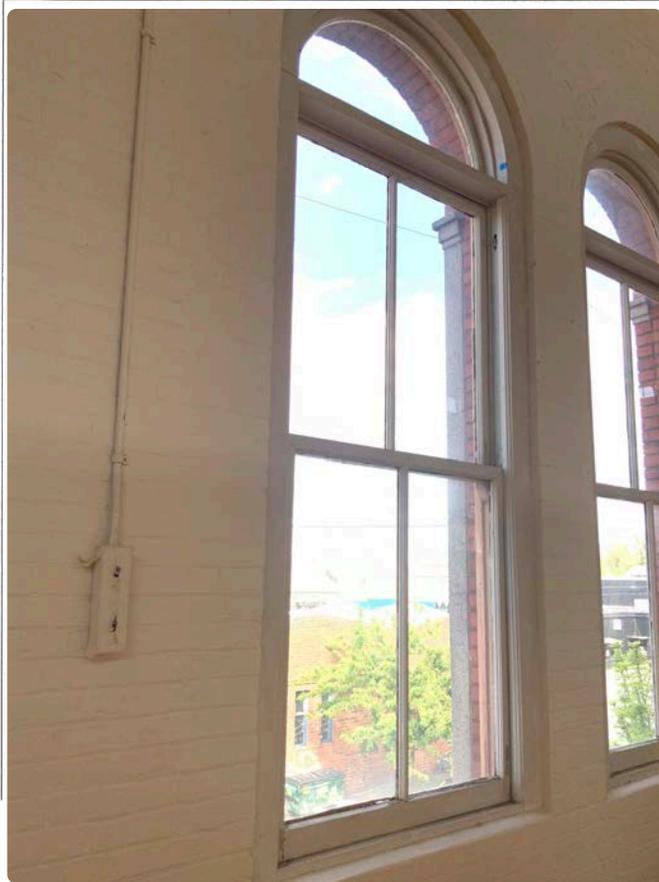
WZ14

Stool: MISSING

Frame/Pulley Stiles: FAIR

Sash/Muntins/Leading: FAIR

- Strip RAILS + BARS
- Repair LOOSE JOINERY
- Replace

- Strip PULLEY
- Missing LOCK LIFT

- Strip
- Repair PAINT
- Replace PARTING BEAD

4x
 Replace

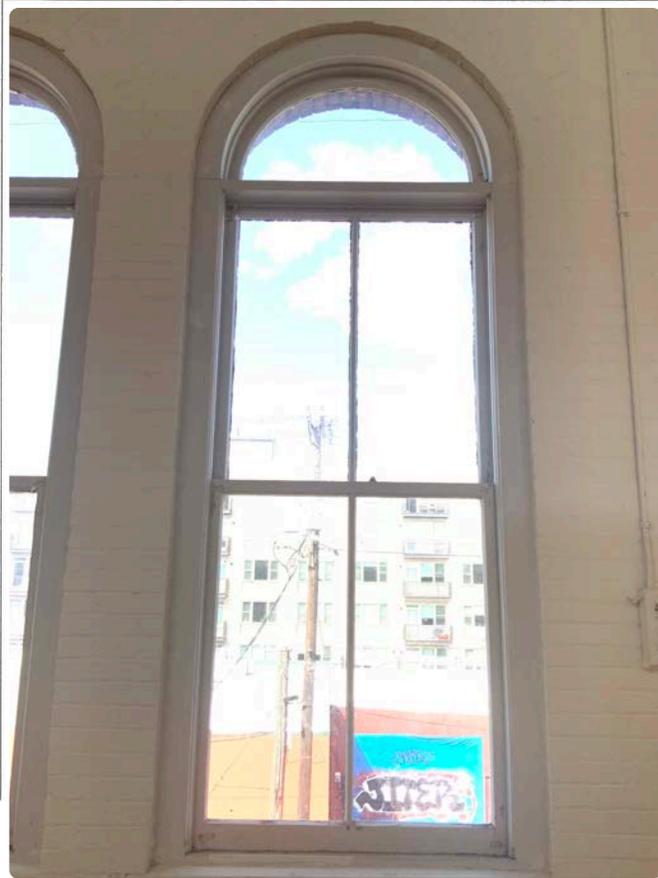
W215

Stool: MISSING

Frame/Pulley Stiles: FAIR

Sash/Muntins/Leading: FAIR

- Strip PULLEY
- Missing STRIKE IS PRESENT

- Strip BARS + TRAILS
- Repair
- Replace

- Strip
- Repair PAINT
- Replace

- Replace 4X

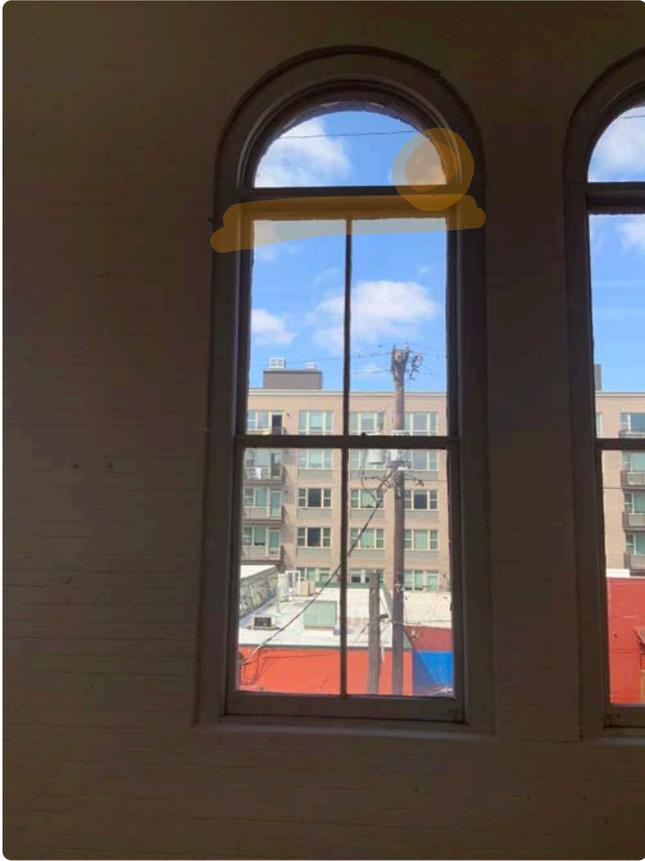
Location: <u>W216</u>
	Window Description: <u>DH w/ TRANSOM</u>
	Stool: <u>MISSING</u> <input type="checkbox"/> Strip <input type="checkbox"/> Repair <input checked="" type="checkbox"/> Replace
	Frame/Pulley Stiles: <u>FAIR</u> <input checked="" type="checkbox"/> Strip <input type="checkbox"/> Repair <input type="checkbox"/> Replace
	Sash/Muntins/Leading: <u>FAIR</u> <input checked="" type="checkbox"/> Strip <u>SASH</u> <input checked="" type="checkbox"/> Repair <u>TRANSOM TOPRAIL</u> <input type="checkbox"/> Replace
	Trim: <u>FAIR</u> <input type="checkbox"/> Strip <input checked="" type="checkbox"/> Repair <u>PAINT</u> <input type="checkbox"/> Replace
	Hardware Description: <u>PULLEY</u> <input checked="" type="checkbox"/> Strip <u>PULLEY</u> <input checked="" type="checkbox"/> Missing <u>SPRINGS IS PRESENT</u>
Remarks:	Rope/Chains: <u>4x</u> <input checked="" type="checkbox"/> Replace
Remarks:	Weatherstripping: <u>n/a</u>

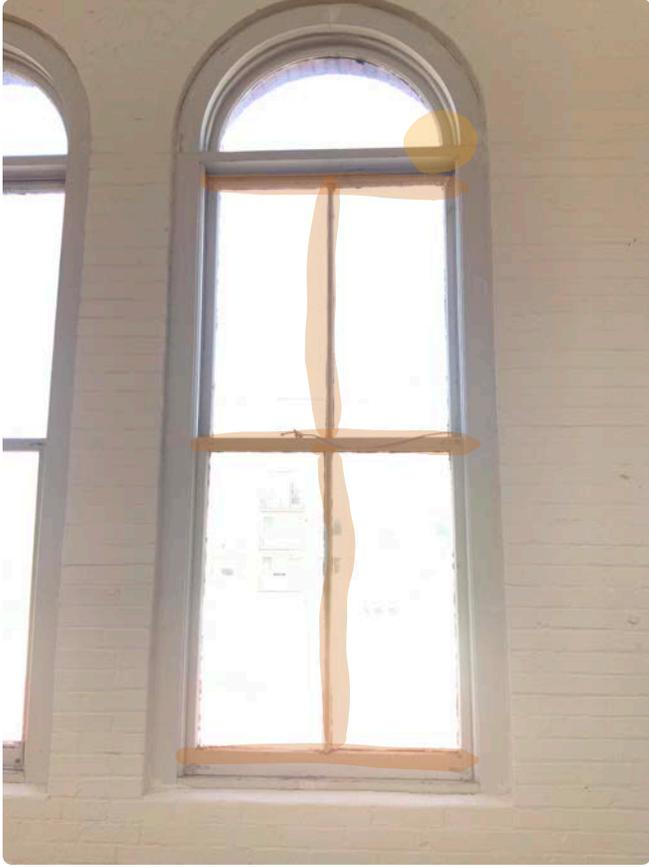
Location: W217
	Window Description: DH w/ TRANSOM
	Stool: MISSING <input type="checkbox"/> Strip <input type="checkbox"/> Repair <input checked="" type="checkbox"/> Replace
	Frame/Pulley Stiles: FAIR <input checked="" type="checkbox"/> Strip <input type="checkbox"/> Repair <input type="checkbox"/> Replace
	Sash/Muntins/Leading: <input checked="" type="checkbox"/> Strip BARS + RAJUS <input checked="" type="checkbox"/> Repair TRANSOM <input type="checkbox"/> Replace
	Trim: FAIR <input type="checkbox"/> Strip <input checked="" type="checkbox"/> Repair PAINT <input type="checkbox"/> Replace
	Hardware Description: PULLEY <input checked="" type="checkbox"/> Strip PULLEY <input checked="" type="checkbox"/> Missing LOCK + LIFT
Remarks:	Rope/Chains: 4x <input checked="" type="checkbox"/> Replace Weatherstripping: N/A

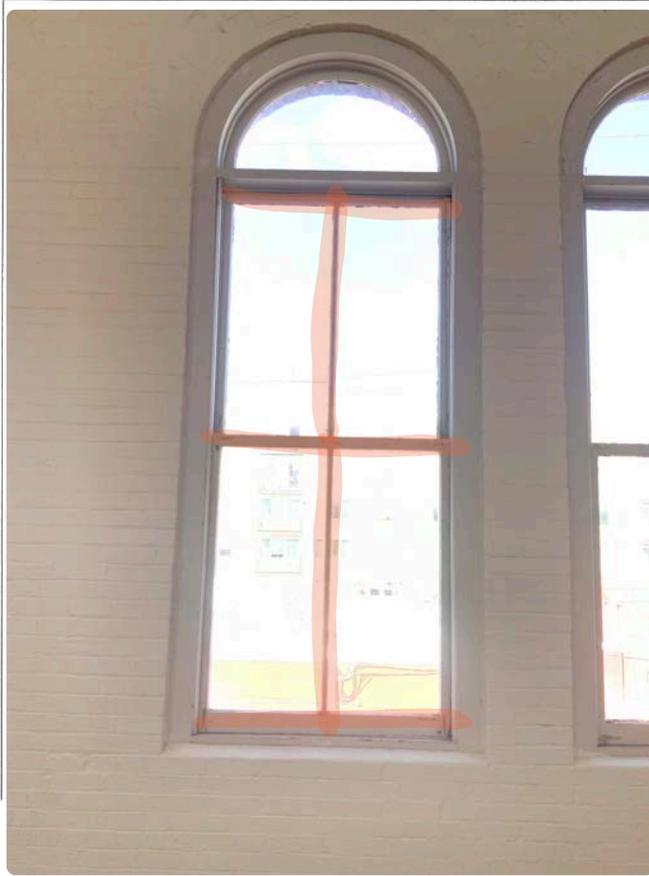
W 218

Stool: MISSING

Frame/Pulley Stiles: FAIR

Sash/Muntins/Leading: FAIR

- PULLEY
- Strip PULLEY
- Missing WORK + LIFT

- Strip
- Repair PAINT
- Replace PARTING BEAD

- Replace 4X

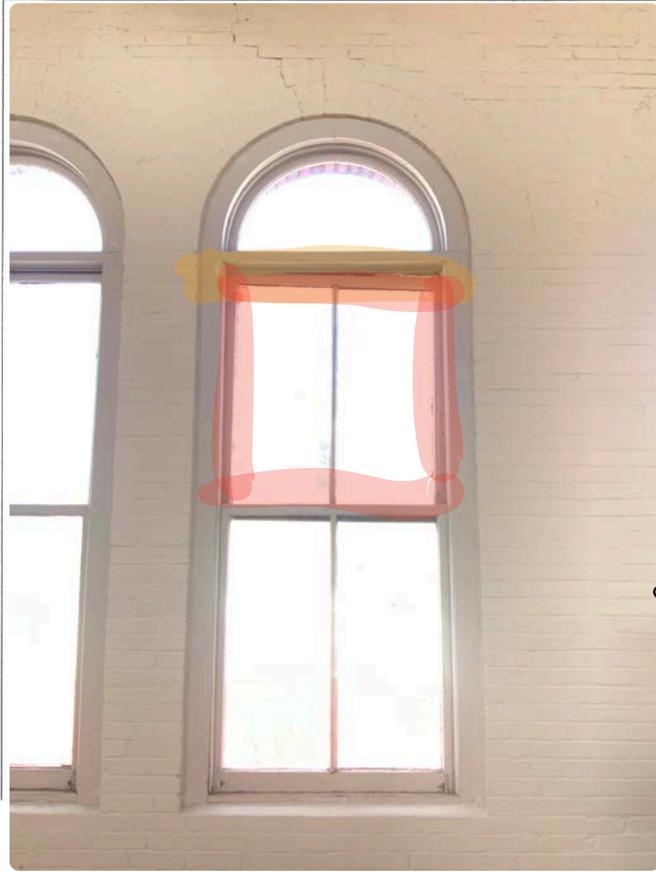
W 219

Stool: MISSING

Frame/Pulley Stiles: FAIR

Sash/Muntins/Leading: CRITICAL

- Strip UPPER IS CRITICAL
- Repair CRITICAL
- Replace

PULLEY
 Strip PULLEY
 Missing LOCK + LIFT

- Strip
- Repair PAINT
- Replace

- Replace 4x

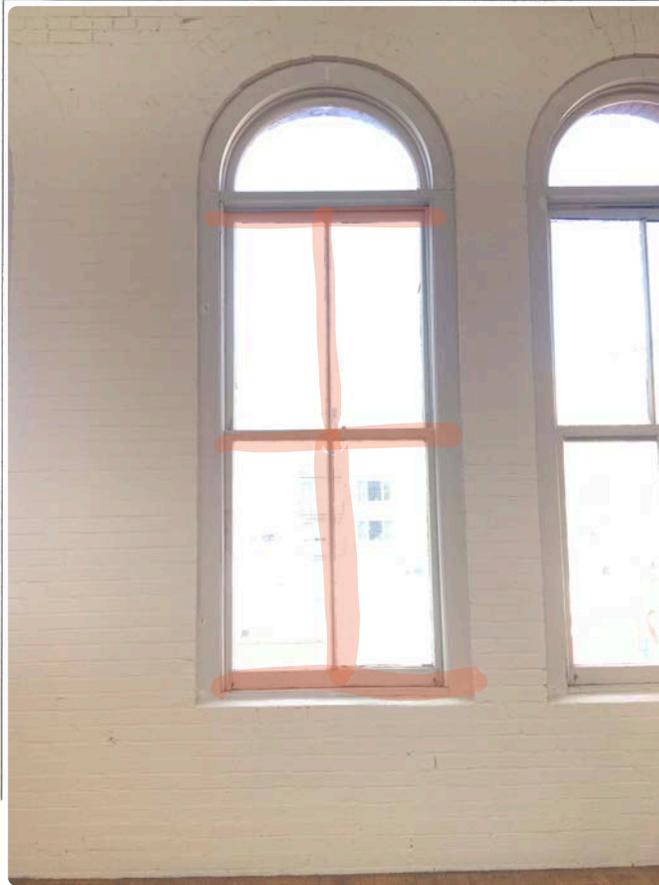
W220

Stool: MISSING

Frame/Pulley Stiles: FAIR

Sash/Muntins/Leading: FAIR

- PULLEY
- Strip PULLEY
 - Missing LOCKUP

- Strip BARS + RAILS
- Repair UPPER SASH
- Replace

- Strip
- Repair PAINT
- Replace PARTING-BEAD + INT. SQP

- Replace 4x

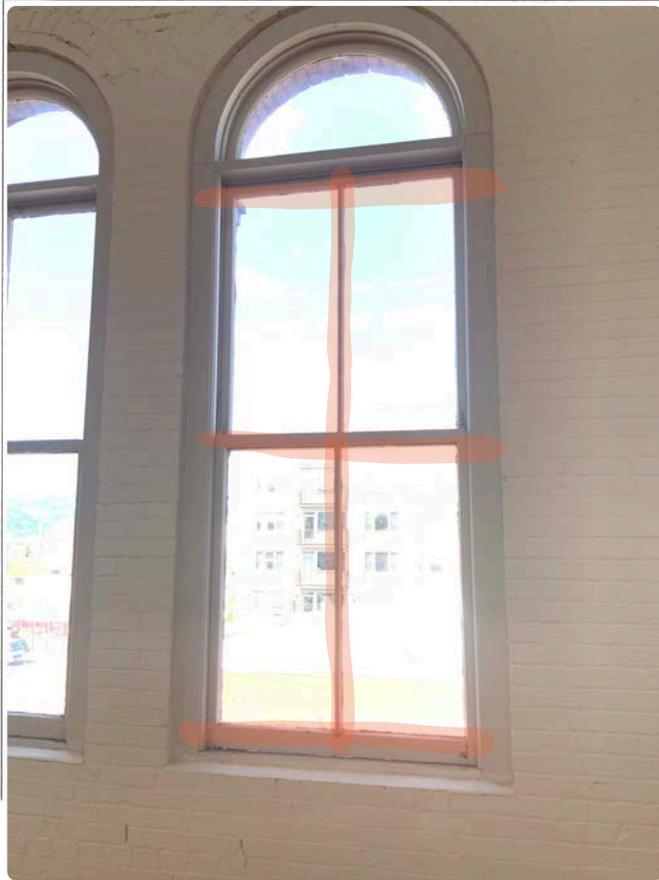
W 221

Stool: MISSING

Frame/Pulley Stiles: FAIR

Sash/Muntins/Leading: FAIR

- Strip **PULLEY**
- Missing **LOCK+LIFT**

- Strip
- Repair **PAINT**
- Replace **PARTING BEAD**

- Replace **4X**

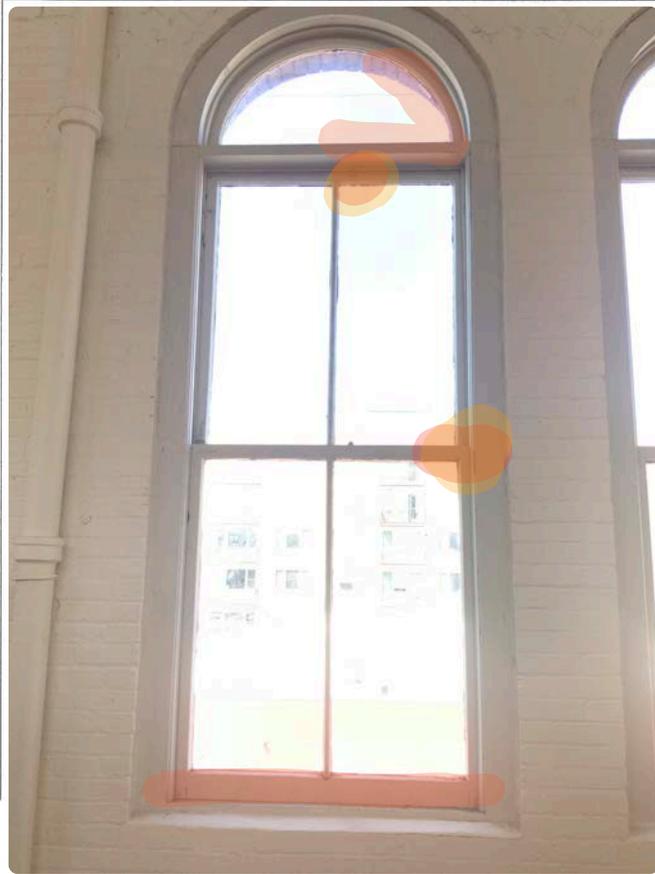
W 222

Stool: MISSING

Frame/Pulley Stiles: FAIR

- Strip
- Repair PROFILE JOINERY TRANSOM
- Replace

- PULLEY
- Strip PULLEY
- Missing LATCH IS PRESENT

- Strip
- Repair PAINT
- Replace

- Replace 4X

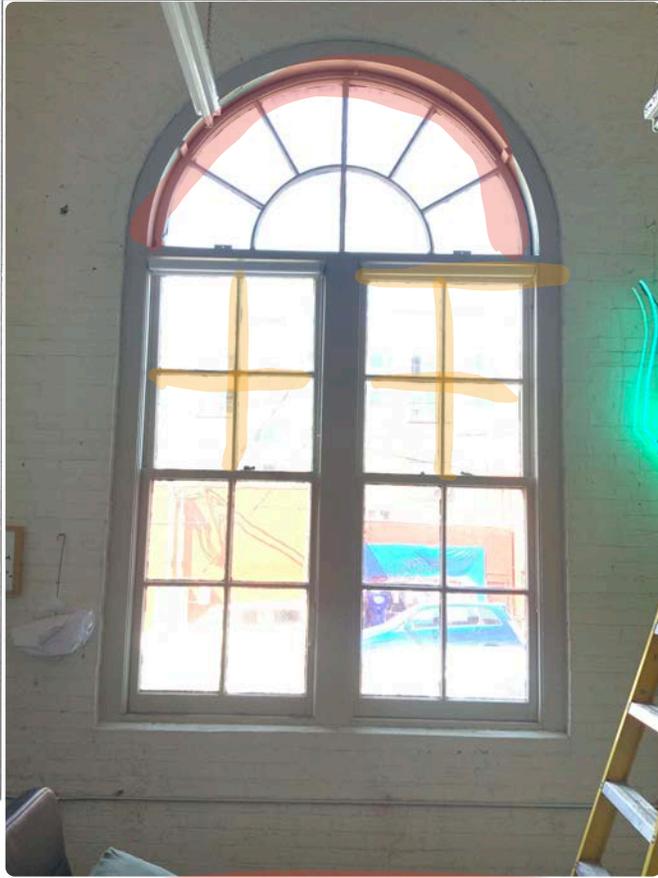
W108

Stool: MISSING

Frame/Pulley Stiles: FAIR

Sash/Muntins/Leading: FAIR

- PROFILES ARE 25%
DAMAGED

- Strip LOCKSTAPLES
- Missing LIFTS

- Strip + REFINISH
- Repair
- Replace

- Strip + REFINISH
- Repair TRANSOM
- Replace UPPER (R) RAIL

- Strip
- Repair SEALANTS
- Replace INT. STOP

~~RECOMMEND INT. STOP INSTALLATION~~

2X

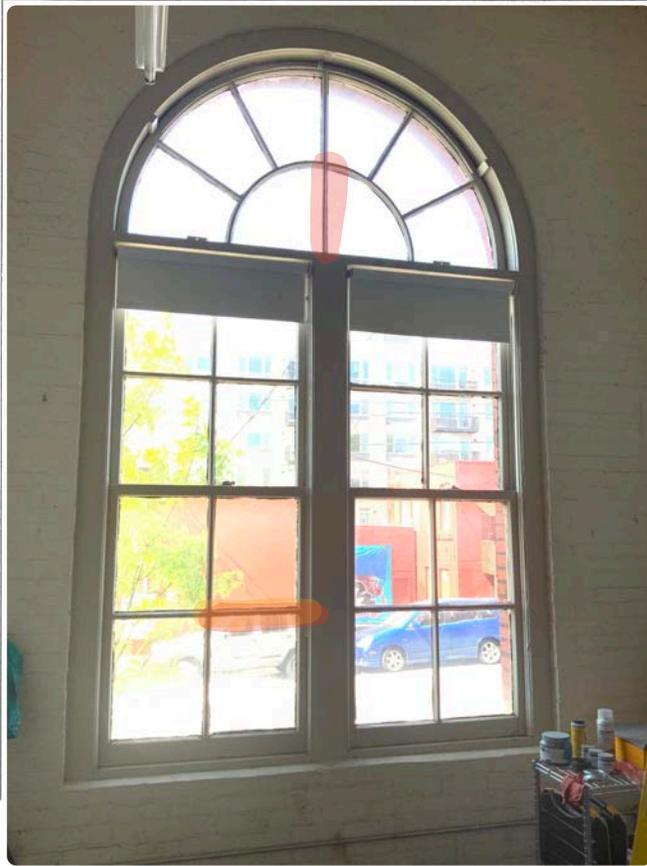
W109

MISSING SPOKE MUNTIN

Stool: MISSING

Frame/Pulley Stiles: FAIR

Sash/Muntins/Leading: FAIR

- Strip SASH
- Repair MUNTIN
- Replace

- Strip
- Repair PAINT
- Replace

- Replace 3X

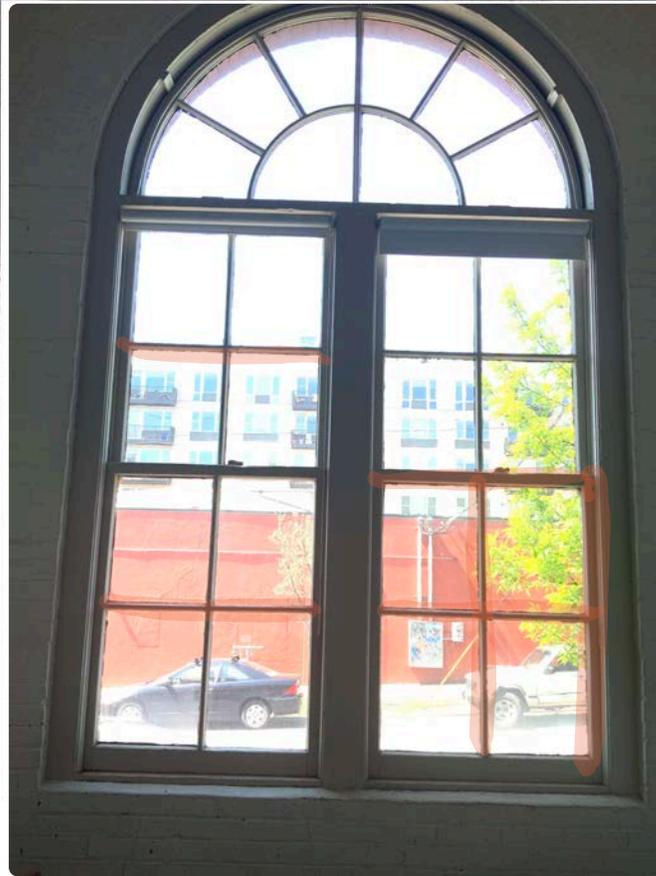
W110

Stool: MISSING

Frame/Pulley Stiles: FAIR

Sash/Muntins/Leading: FAIR

- Strip SASH
- Repair MUNTINS/MTNS RAIL
- Replace

- Strip
- Repair PAINT
- Replace

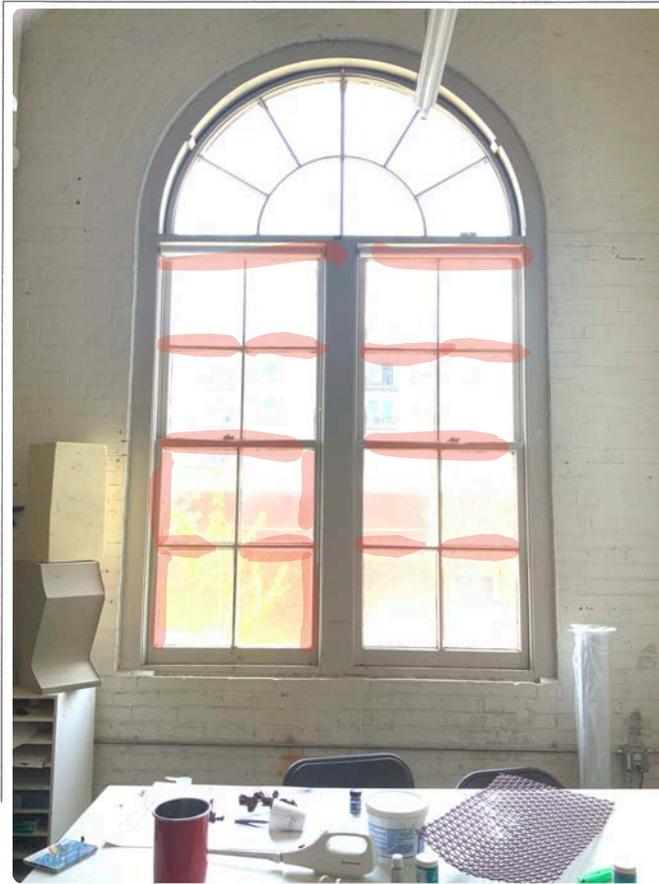
W111

Stool: MISSING

Frame/Pulley Stiles: FAIR

Sash/Muntins/Leading: POOR

Repair 60%

Replace OR NEED WORK

ails: MUNTINS ARE IN POOR CONDITION.
STILES ARE IN POOR CONDITION.
BARS + LOWER RAILES ARE IN FAIR CONDITION

Repair PAINT

Replace BX

Remarks: REPLACEMENT PARTS
