Yale Union Window Assessment

The Condition Assessment

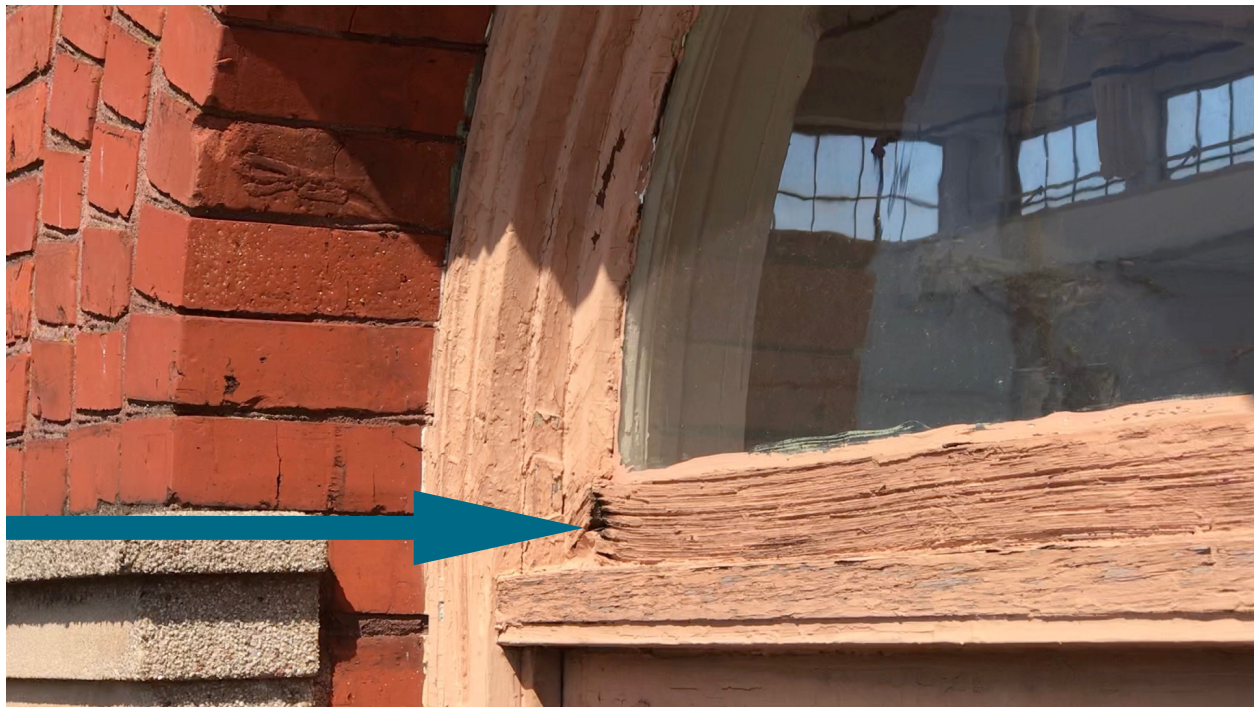
Again, left to right we have found that the grain orientation of the curved work on the transom sash and the transom brick mold to be incompatible

on the left hand side of the work. The highest grade of lumber must be select for this repair to be effective.
