Yale Union Window Assessment

The Condition Assessment

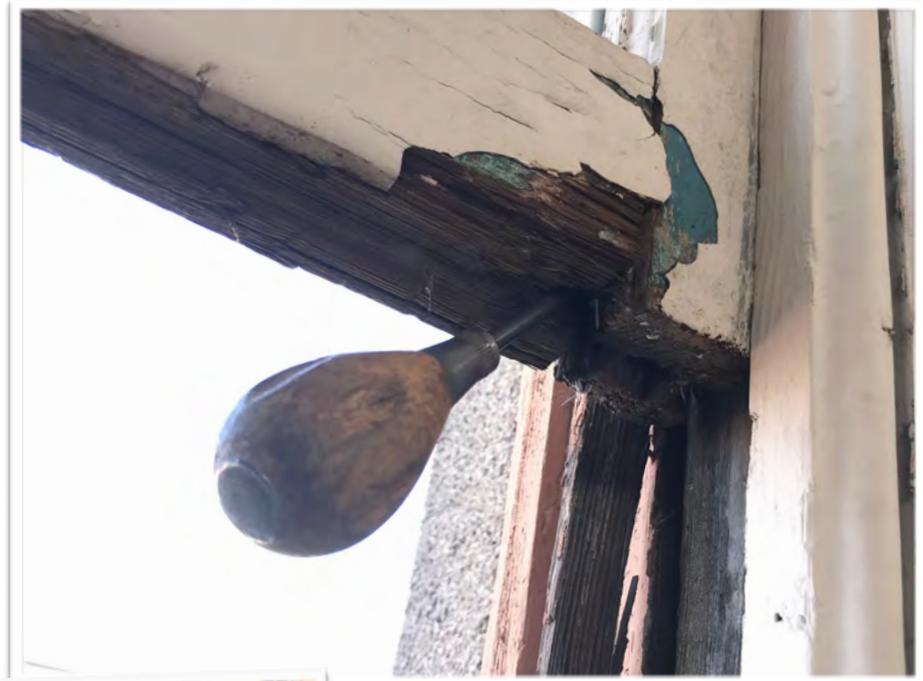
This image was converted to black and white to help indicate typical failure locations of coatings from UV damage and subsequent loss of historic substrate material where coatings are missing altogether. This is W214, and is used as an example for a baseline assessment of all of the W201-W222 windows.

Red indicates severe/high UV Damage, resulting in poor condition assessment.

Yellow indicates moderate/medium UV Damage, resulting in poor to fair condition assessment

Green indicates fair/minimal UV Damage, resulting in fair condition assessment
