Window Assessment--Exterior

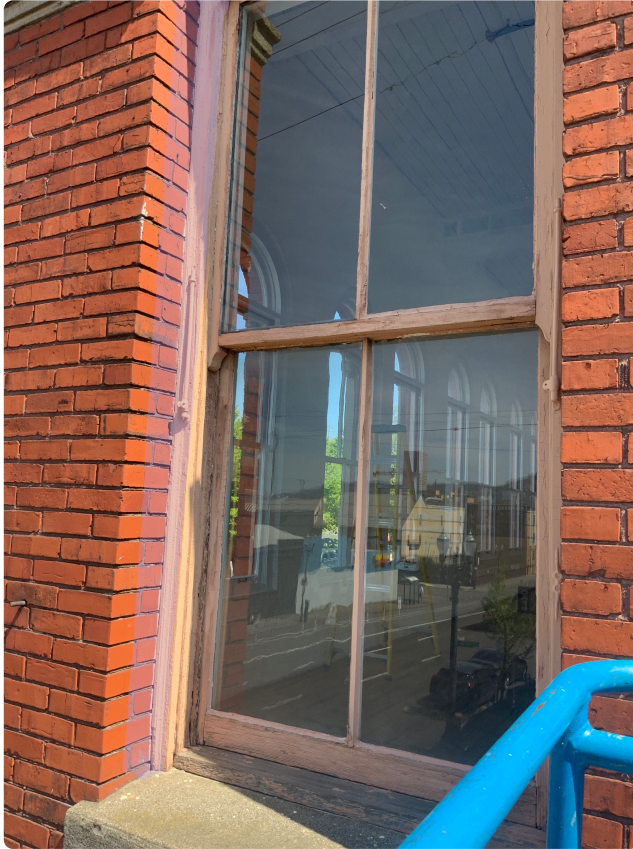
W201

DH w/TRANSOM

Sill: FAIR

Frame/Trim: POOR

Sash/Muntins/Leading: POOR

% to replace 100

- ☒ Old 4
☒ New 1
☐ Broken

- ☒ Strip EPOXY + REFINISH
☒ Repair
☐ Replace

- ☒ Strip REFINISH
☒ Repair
☐ Replace

Details: APPLY SEALANTS @ MASONRY
TO ALL LOCATIONS.

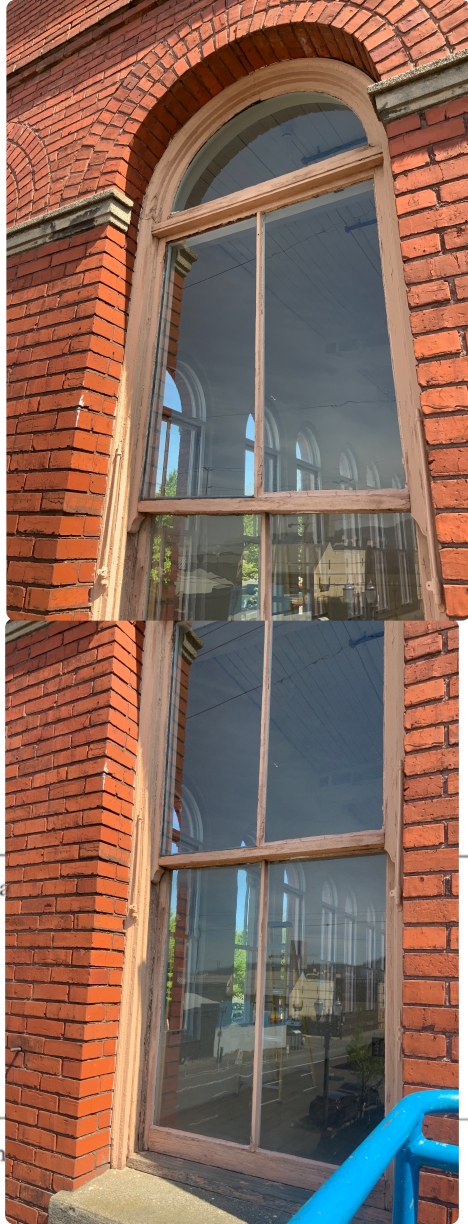
W202

Sill: FAIR

Frame/Trim: POOR

Sash/Muntins/Leading: POOR

% to replace 100 %

- ☒ Strip EPOXY + REFINISH
☐ Repair
☐ Replace

- ☒ Strip
☒ Repair + REFINISH
☐ Replace

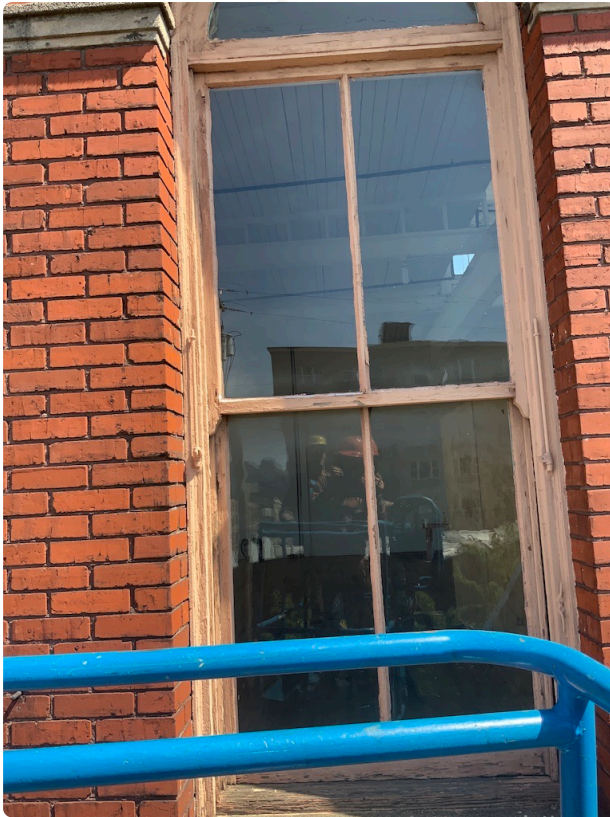
W203

Sill: POOR

Frame/Trim: POOR

Sash/Muntins/Leading: POOR

- ☒ Old 3
- ☒ New 1
- ☒ Broken 1

- ☒ Strip REFINISH
- ☒ Repair EPOXY
- ☐ Replace

- ☒ Strip
- ☒ Repair
- ☒ Replace PARTING BEAD

- ☒ Strip REFINISH
- ☒ Repair
- ☐ Replace

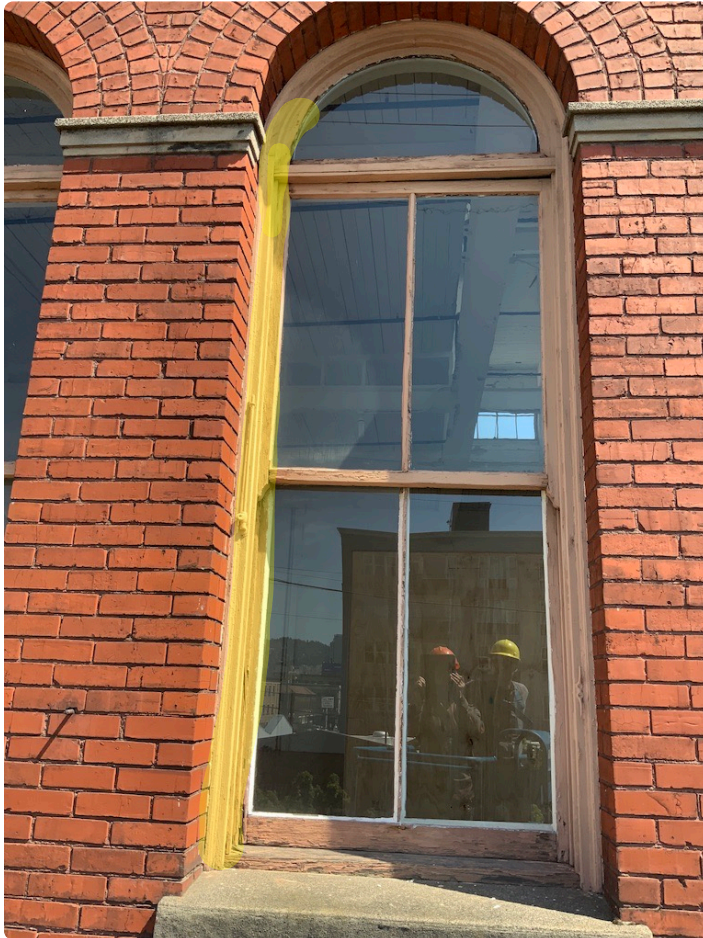
W204

Sill: POOR

Frame/Trim: POOR

Sash/Muntins/Leading: POOR

UPPER SASH HAS DROPPED
DECAY/ROT IN LEFT JOINERY

- ☒ Strip EPOXY +
- ☒ Repair REFINISH
- ☐ Replace

- ☒ Strip
- ☒ Repair
- ☐ Replace

- ☒ Strip REFINISH
- ☒ Repair
- ☐ Replace

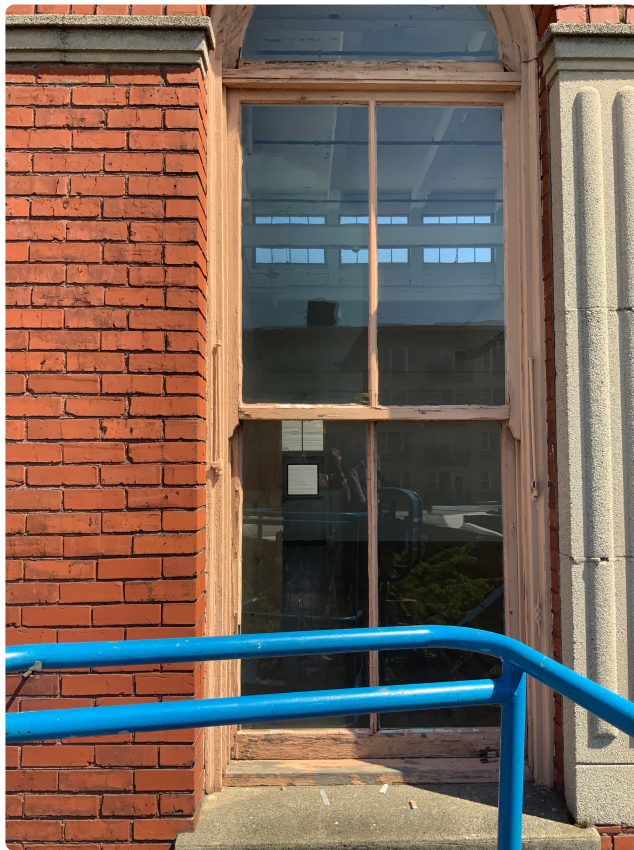
W205

Sill: FAIR

Frame/Trim: FAIR

Sash/Muntins/Leading: POOR

- ☒ Strip EPOXY
☒ Repair REFINISH
☐ Replace

- ☒ Strip REFINISH
☒ Repair
☐ Replace

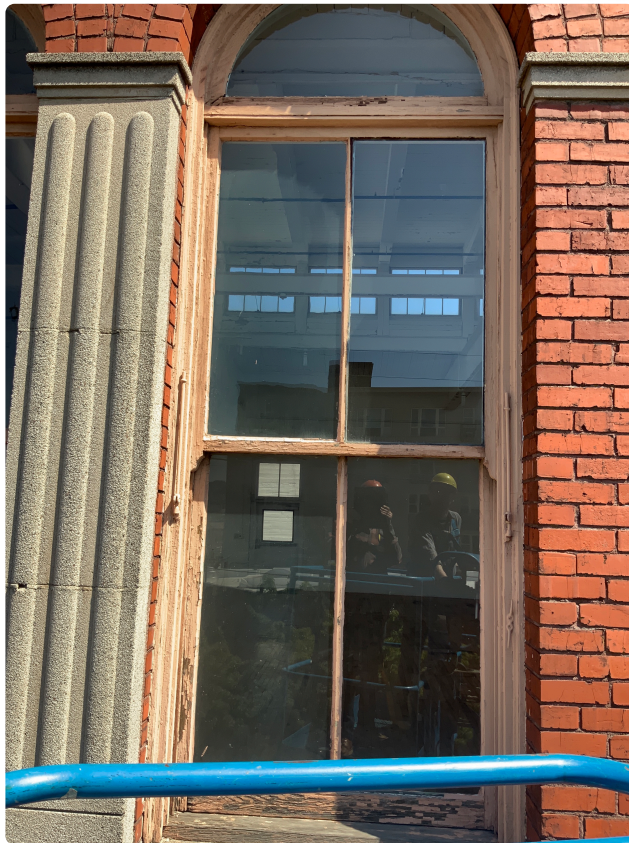
W 206

Sill: POOR

Frame/Trim: POOR

Sash/Muntins/Leading: POOR

- ☒ Strip EPOXY +
- ☒ Repair REFINISH
- ☐ Replace

- ☒ Strip REFINISH
- ☒ Repair
- ☐ Replace

- ☒ Strip STILE + RAIL
- ☒ Repair JOINERY @
- ☐ Replace LEFT SIDE

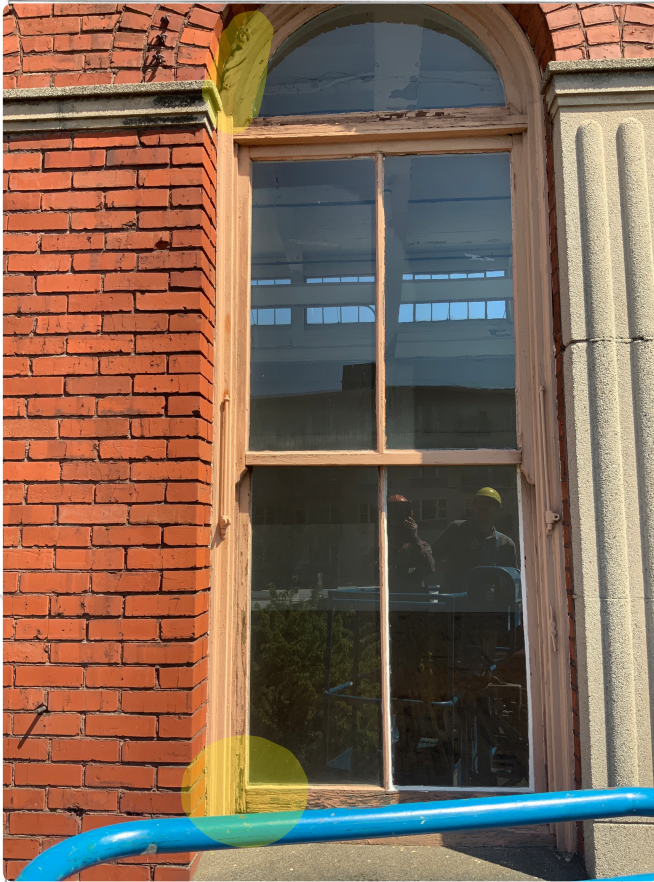
W207

Sill: FAIR

Frame/Trim: POOR

LEFT STILE + RAIL JOINT
HAS DECAY

- ☒ Strip REFINISH
☒ Repair
☐ Replace

- ☒ Strip
☒ Repair
☒ Replace LOWER RAIL

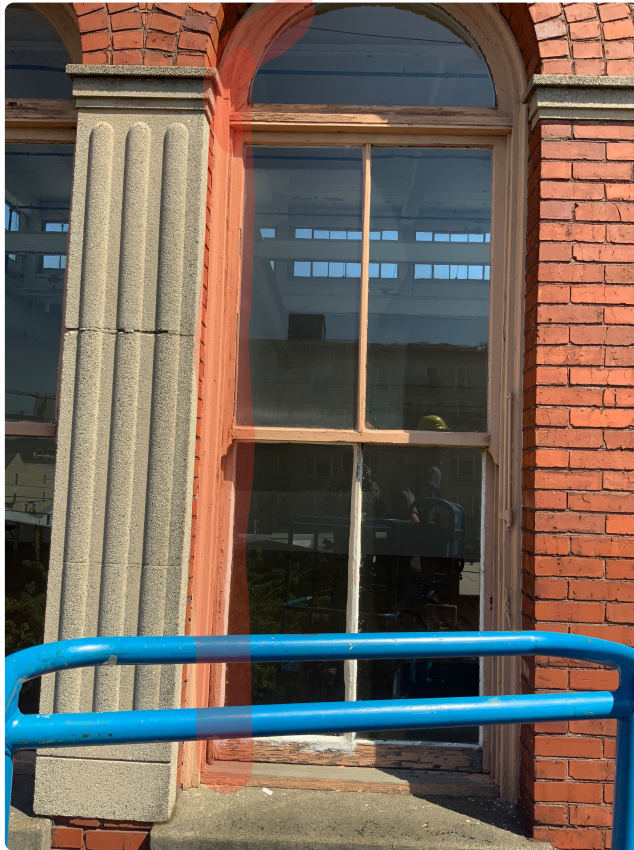
W208

Details: JOINERY FAILURE @
LEFT HAND JOINTS OF
DH + TRANSOM SASH.

Sill: FAIR

Frame/Trim: POOR

Sash/Muntins/Leading: POOR

☒ Strip REFINISH

☒ Replace PARTING BEAD

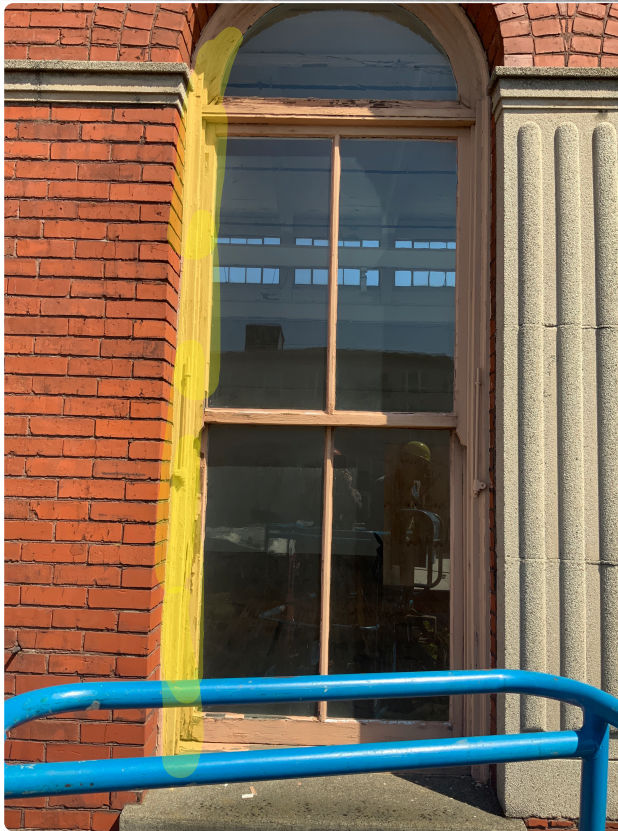
W209

Details: BLIND STOP LEFT and ALL LEFT HAND JOINTERY IS DECAYING.

Sill: FAIR

Frame/Trim: POOR

Sash/Muntins/Leading: POOR

☒ Strip + REFINISH

☒ Replace BLIND STOP

☒ Strip REFINISH

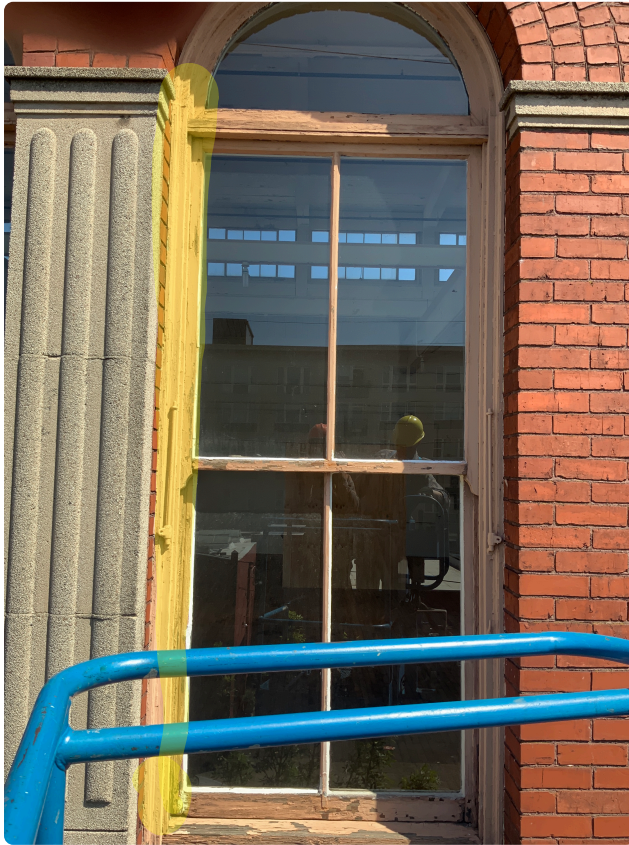
W210

Details: TYPICAL LEFT HAND JOINERY
DECAY

Sill: POOR

Frame/Trim: POOR

POOR

- ☒ Strip REFINISH
☐ Repair
☐ Replace

- ☒ Strip REFINISH
☐ Repair
☒ Replace BLIND STOP

- ☒ Strip REFINISH
☒ Repair
☐ Replace

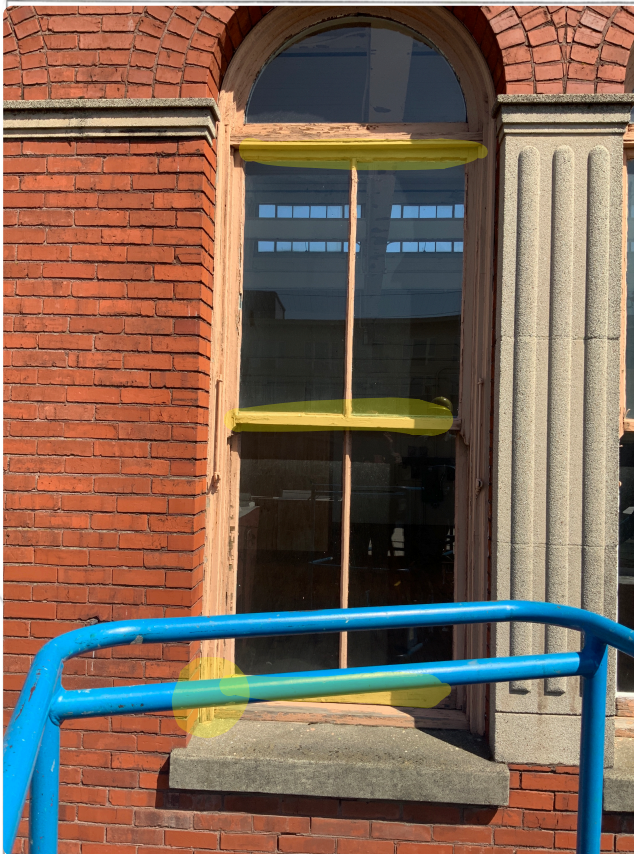
W 211

Details: TRIM HAS SEPERATED FROM
FRAME @ LEFT SILL
CONNECTION.
SASH RAILS ARE
CANDIDATES FOR REPLACEMENT
SASH ARE IN OVERALL POOR CONDIN.

Sill: POOR

Frame/Trim: POOR

Sash/Muntins/Leading: POOR

- ☒ Strip EPOXY + REFINISH
☒ Repair
☐ Replace

- ☒ Strip REFINISH
☒ Repair
☐ Replace

- ☒ Strip REFINISH
☒ Repair
☒ Replace MEETING
LOWER RAIL

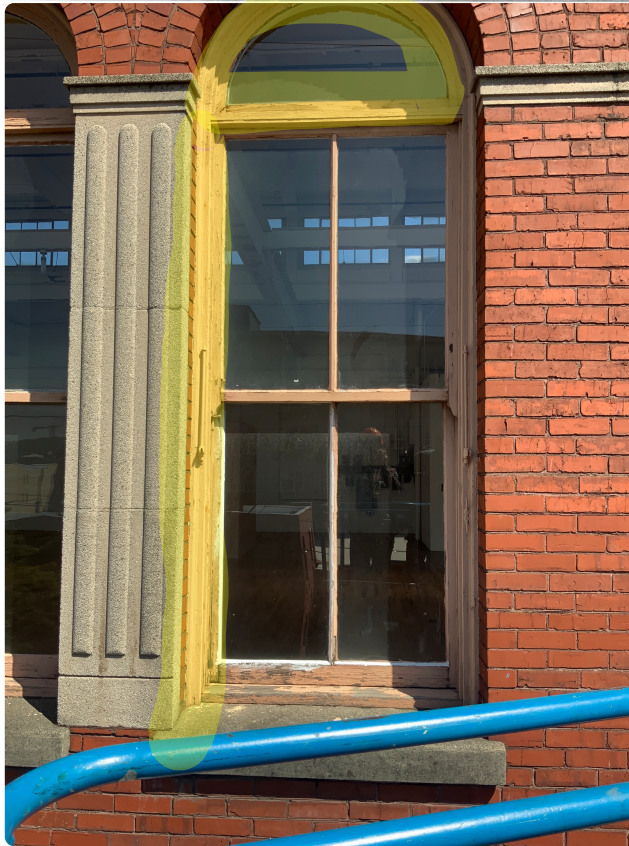
W212

Sill: FAIR

Frame/Trim: POOR

Sash/Muntins/Leading: POOR

TRANSOM IS POOR/CRITICAL

TYPICAL LEFT HAND SASH

JOINERY FAILURE

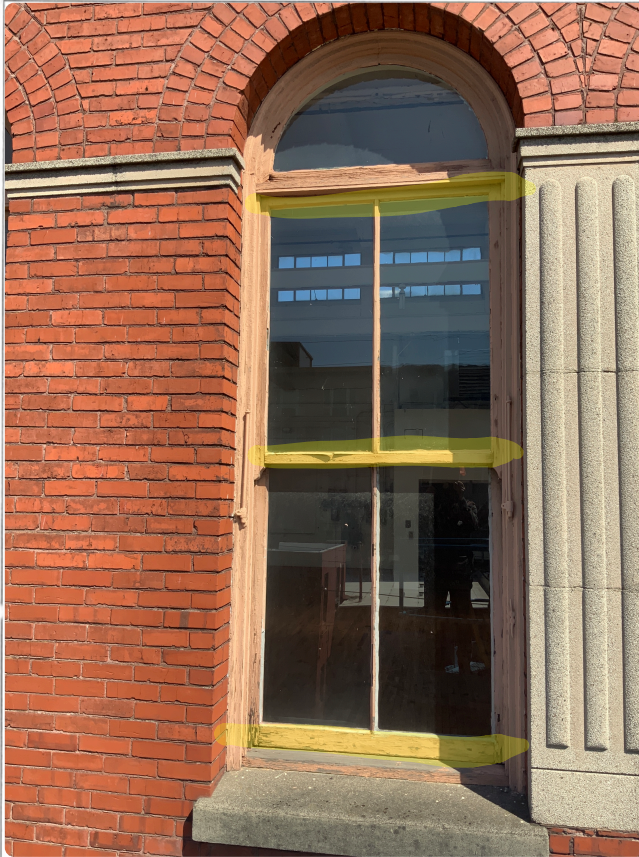
W213

Details: **SASH ARE APPROACHING
CRITICAL CONDITION**

Sill: FAIR

Frame/Trim: FAIR

Sash/Muntins/Leading: **POOR**

- ☒ Strip **REFINISH**
☐ Repair
☐ Replace

- ☒ Strip
☒ Repair
☒ Replace **RAILS**

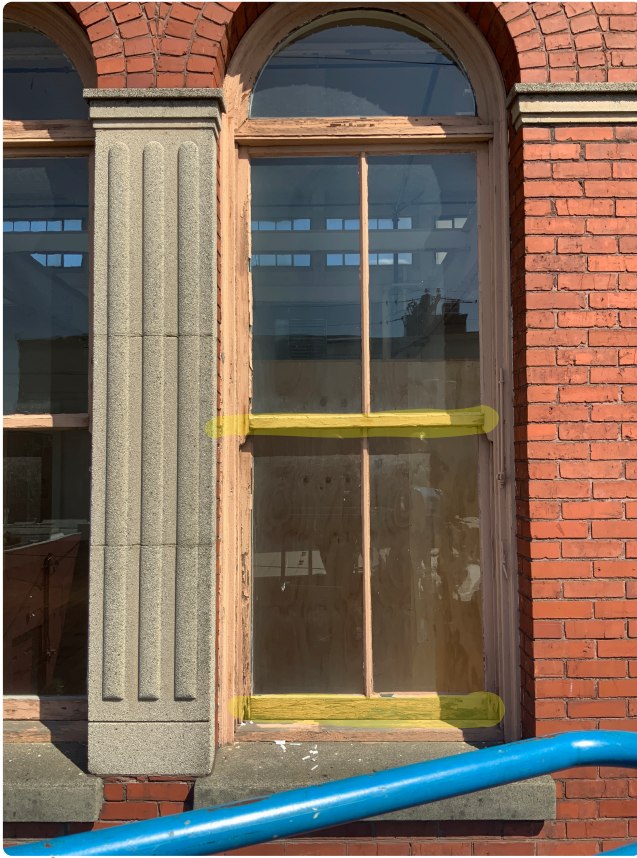
W214

Details: **OVERALL POOR CONDITION**

Sill: FAIR

Frame/Trim: **POOR**

CRITICAL

- ☒ Strip **REFINISH**
- ☐ Repair
- ☐ Replace

- ☒ Strip
- ☒ Repair
- ☒ Replace **BLIND STOP**

- ☒ Strip
- ☒ Repair
- ☒ Replace **AS NEEDED**

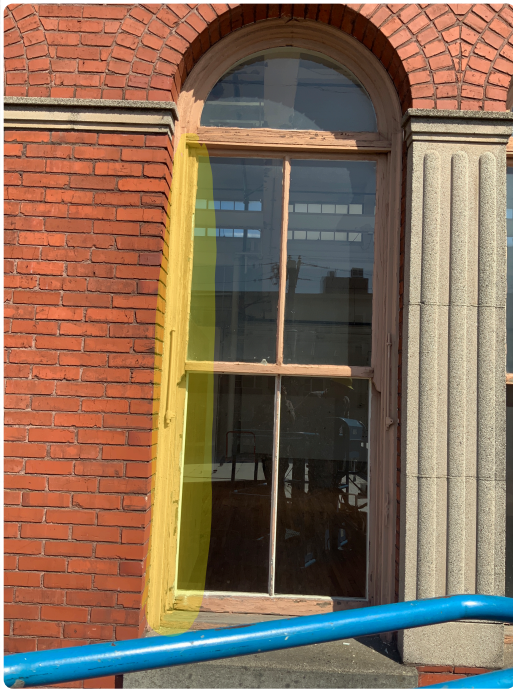
W215

Sill: FAIR

Frame/Trim: FAIR

POOR

Details: TYPICAL LEFT HAND JOINERY FAILURE.

- ☒ Strip REFINISH
☐ Repair
☐ Replace

- ☒ Strip
☒ Repair
☐ Replace

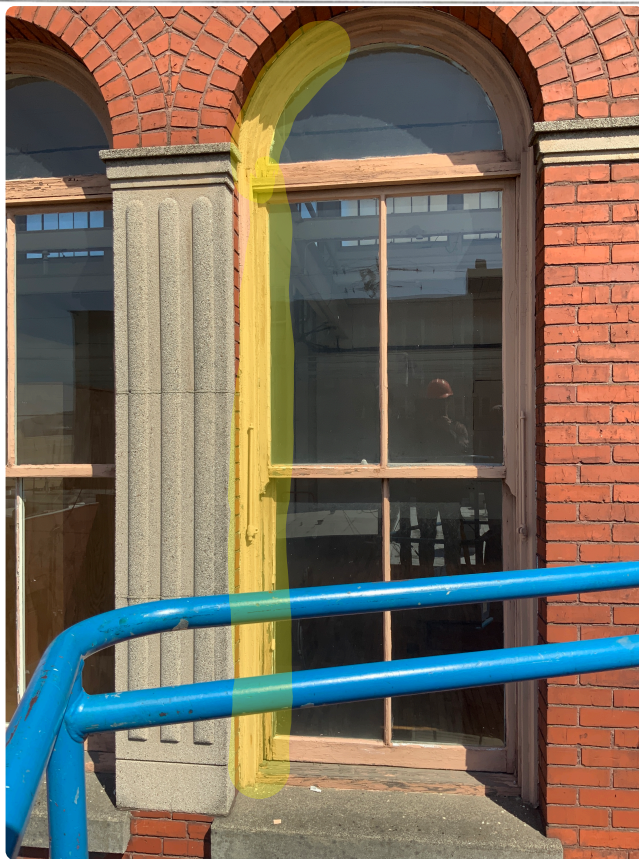
W216

Details: LEFT HAND JOINERY
FAILURE TYPICAL

Sill: FAIR

Frame/Trim: FAIR

POOR

- ☒ Strip EPOXY + REFINISH
- ☐ Repair
- ☐ Replace

- ☒ Strip REFINISH
- ☐ Repair
- ☐ Replace

- ☒ Strip
- ☒ Repair
- ☐ Replace

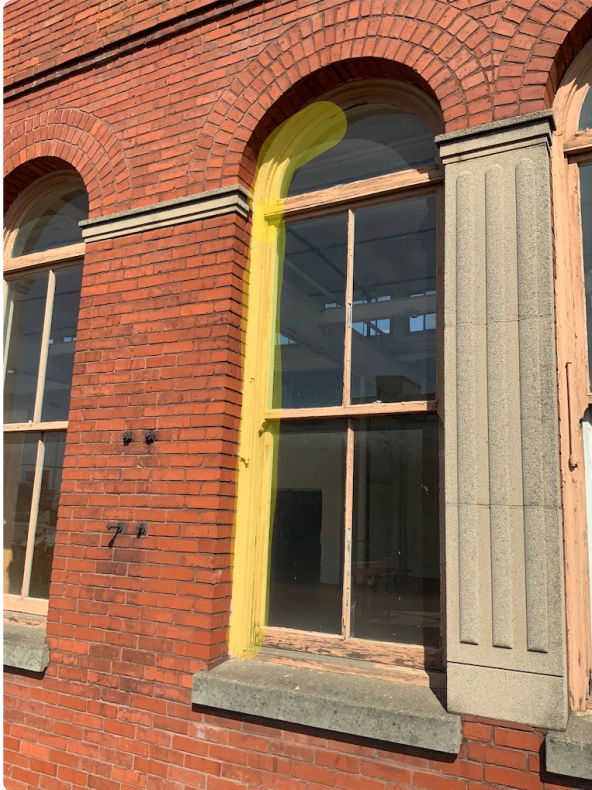
W 217

Details: **LEFT HAND JOINERY
FAILURE - TYPICAL**

Sill: **FAIR**

Frame/Trim: **FAIR**

Sash/Muntins/Leading: **POOR**

- ☒ Strip **REFINISH**
☐ Repair
☐ Replace

- ☒ Strip **REFINISH**
☒ Repair
☐ Replace

- ☒ Strip
☒ Repair
☐ Replace

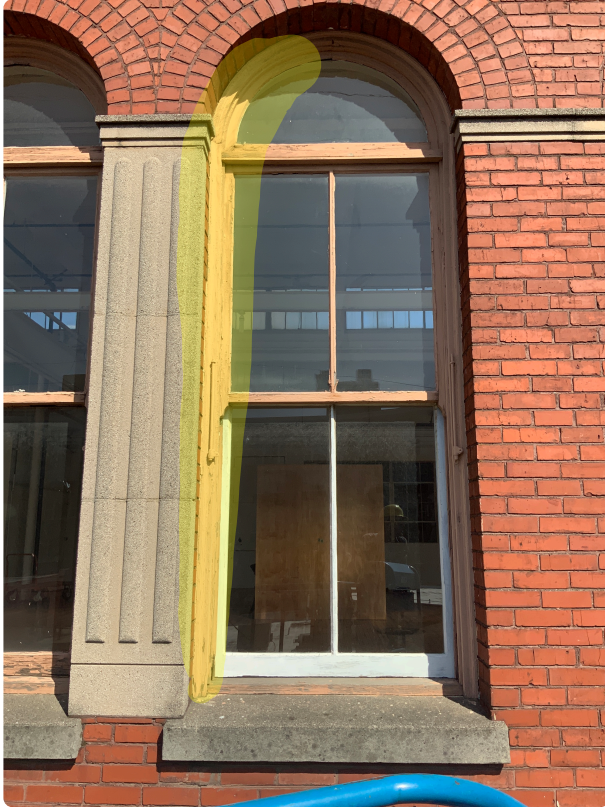
W218

Details: TYPICAL CASH JOINERY
FAILURE @ LEFT SIDE.

Sill: FAIR

Frame/Trim: FAIR

Sash/Muntins/Leading: POOR

- ☒ Strip EPoxy + REFINISH
☒ Repair
☐ Replace

- ☒ Strip REFINISH
☐ Repair
☐ Replace

- ☒ Strip
☒ Repair
☐ Replace

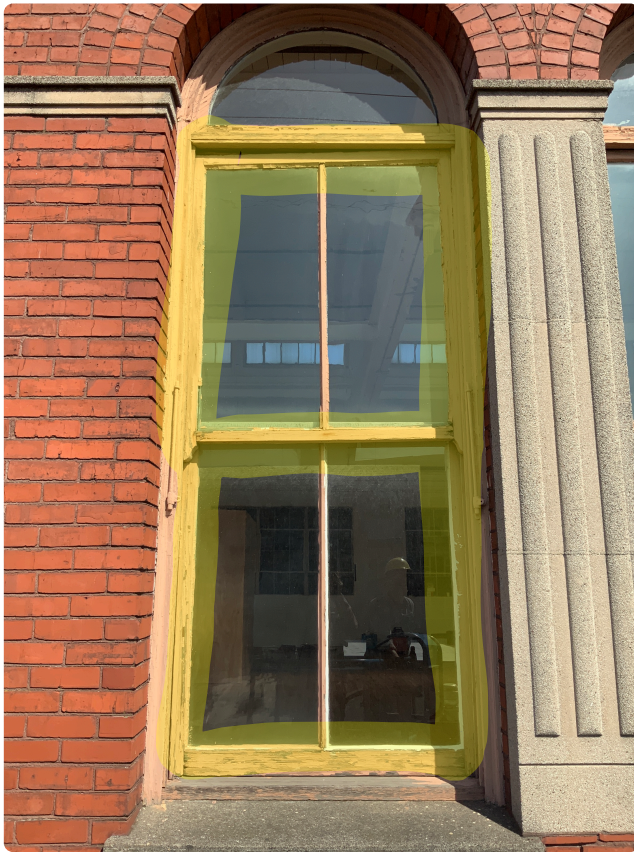
W219

Sill: FAIR

Frame/Trim: POOR

CRITICAL

☒ Strip EPOXY + REFINISH

☒ Strip REFINISH

☒ Replace DH SASH

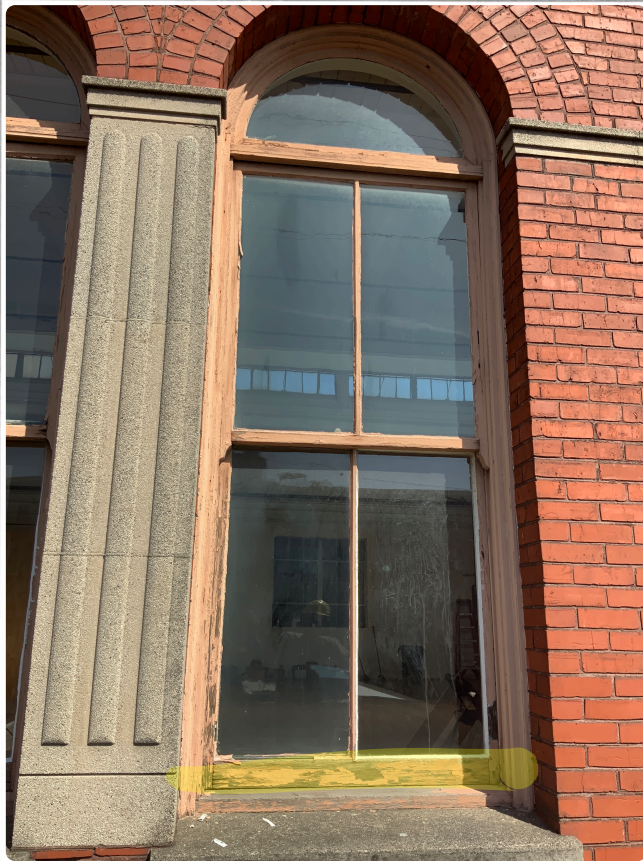
W 220

Sill: POOR

Frame/Trim: POOR

Sash/Muntins/Leading: POOR

- ☒ Strip REFINISH
☐ Repair
☐ Replace

- ☒ Strip
☒ Repair
☐ Replace

- ☒ Strip
☒ Repair LOWER RAIL
☐ Replace

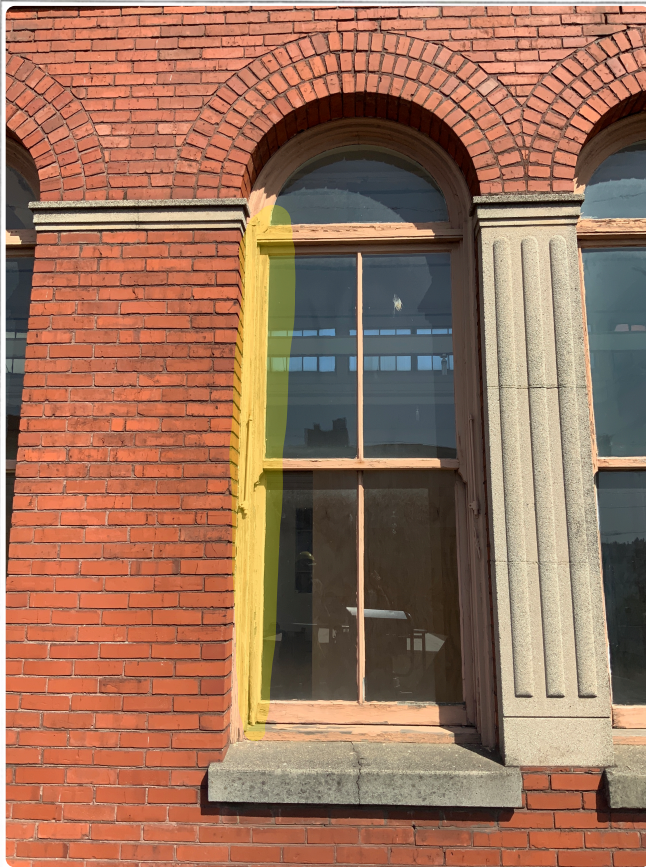
W 221

Sill: FAIR

Frame/Trim: *PUDR*

Sash/Muntins/Leading: *POOR*

☒ Strip *REFINISH*

~~Strip~~ REFINISH

☒ Replace PARTING BEAD

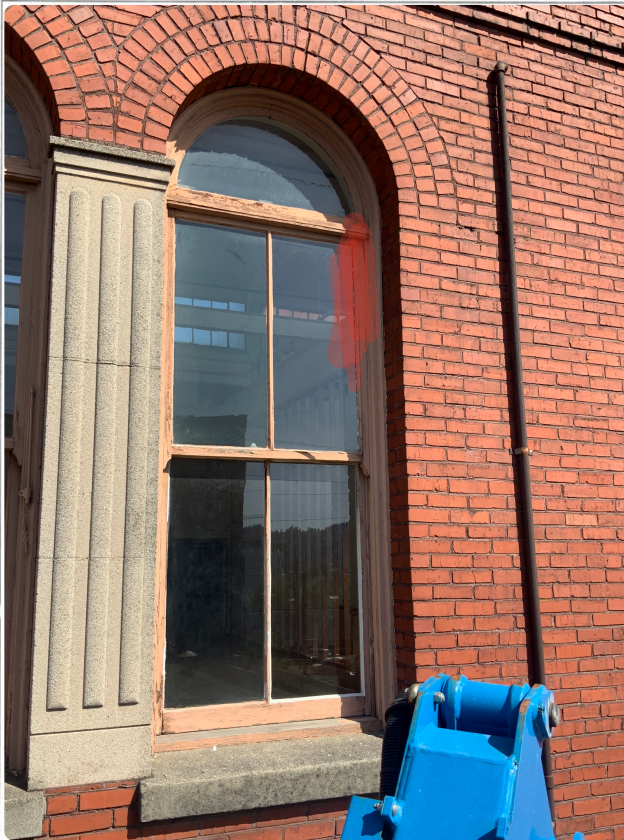
W222

Details: UPPER RIGHT STILE IS
MISSING MATERIAL

Sill: FAIR

Frame/Trim: POOR

POOR

- ☒ Strip
☒ Repair
☐ Replace

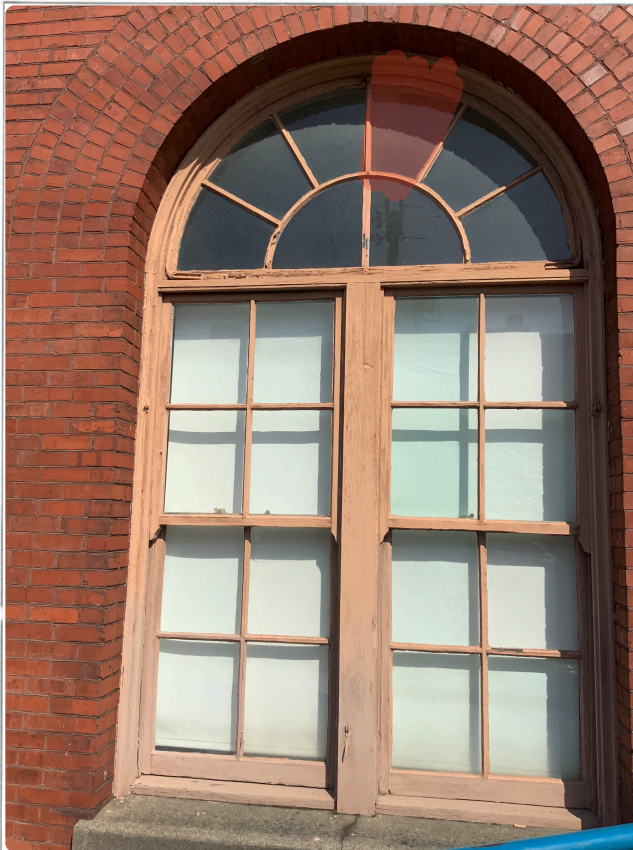
Location: W108

Sill: FAIR

Frame/Trim: FAIR

OOD Sash/Muntins/Leads: FAIR

Details: BROKEN TRANSOM LITE

- ☒ Strip REFINISH
- ☐ Repair
- ☐ Replace

- ☒ Strip
- ☒ Repair
- ☒ Replace MUNTINS

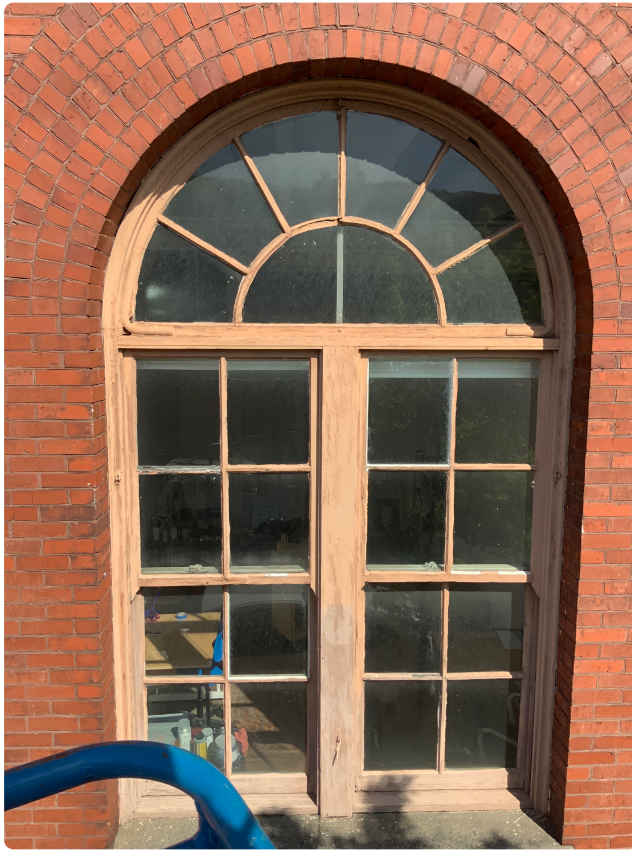
W109

Sill: FAIR

Frame/Trim: FAIR

POOR

☒ Strip REFINISH

☒ Replace MUNTINS/BARS

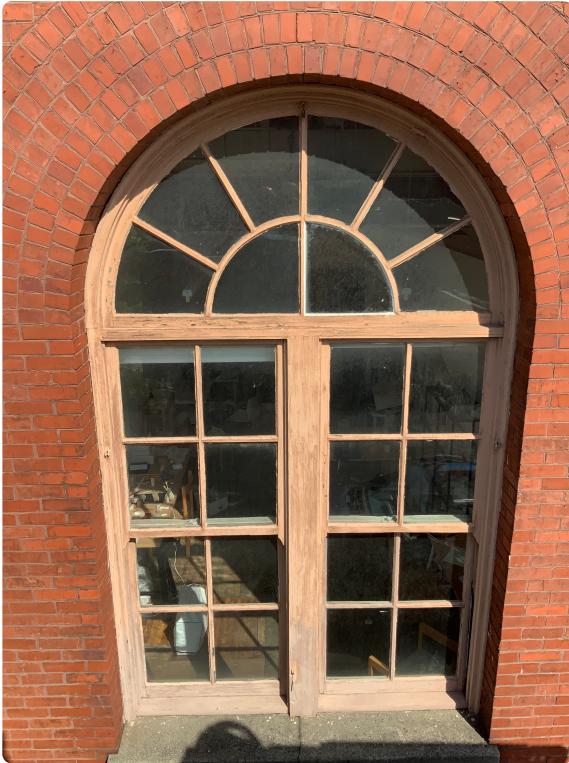
W110

Sill: FAIR

Frame/Trim: FAIR

Sash/Muntins/Leading: FAIR

- ☒ Strip REFINISH
☐ Repair
☐ Replace

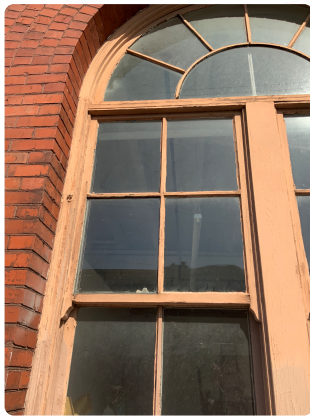
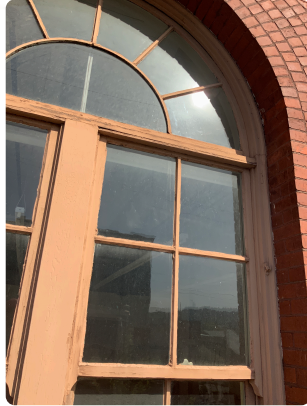
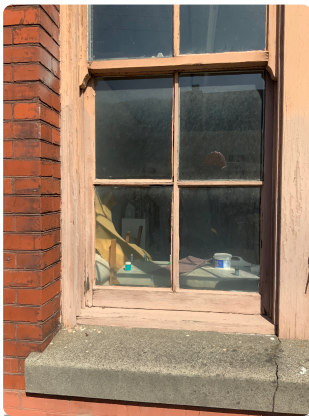
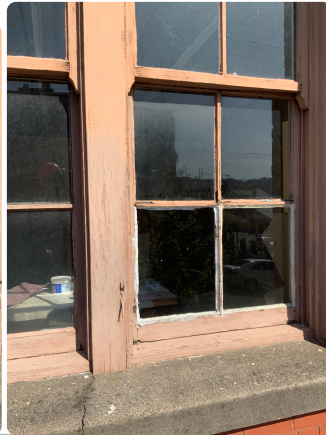
W111

Sill: FAIR

Frame/Trim: FAIR

Sash/Muntins/Leading: FAIR

- ☒ Strip **REFINISH**
☐ Repair
☐ Replace

- ☒ Strip
☒ Repair
☒ Replace **MUNTINS/BARS**
